APPENDIX A – HYDROMODIFICATION SITE CROSS-SECTIONS, BANKS, AND PHOTOGRAPHS

PURPOSE AND MEASUREMENT PROTOCOL

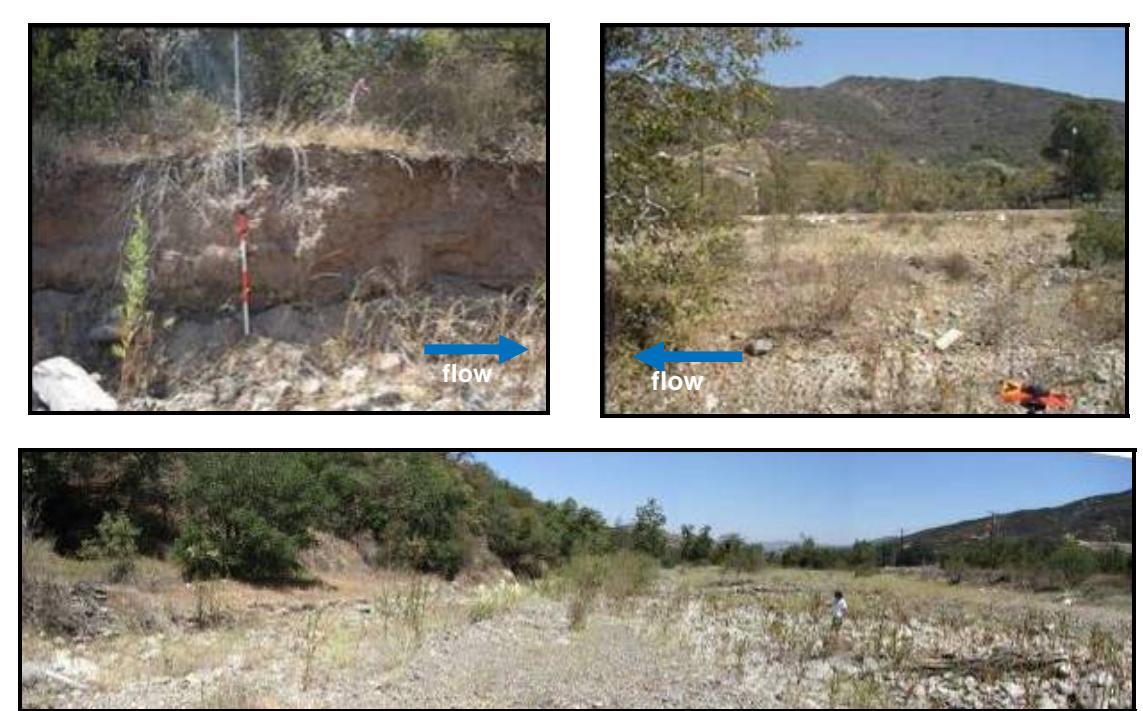
Figure A.1 – Santiago_A

LB U-MW-C

Near Santiago_A looking downstream

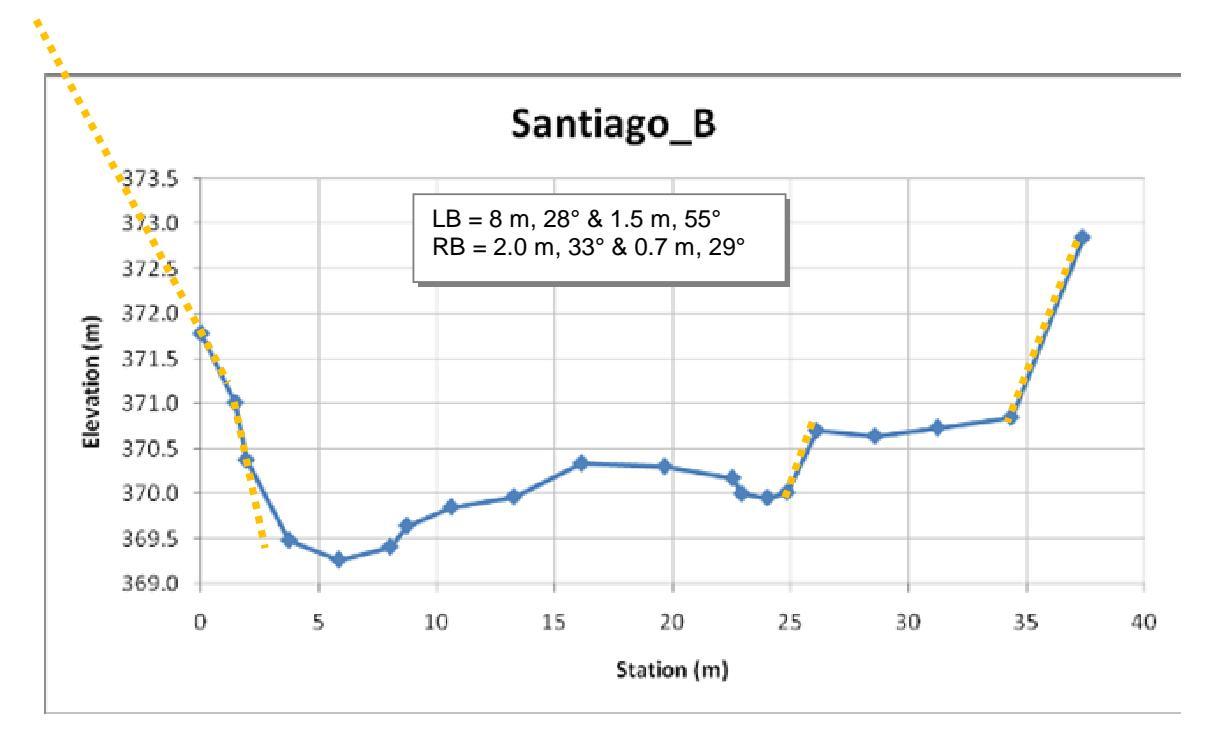
Figure A.2 – Santiago_B

Note(s): Flood control embankment constructed on right bank (date unknown)

LB S-CONFND

RB S-CONSTR (upper) and U-MW-UC (lower)

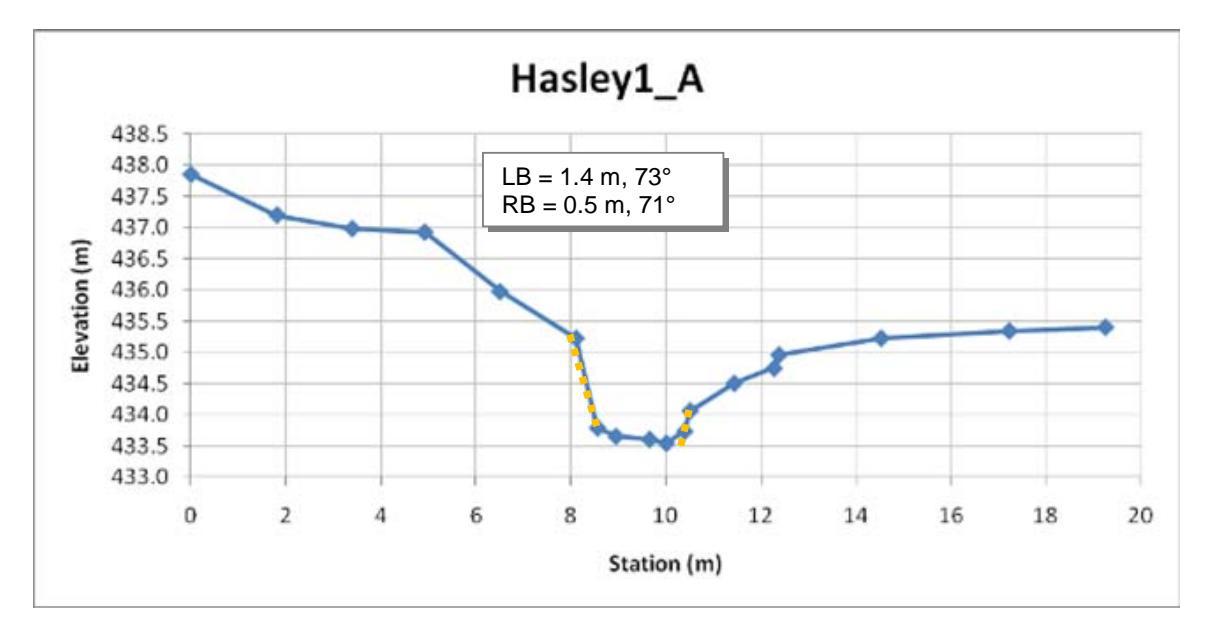
Figure A.3 – Hasley1_A

Note(s): Site was graded and realigned/partially channelized during development circa 2002.

LB U-MW-PC

RB U-MW-PC

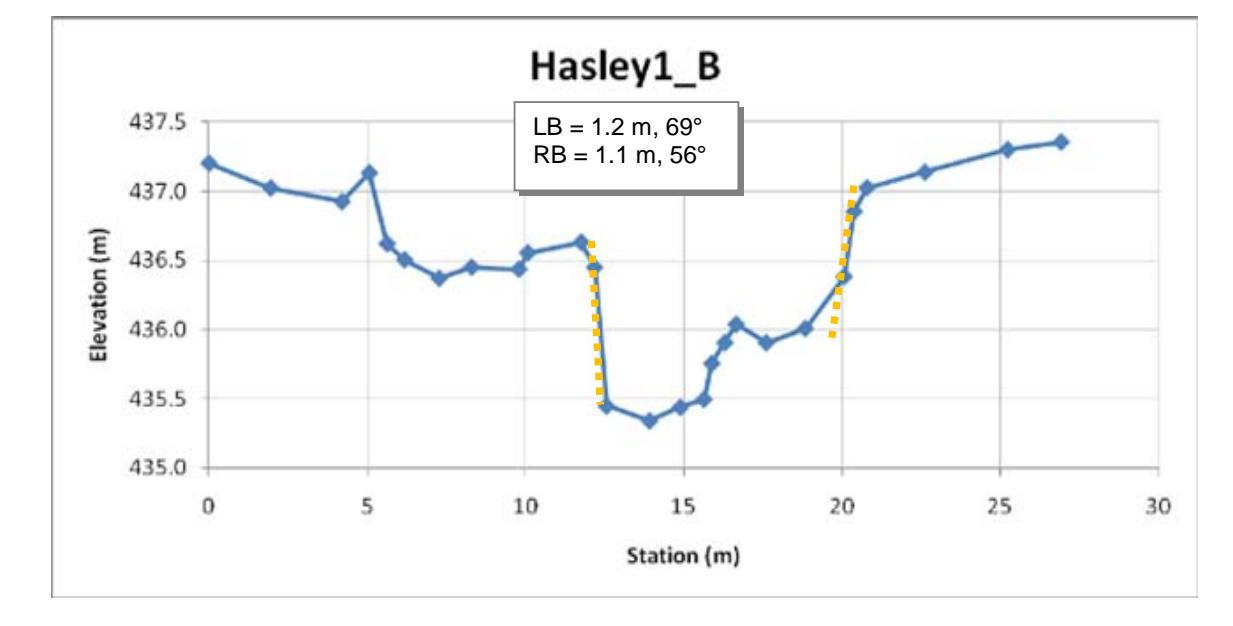
Figure A.4 – Hasley1_B

Note(s): Site was graded and realigned/partially channelized during development circa 2002.

LB U-MW-PC

RB U-MW-PC

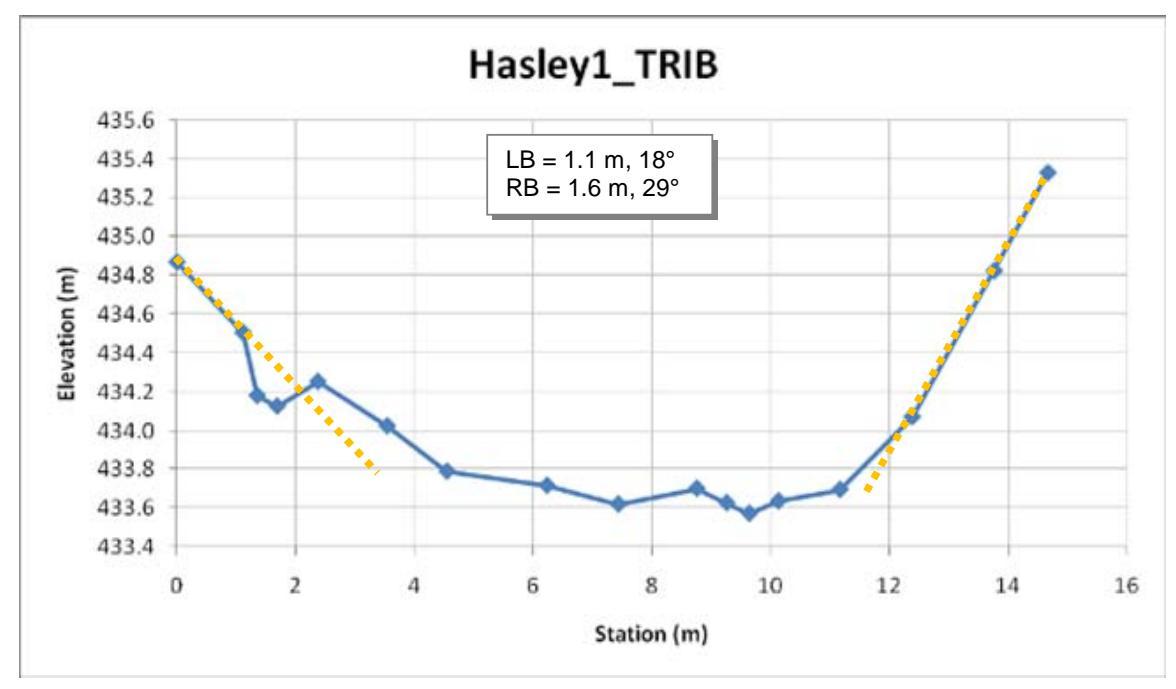
Figure A.5 – Hasley1_TRIB

Note(s): Right bank is unconsolidated fill (i.e., built up higher than original floodplain for lot creation)

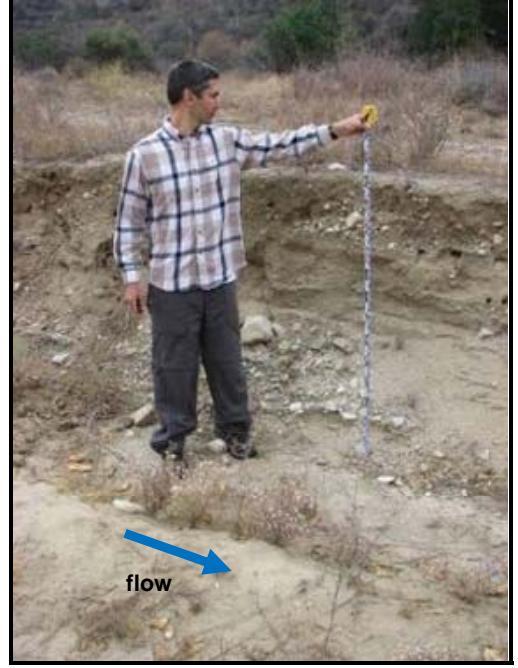
Figure A.6 – Hasley2_A

LB U-FAILED

Near Hasley2_A (survey captured geometry of a recently failed bank ($<30^{\circ}$ vs. pictured $>75^{\circ}$))

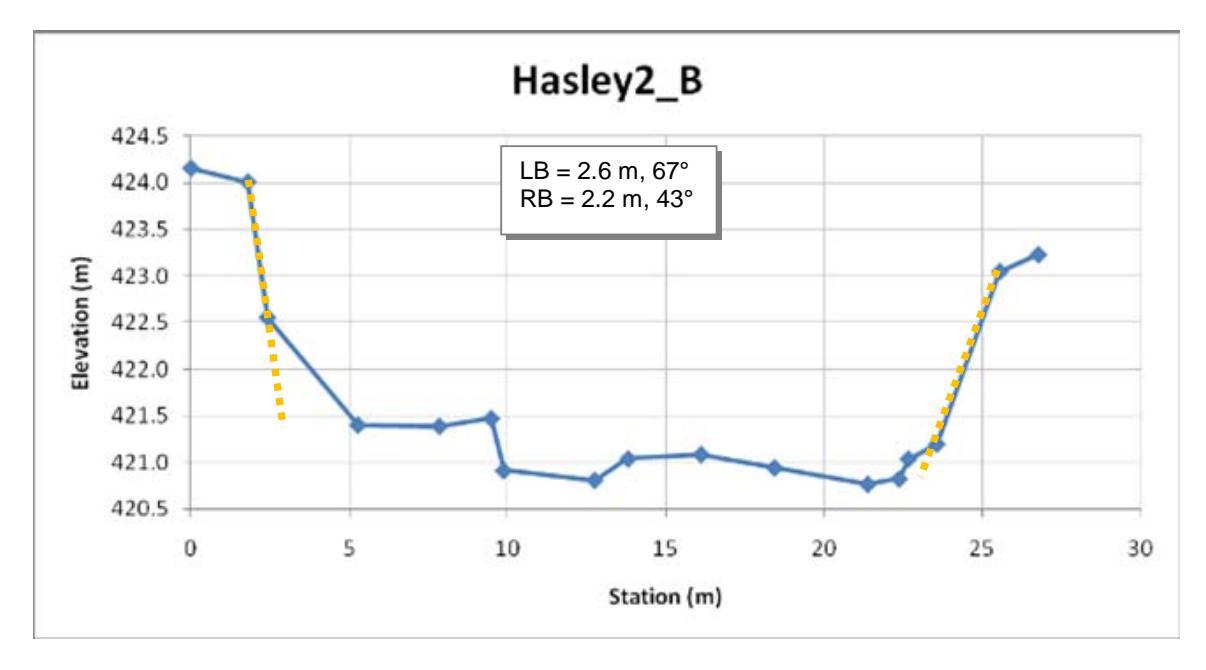
Figure A.7 – Hasley2_B

LB U-MW-C

Rilling evident, but no mass wasting, possibly graded

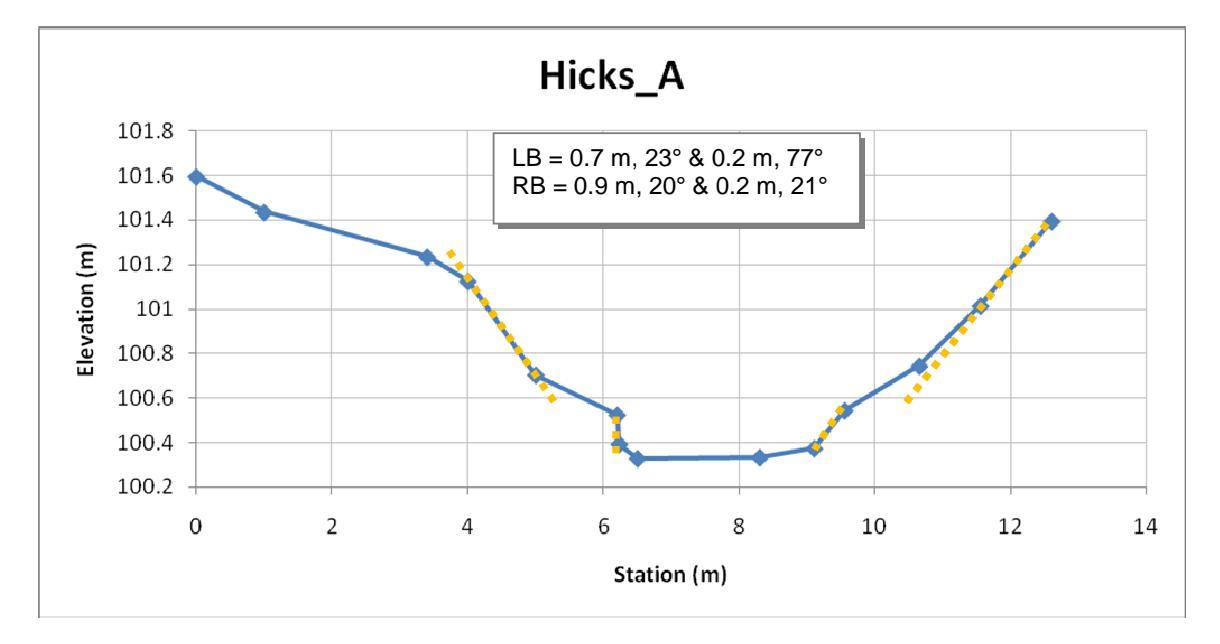
Figure A.9 – Hicks_A

LB STABLE-PC (upper) U-MW-UC (lower) RB

Unconsolidated bed of pre-incised channel

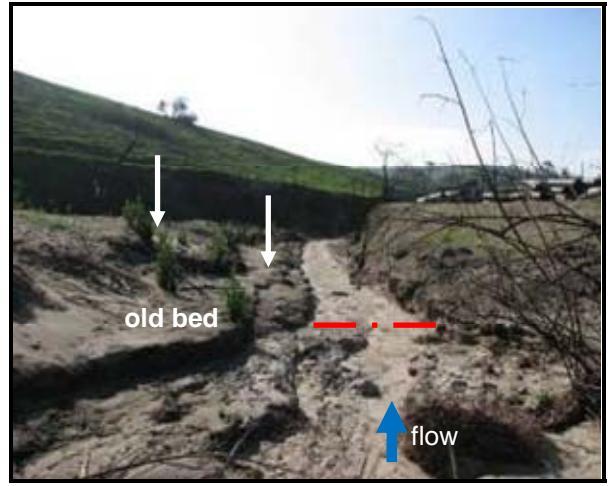
Figure A.10 – Hicks_B

LB U-FAILED (upper) and U-FAILED RB U-MW-PC (lower)

Fluvial activity across failed surfaces makes it difficult to re-project pre-failure geometry

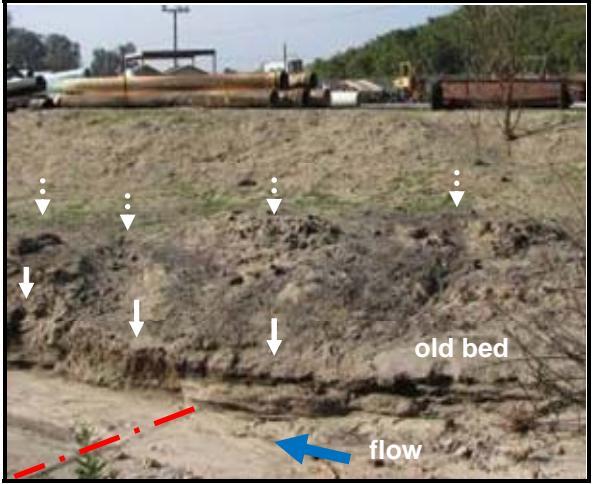
Historic MW (dotted arrows) converges with recent MW (solid arrows) just downstream of survey. Just upstream of cross section, MW through pre-incised bed

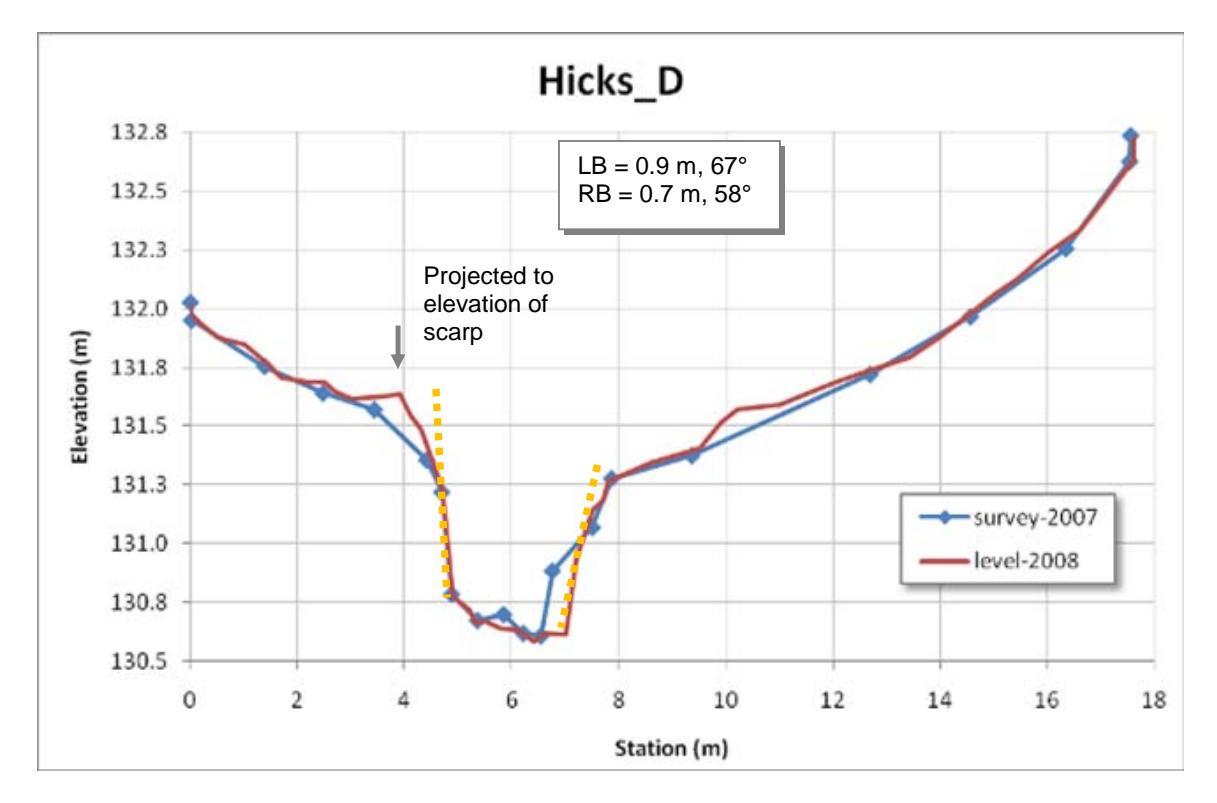
Figure A.12 – Hicks_D

LB U-MW-PC

RB U-MW-PC

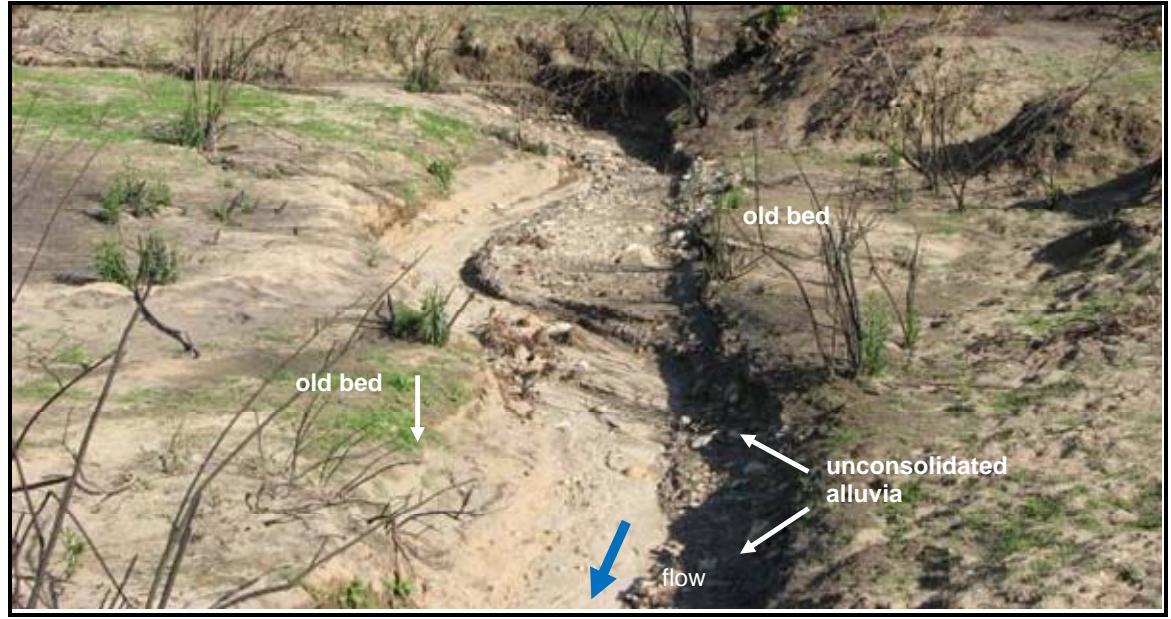
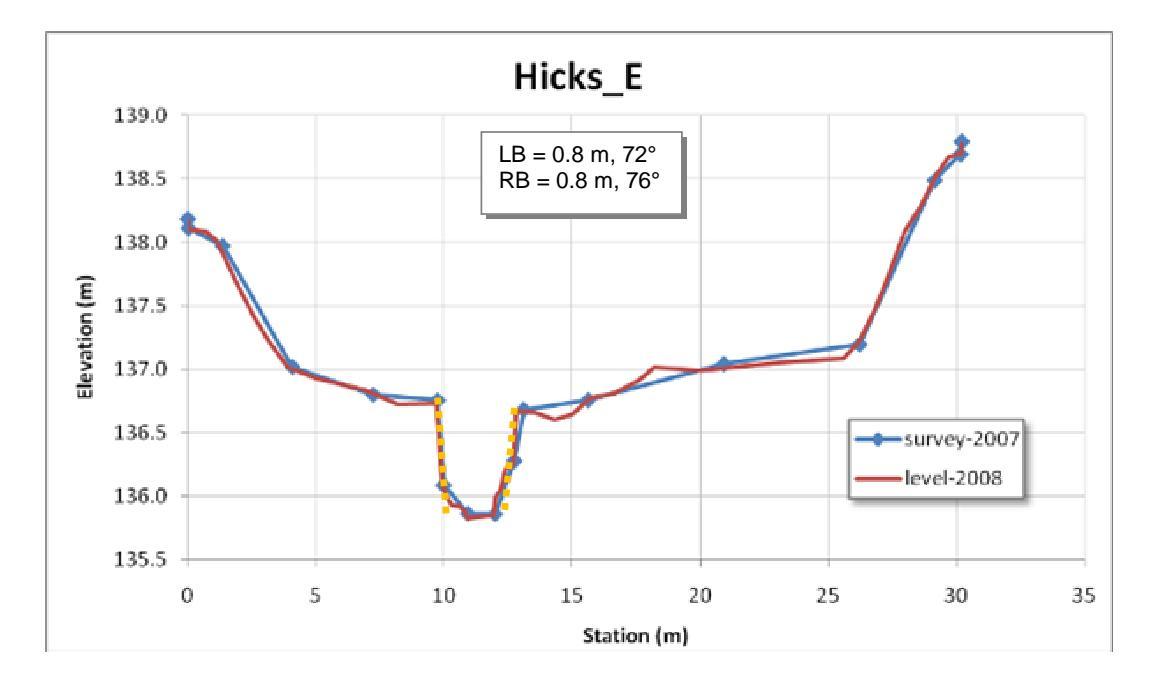
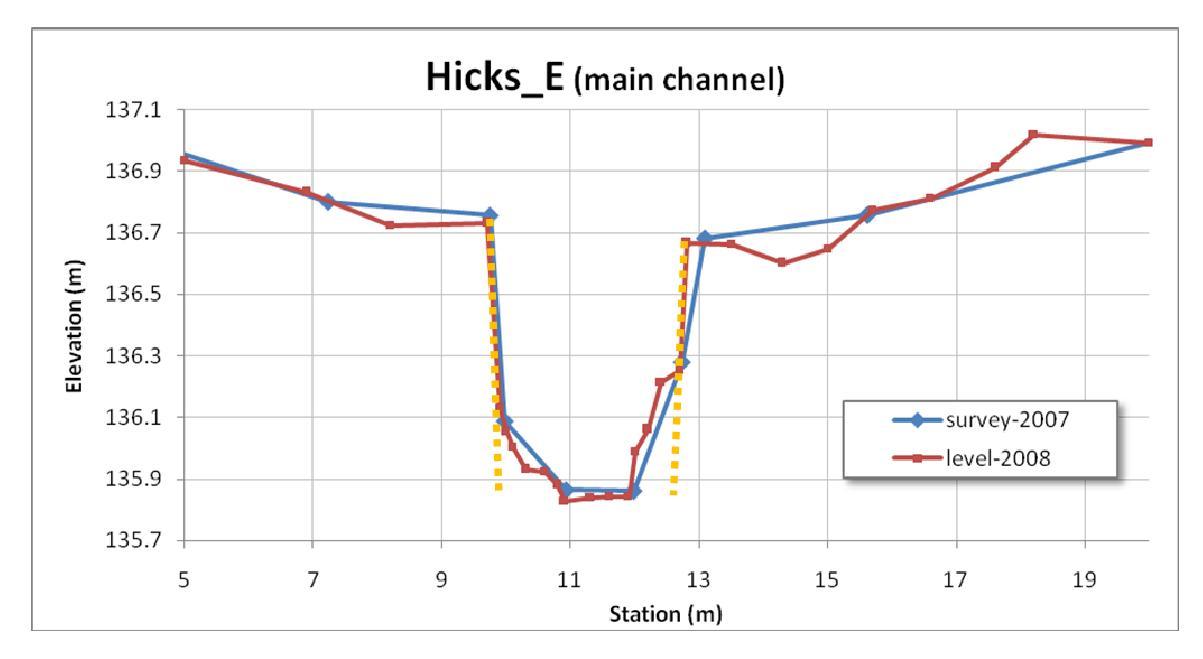
Figure A.13 – Hicks_E

LB U-MW-PC

RB U-MW-PC

The scarp in the pre-fire (2007) photograph of the right bank below is consistent with the post-fire (2008) photograph on the previous page.

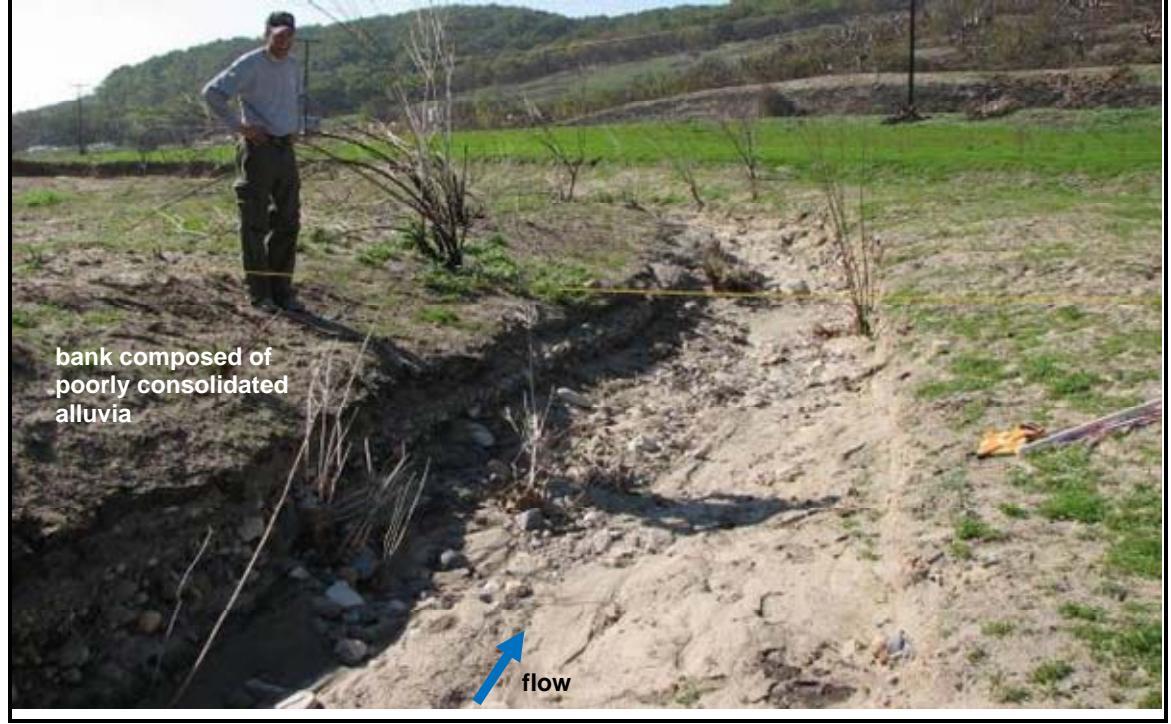
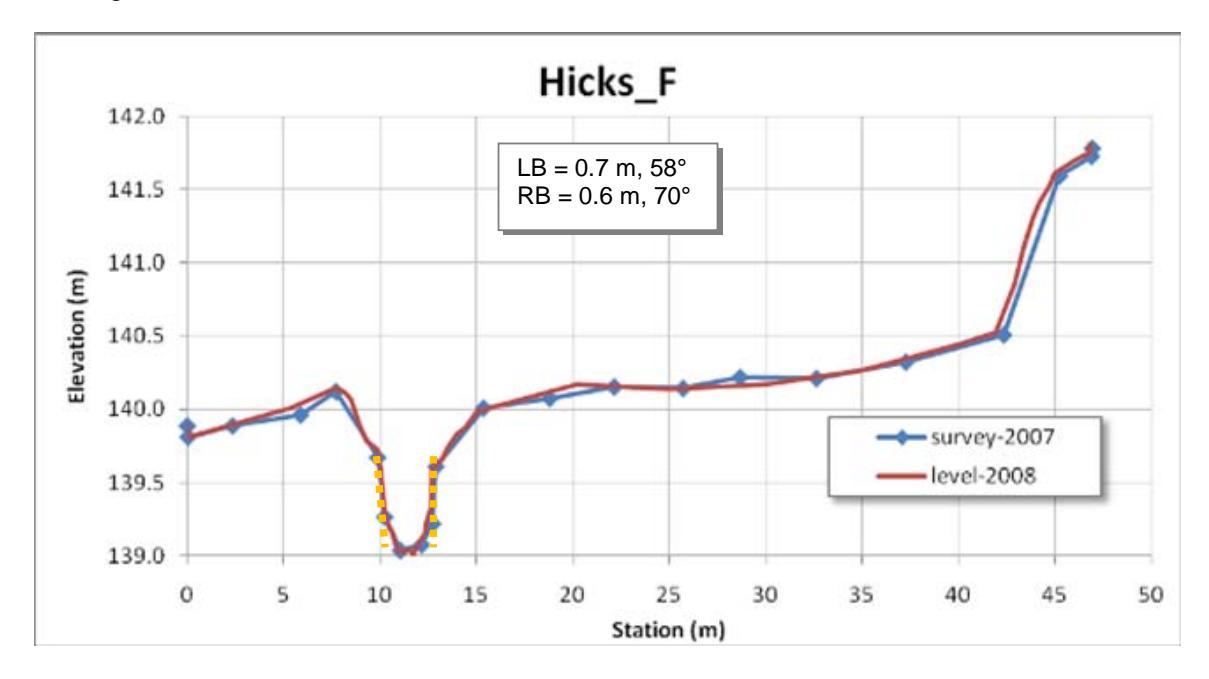
Figure A.14 – Hicks_F

LB U-MW-PC RB U-MW-PC

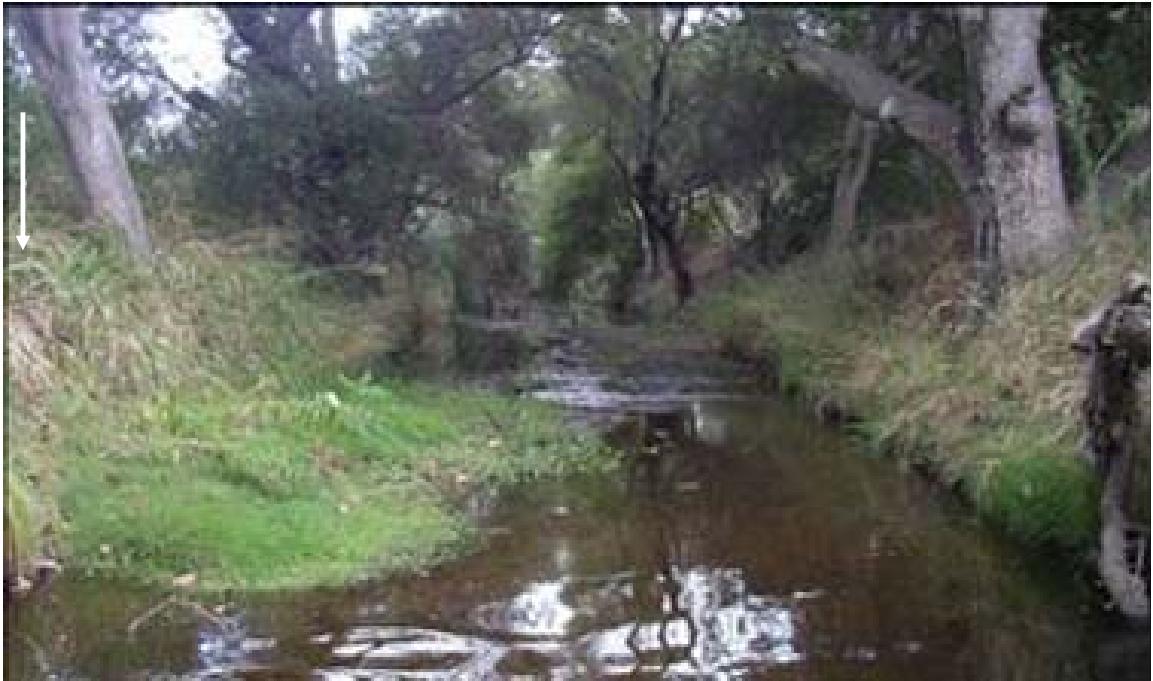
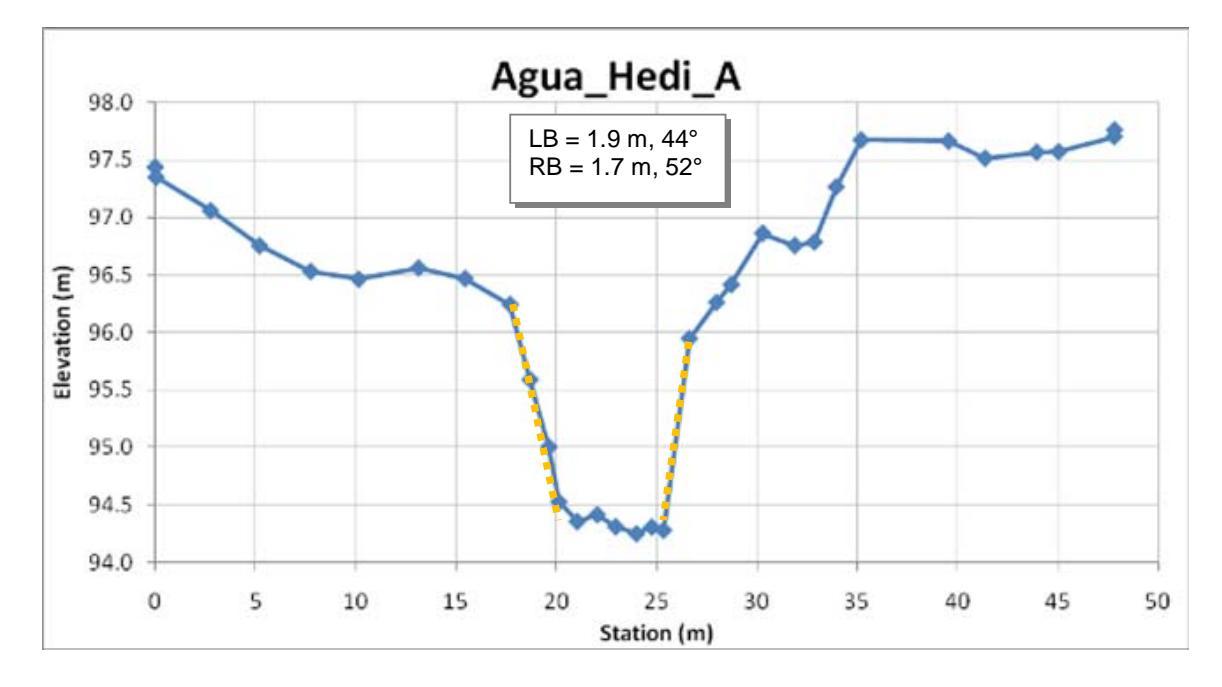
Figure A.15 – Agua_Hedi_A

LB STABLE RB U-MW-C

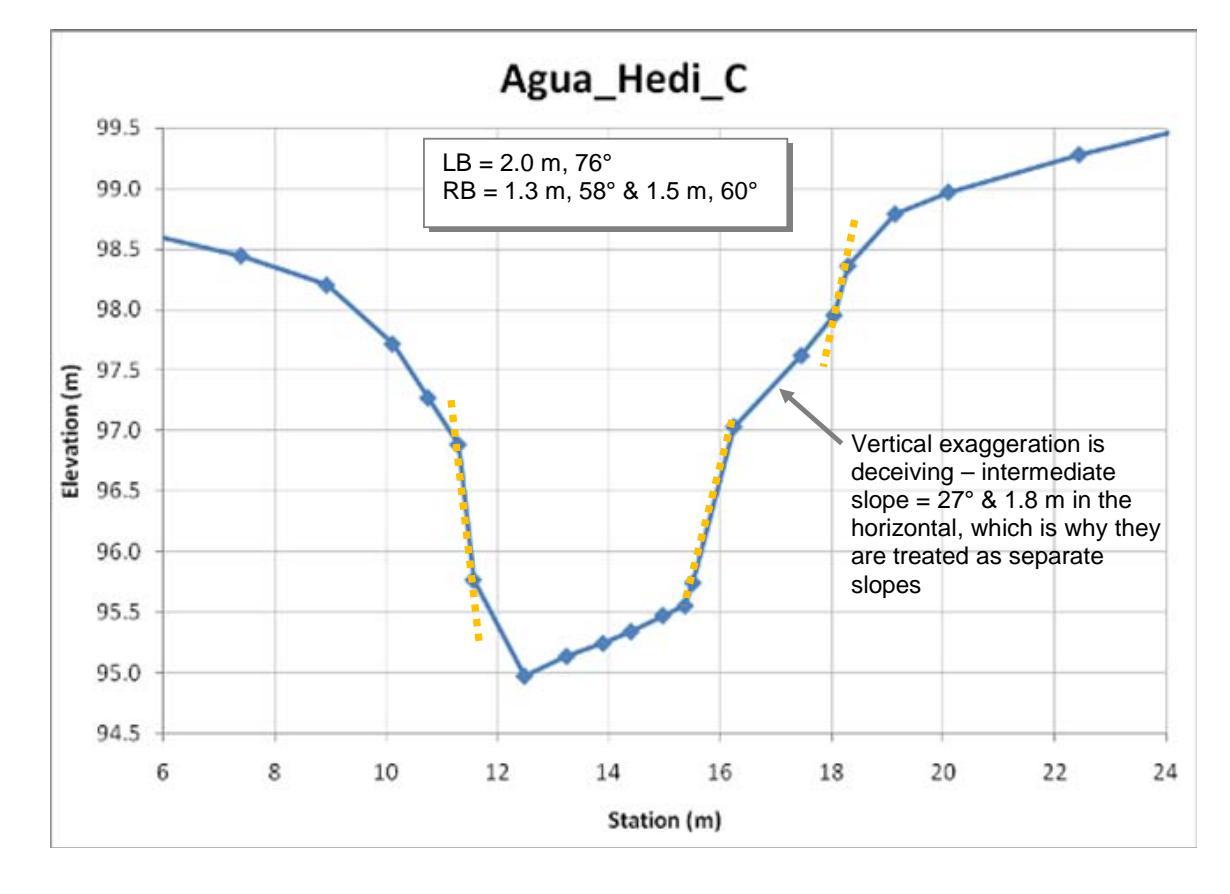
Figure A.17 – Agua_Hedi_C

LB U-MW-C

RB U-MW-C (upper) and U-MW-C (lower)

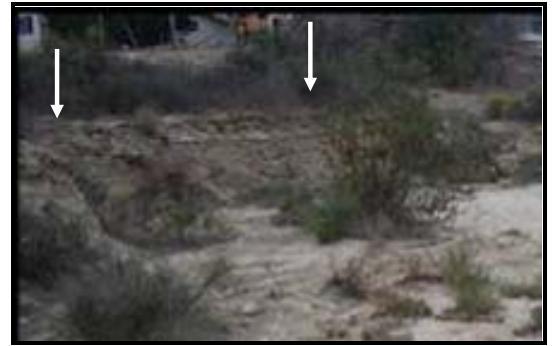
Figure A.18 – Dry_A

LB STABLE (upper) and U-FAILED (lower) RB

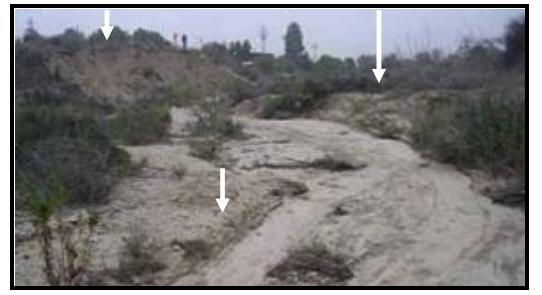
Figure A.19 – Dry_B

LB STABLE (upper) and U-FAILED (lower)

STABLE (upper) and U-MW-C (lower)

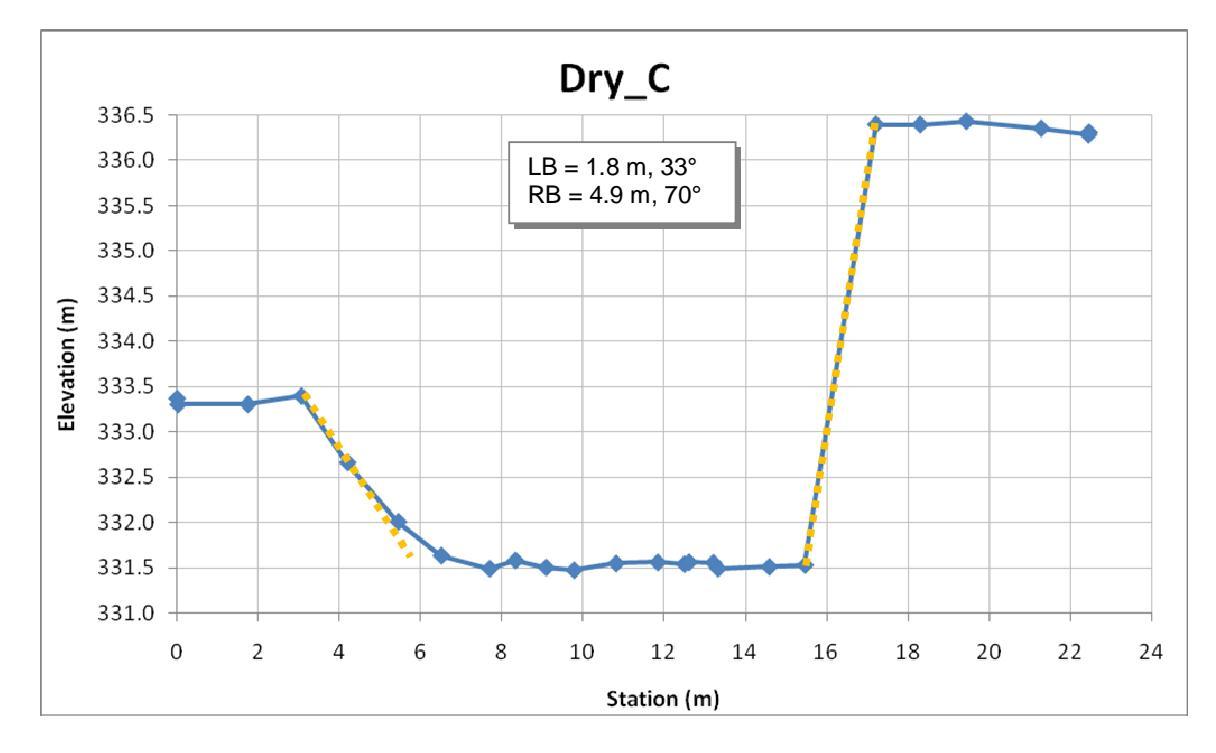
Figure A.20 – Dry_C

U-MW-C

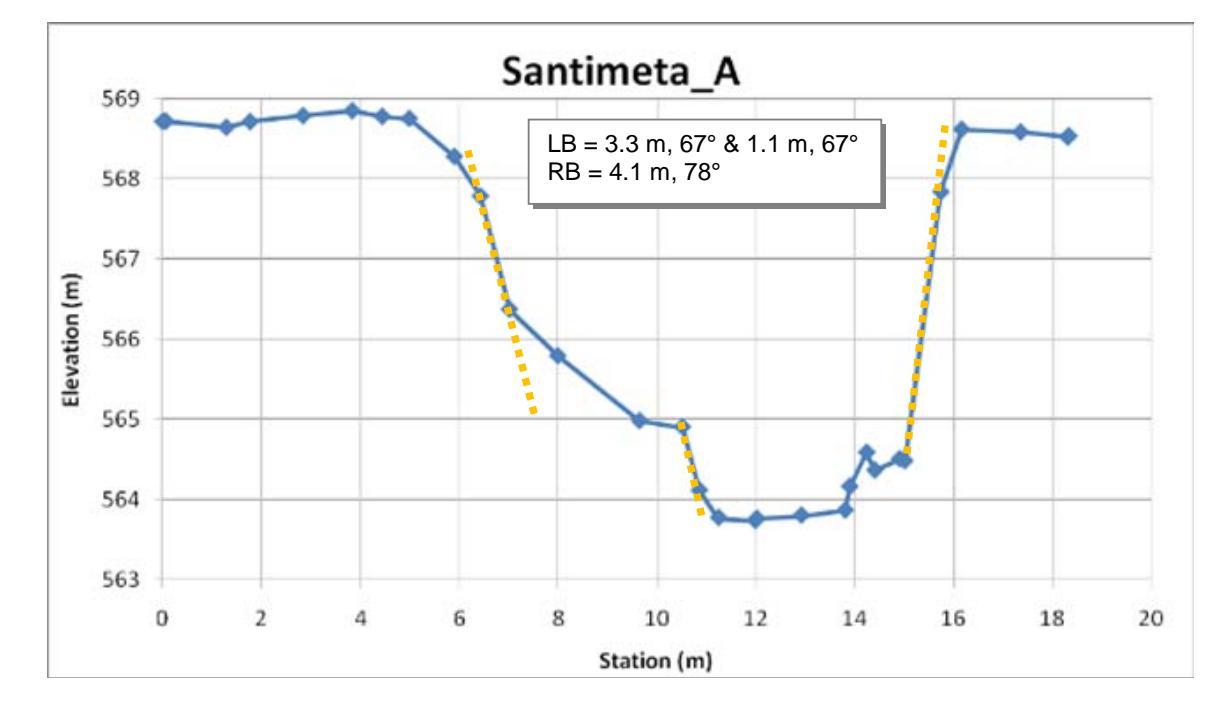
Figure A.23 – Santimeta_A (San Timetao)

LB U-MW-C

RB U-MW-C (upper) and U-MW-C (lower)

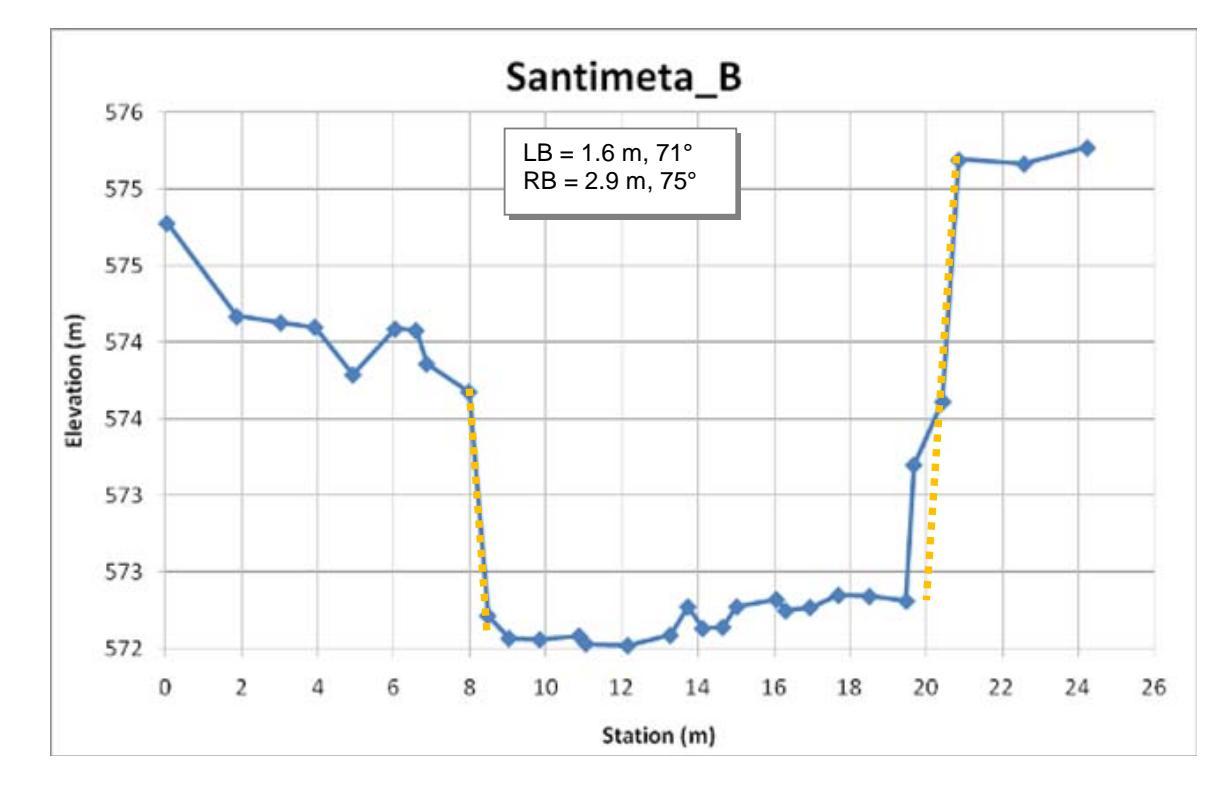
Figure A.24 – Santimeta_B (San Timetao)

U-MW-C

LB U-MW-C

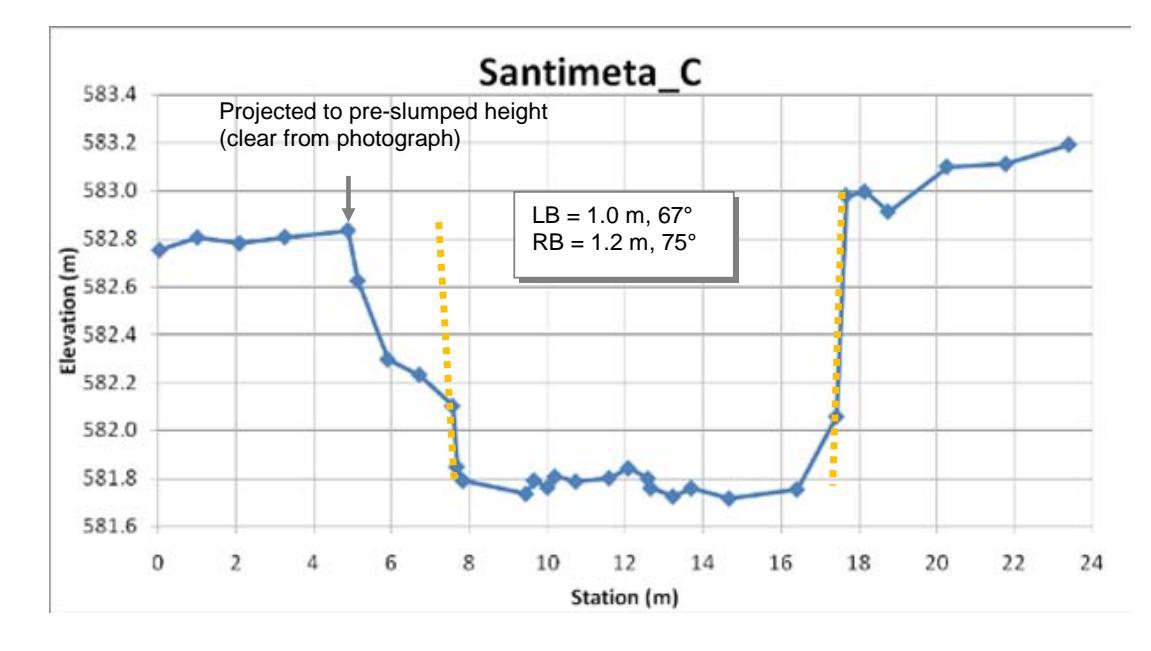
Figure A.25 – Santimeta_C (San Timetao)

U-MW-C

LB U-MW-C

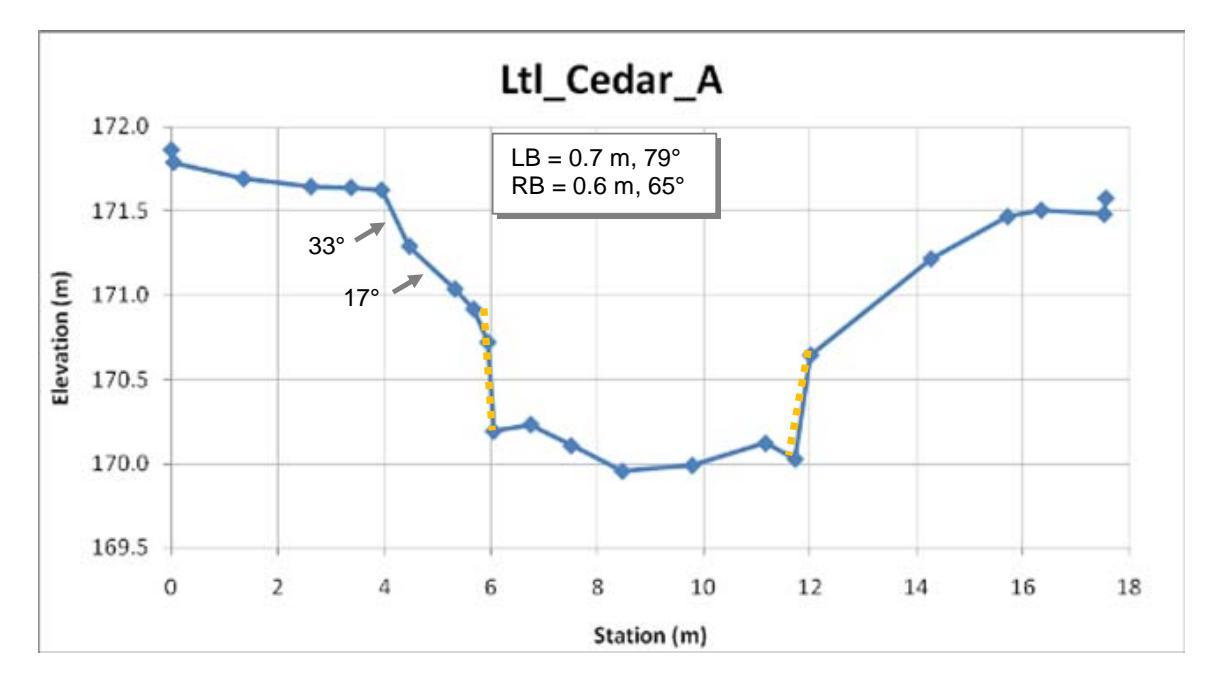
Figure A.26 – Ltl_Cedar_A (Little Cedar)

LB U-MW-PC

Incising through poorly consolidated alluvia downstream of bridge (forced confinement)

RB U-MW-PC

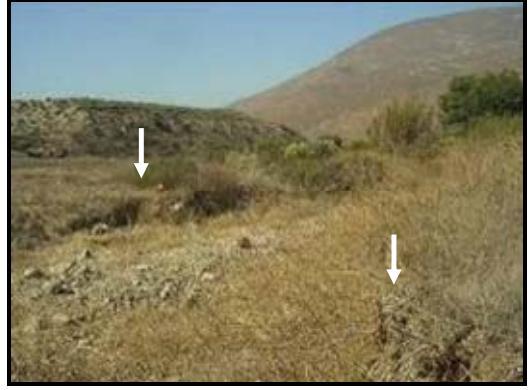
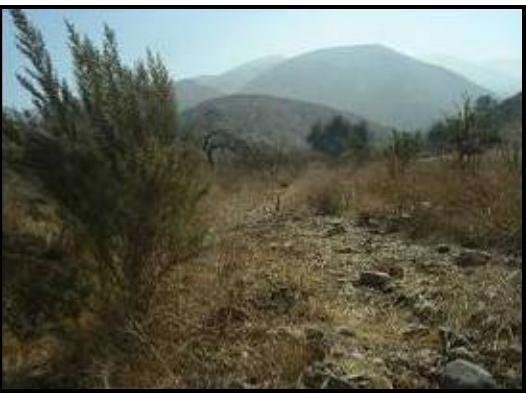
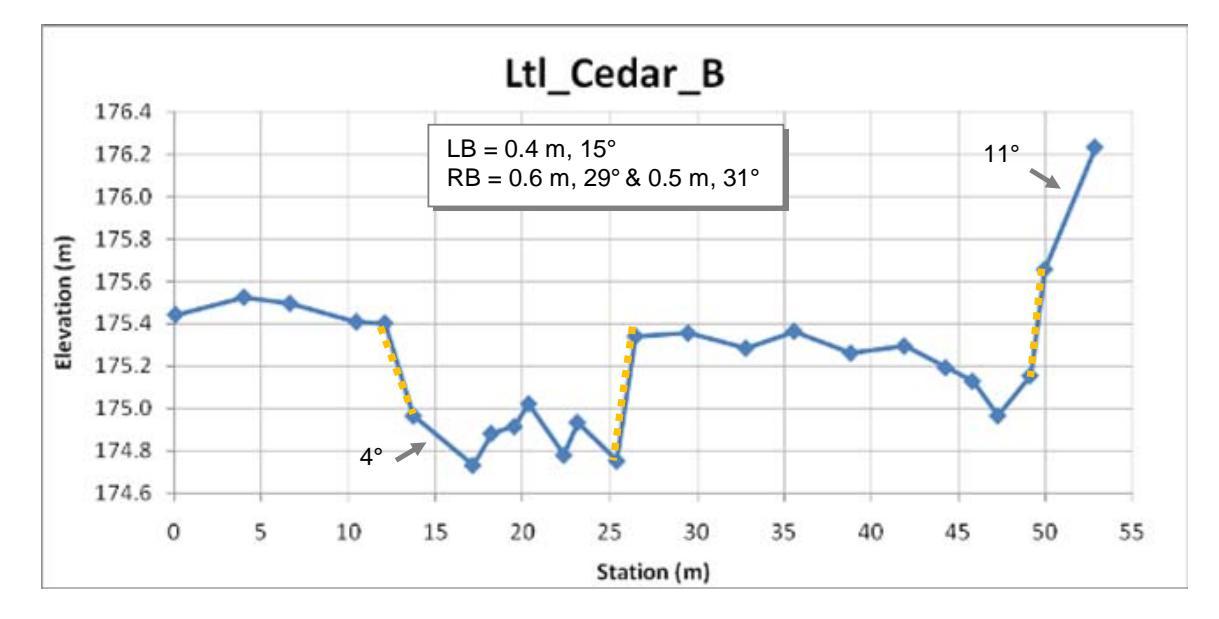
Figure A.27 – Ltl_Cedar_B (Little Cedar)
Proctor_A

LB STABLE-UC

RB U-FAILED (lower) and STABLE (upper)

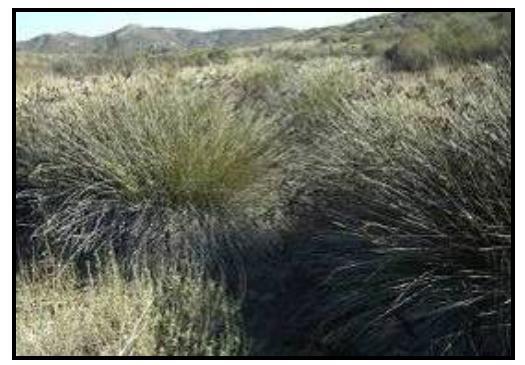
Figure A.28 – Proctor_A

LB U-FAILED

RB U-MW-UC (lower) and STABLE (upper)

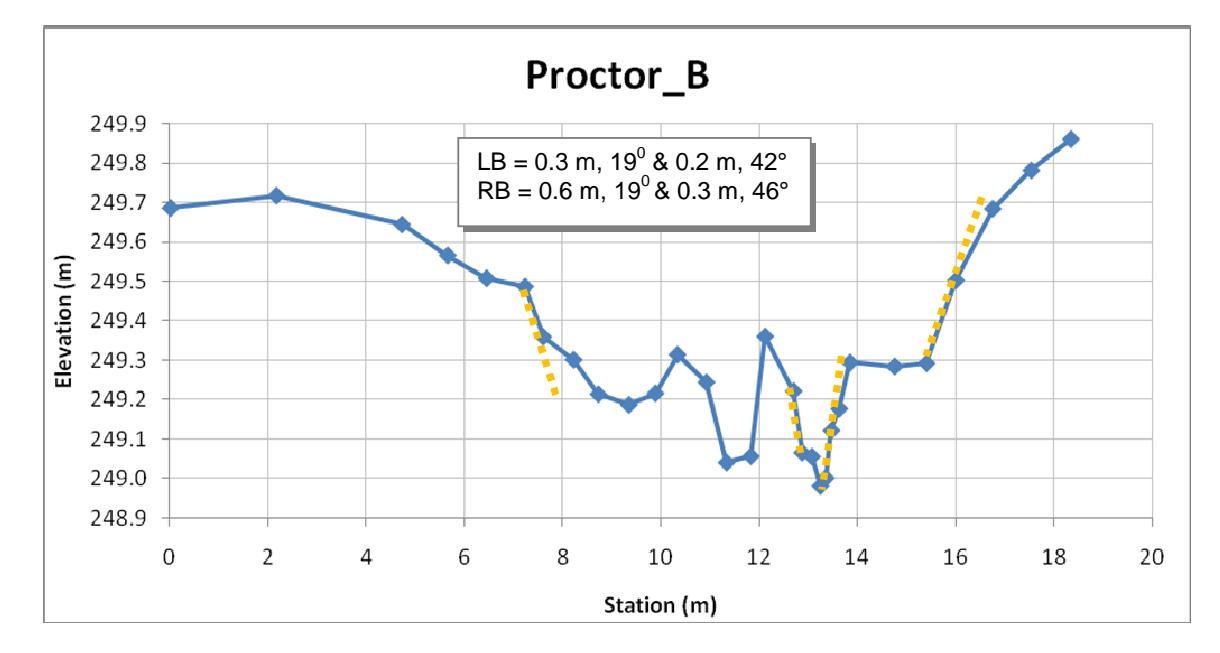
Figure A.29 – Proctor_B

LB STABLE (upper) and U-MW-UC (lower) RB

STABLE (upper) and U-MW-UC (lower)

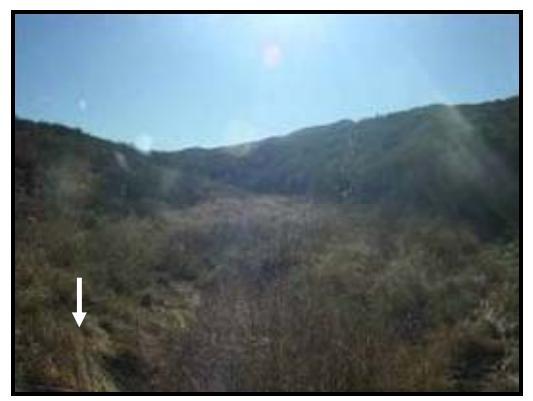
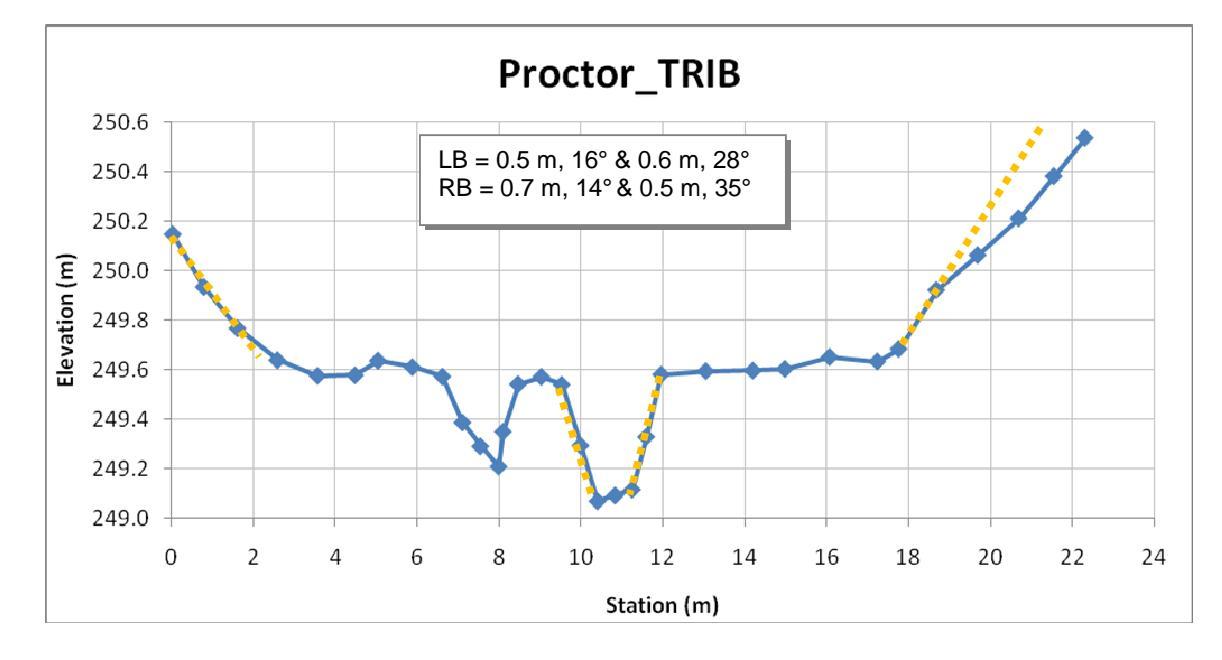
Figure A.30 – Proctor_TRIB

LB STABLE (upper) and U-FAILED (lower) RB
