APPENDIX A – HYDROMODIFICATION SITE CROSS-SECTIONS, BANKS, AND PHOTOGRAPHS

PURPOSE AND MEASUREMENT PROTOCOL

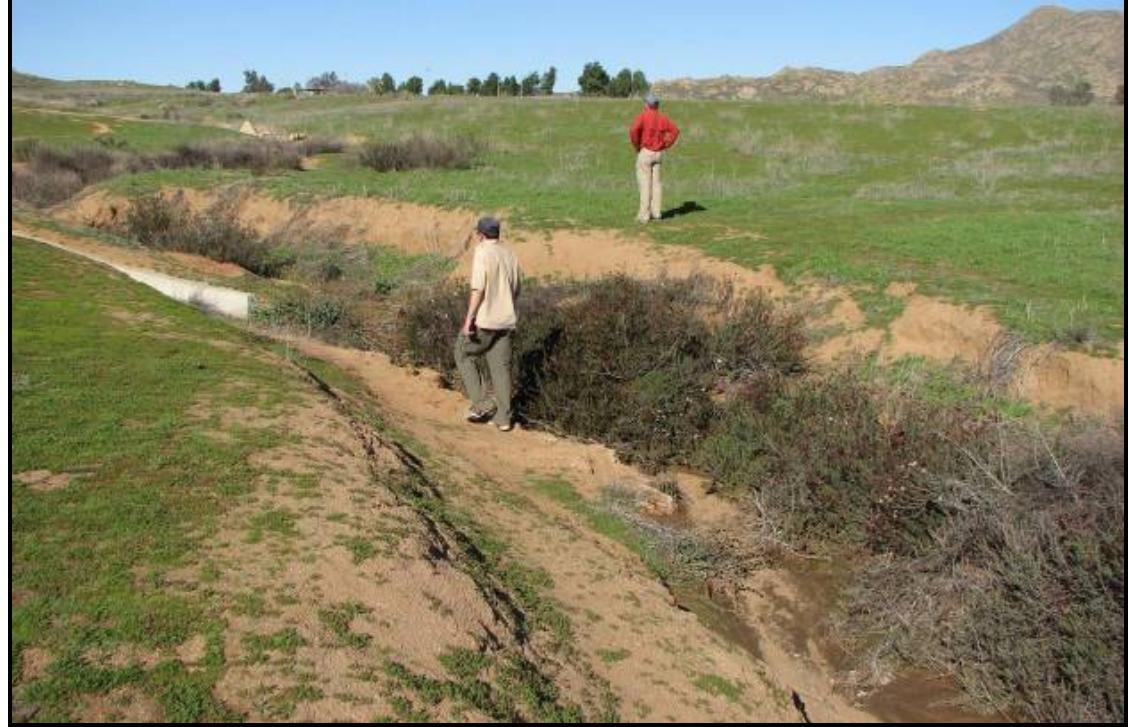
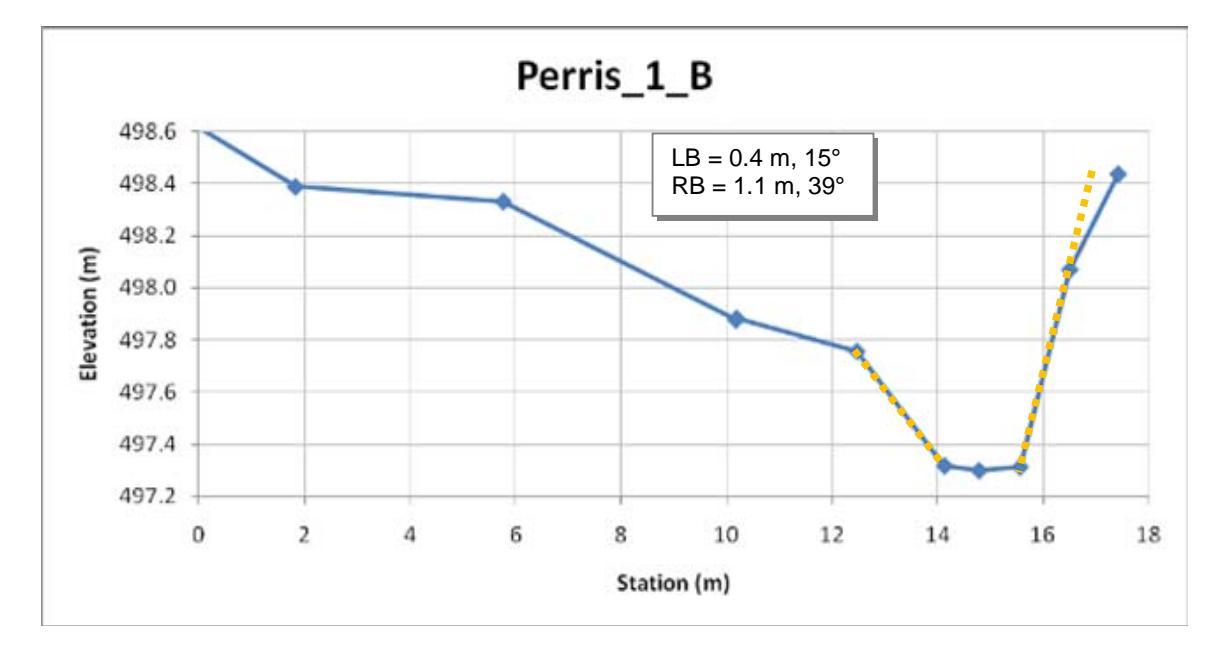
Figure A.32 – Perris_1_B

LB STABLE-PC RB U-MW-PC

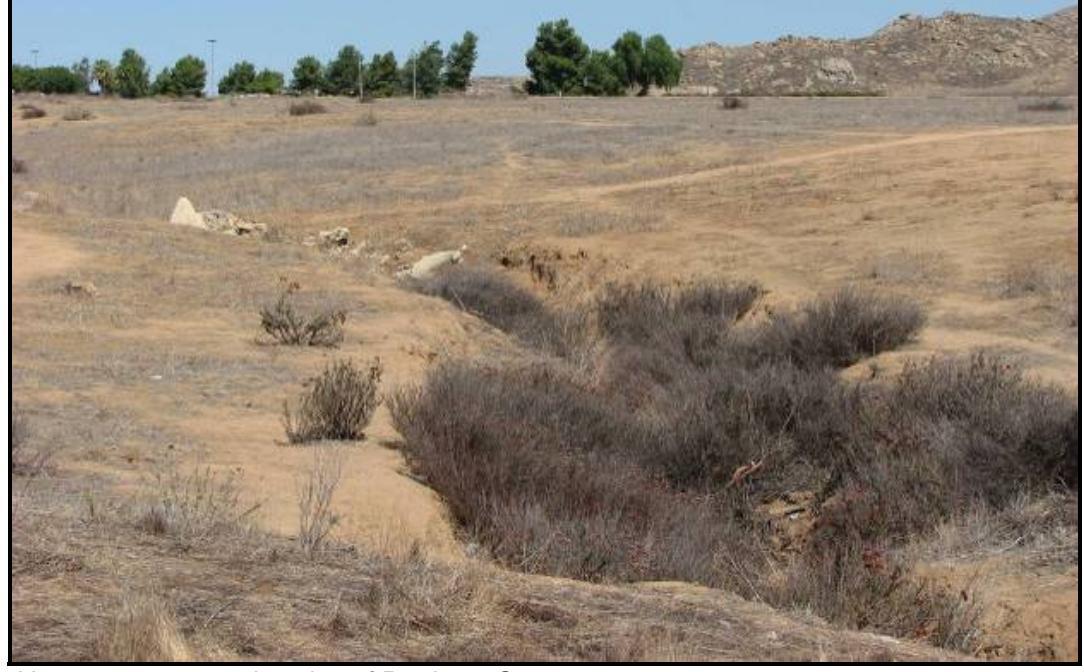
Figure A.33 – Perris_1_C

LB U-MW-PC (upper) and U-MW-PC RB U-MW-PC (lower)

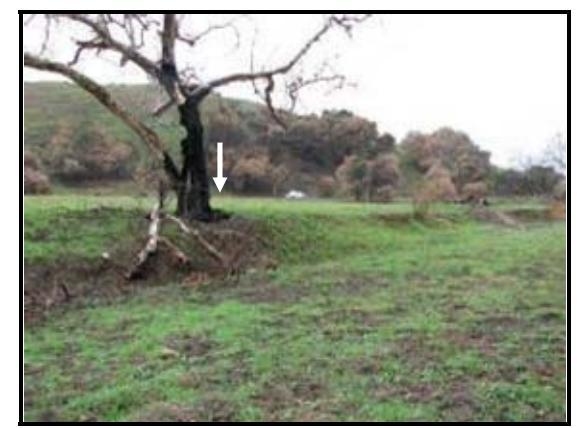
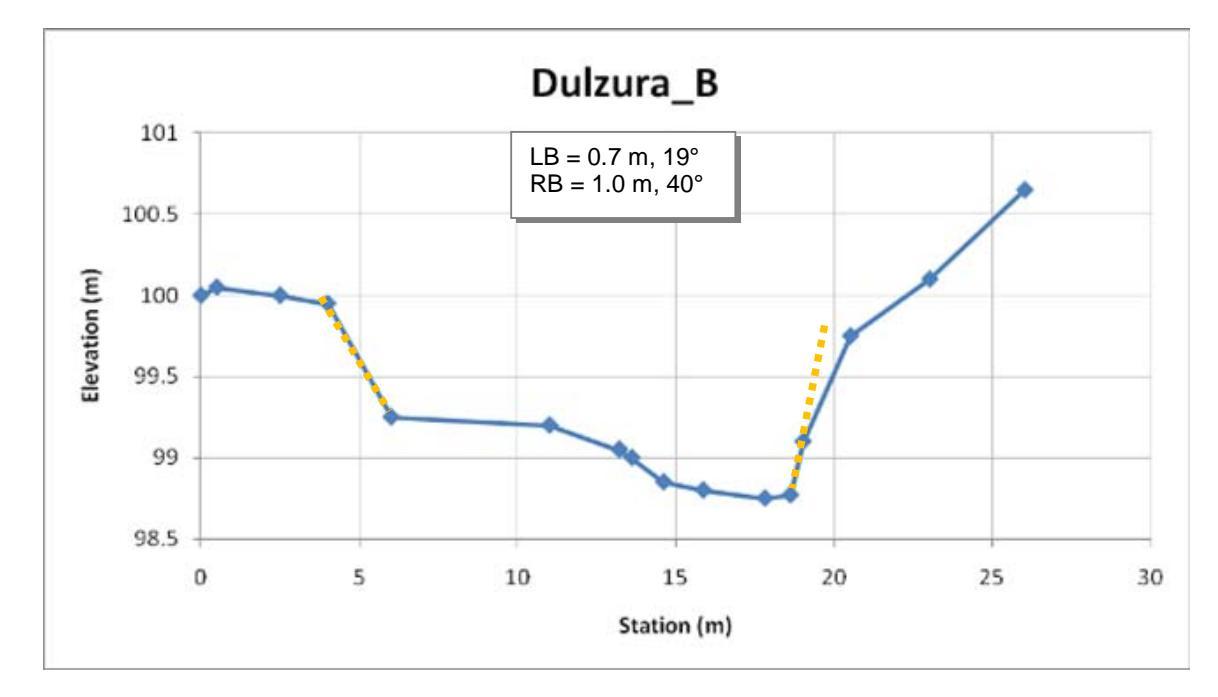
Figure A.42 – Dulzura_B

LB U-FAILED

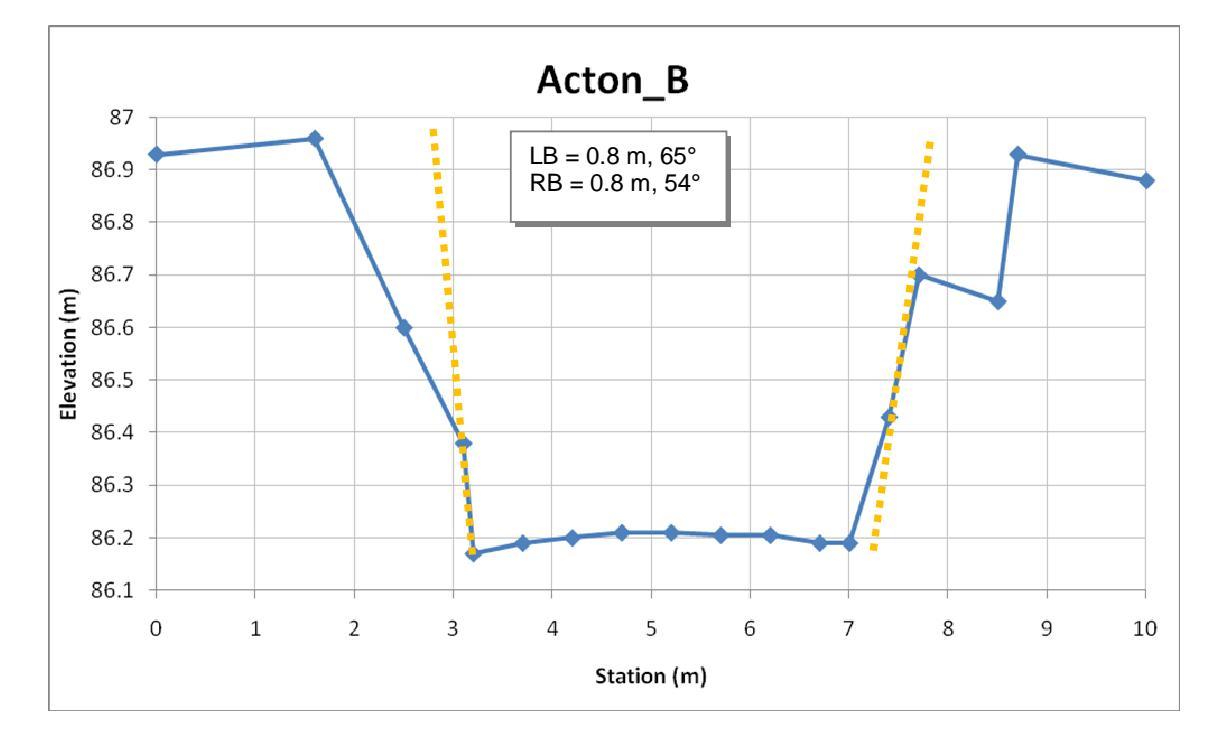
Figure A.44 – Acton_B

LB U-MW-PC RB U-MW-PC

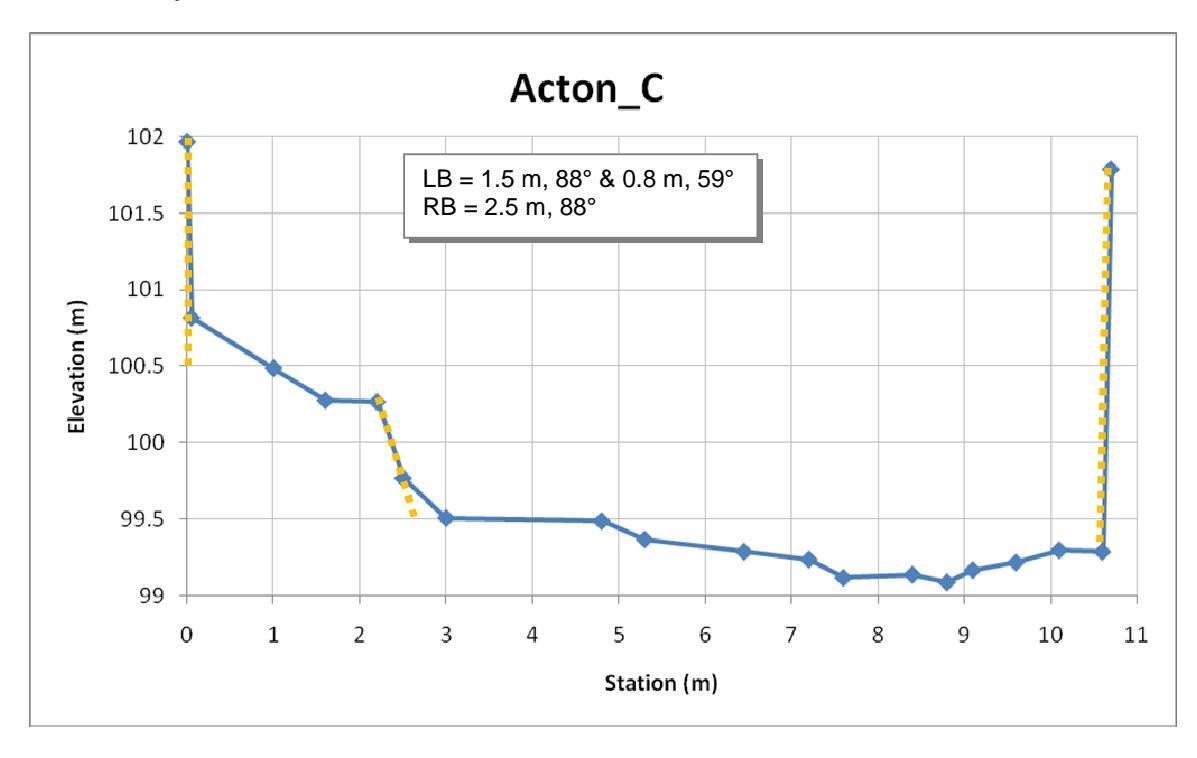
Figure A.45 – Acton_C

LB U-MW-C (upper) and U-MW-PC (lower) RB U-MW-C

Lower left bank appears to be at edge of old channel bank and bed. It's not fully unconsolidated, but not nearly as consolidated as the outer banks.

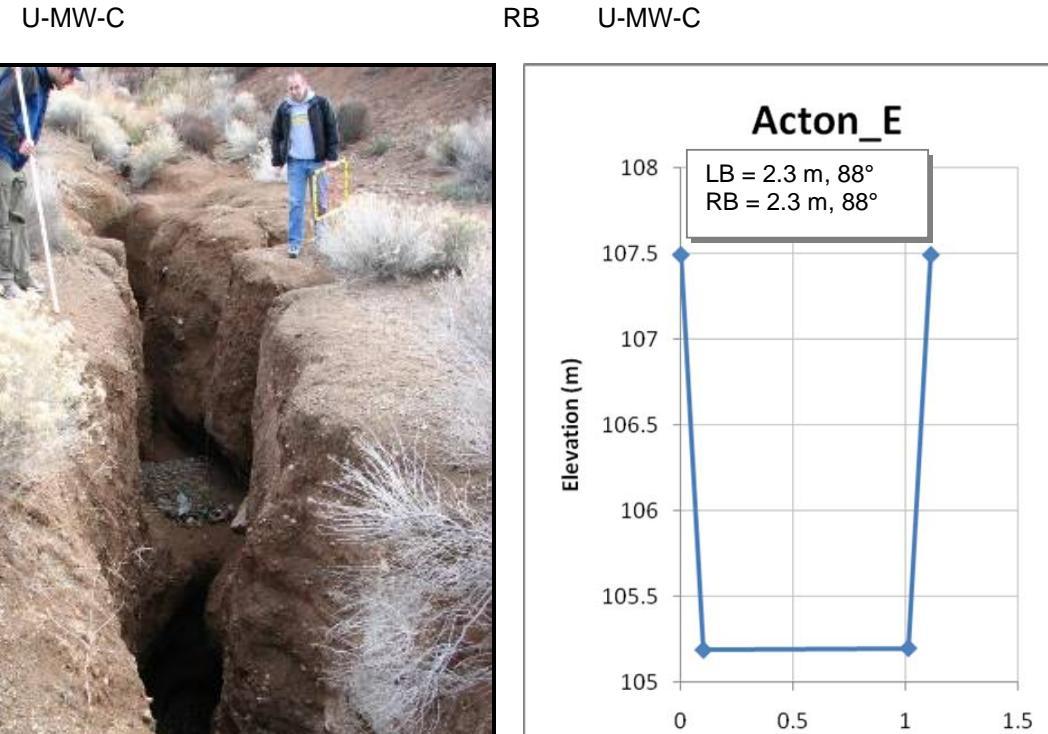
Figure A.47 – Acton_E

LB U-MW-C

Cross-section was taped, not surveyed due to hazard risk

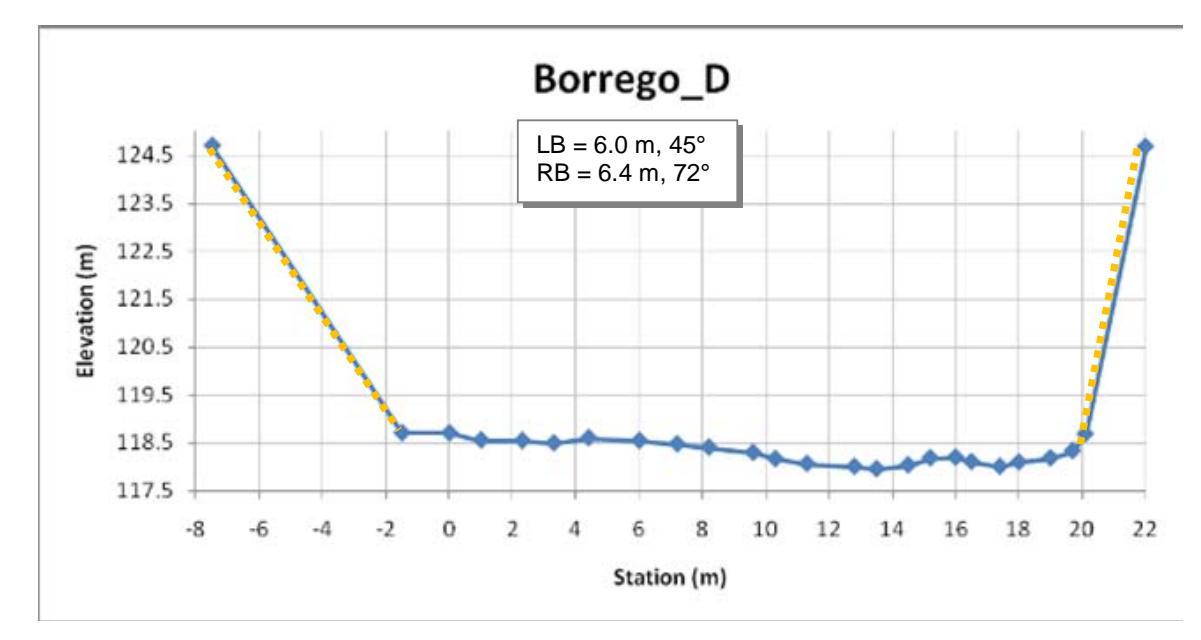
Figure A.51 – Borrego_D

LB U-MW-C

RB U-MW-C

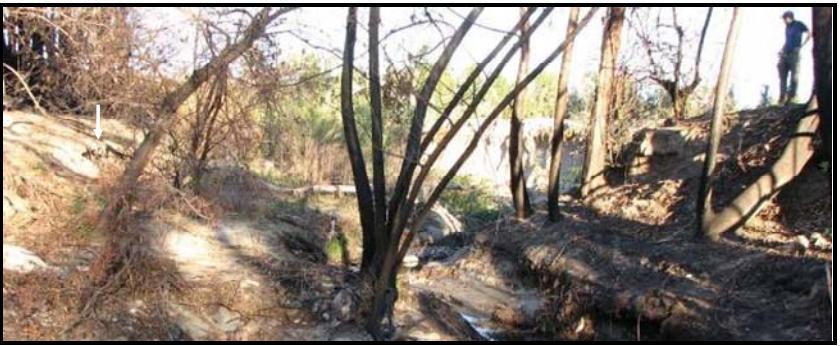
Figure A.52 – Borrego_E

LB U-MW-C (upper) and U-MW-PC (lower) RB

U-FAILED (upper) and U-MW-PC (lower)

Incised section is classified as PC (poorly consolidated) instead of UC (unconsolidated) because, although they are a part of a historic bed, tree locations indicate that the tops of these banks have been at that elevation for 20+ yrs, which is considerably different from the way we've been applying the UC rating.

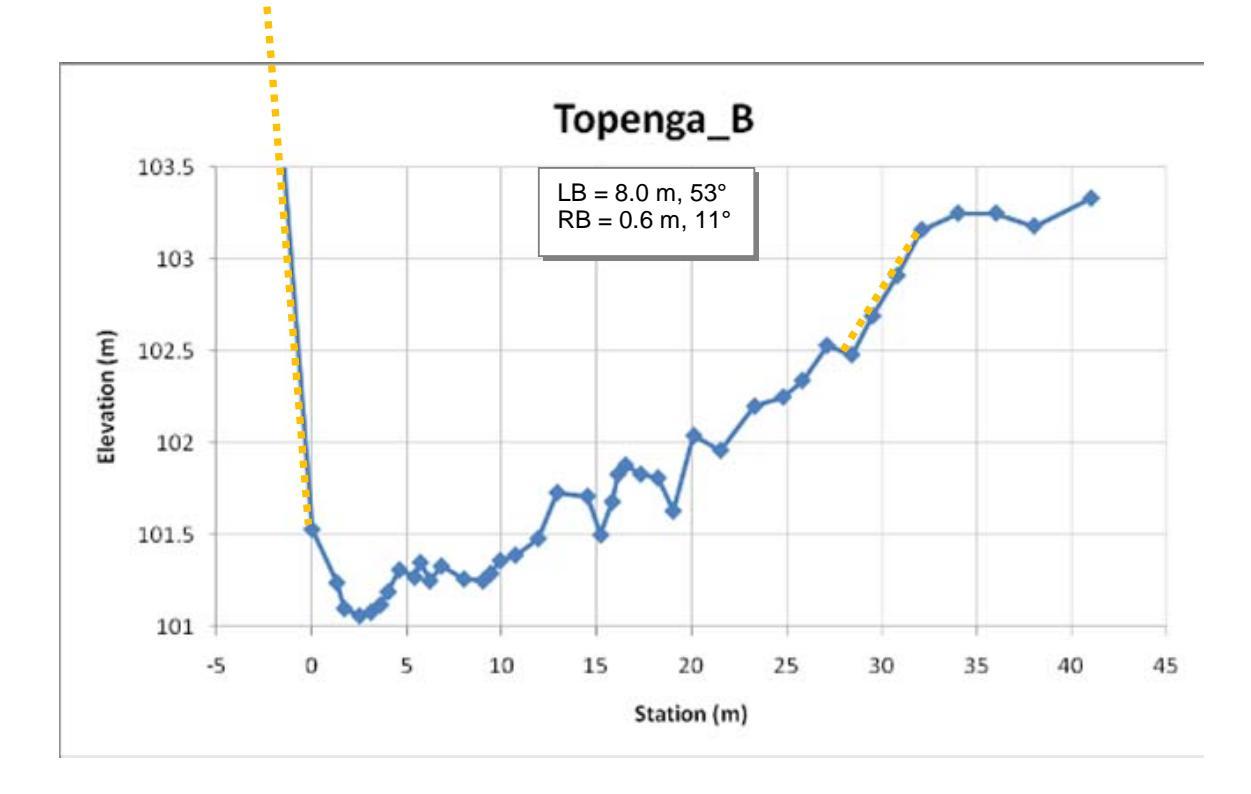
Figure A.54 – Topanga_B

LB U-CONFND

RB STABLE-UC

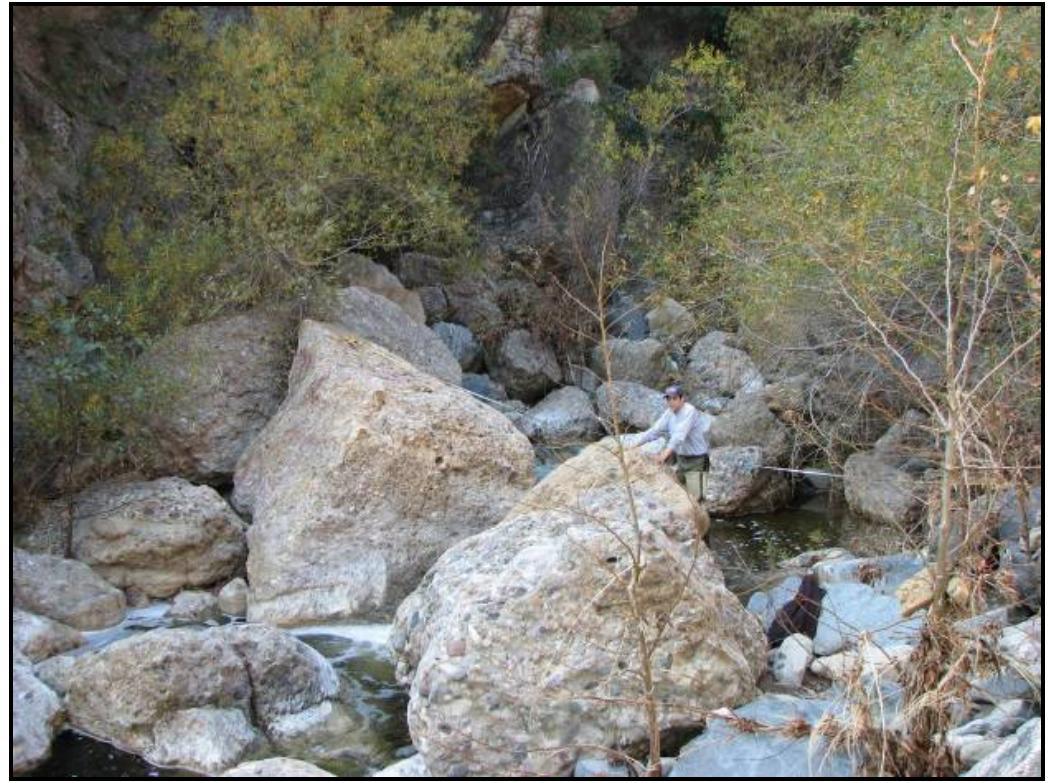
Figure A.55 – Topanga_C

LB U-CONFND RB U-CONFND

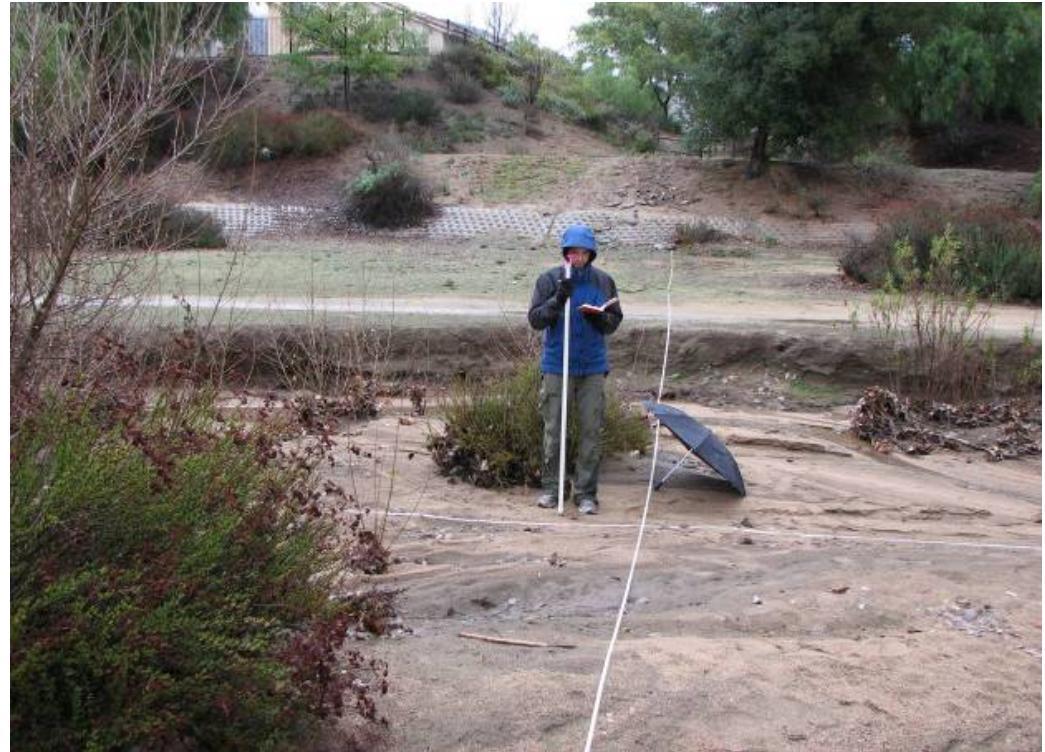
Figure A.63 – Pigeon_B (Pigeon Pass)
Pigeon_C (Pigeon Pass)

LB U-MW-PC RB STABLE-UC

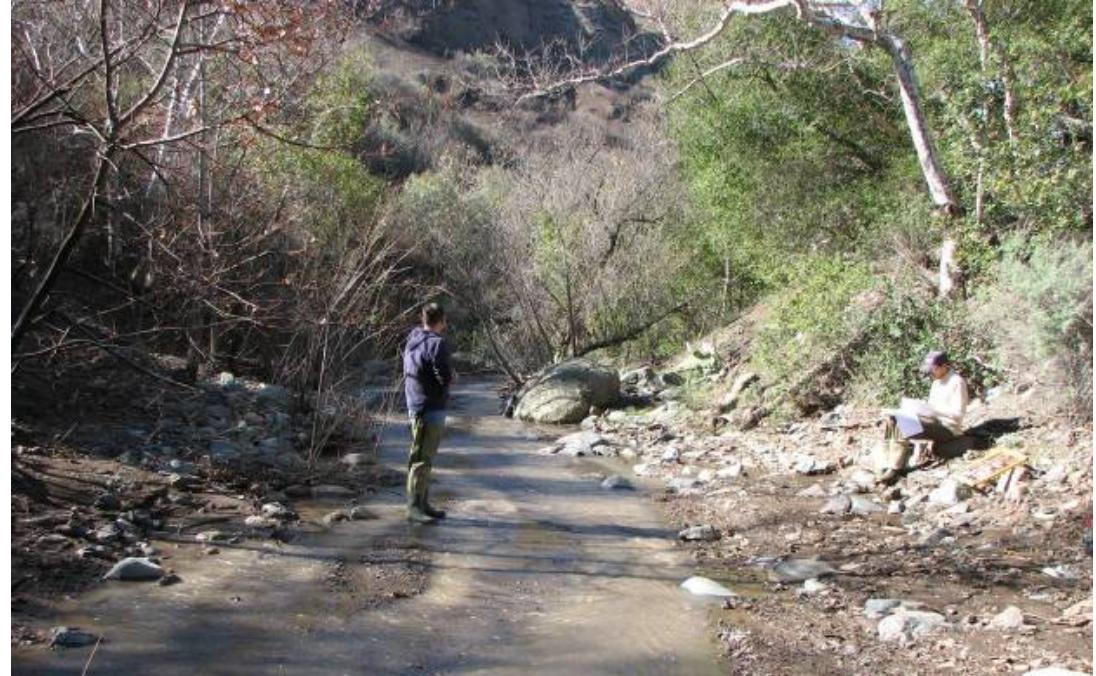
Figure A.68 – Santiagnl_A (Santiago at Natural-loading site)

LB U-CONFND (upper) and U-MW-UC RB STABLE (lower)
