Automated detection of illicit discharges in storm drains using a distributed network of low-cost IoT sensors

Edward Tiernan , Jerod Gray , Duy Nguyen , Baiqian Shi , Miao Wang , Kevin Dunn , Jian Peng , David McCarthy & Elizabeth Fassman-Beck

A novel, sensor-driven approach that automates the detection of transient illicit discharges in storm drains was piloted across ten storm drain outfalls in southern California. The sensor network continuously monitors key hydrologic and water quality variables. An automated algorithm utilizing a differential exponentially weighted moving average model was deployed to identify trends that indicate a potential illicit discharge. When a potential discharge is detected, an email alarm notifies stormwater managers in near-real-time. The manager may view the data immediately via a custom visualization dashboard and/or follow up in-person at the offending site. Rapid responses enabled by automated detection greatly improve the likelihood that intermittent illicit discharges will be detected, traced and eliminated. Results from the pilot program show that the open-source, 3D printed, internet-of-things (IoT)-enabled sensors utilized herein offer a

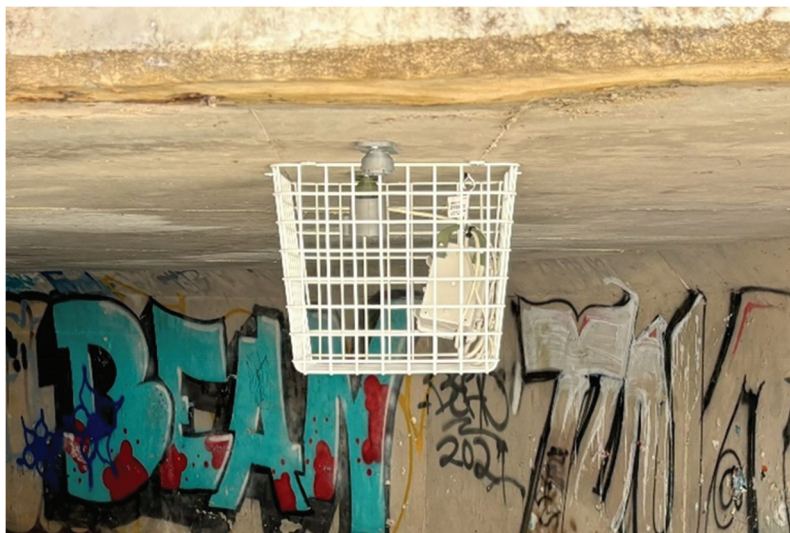
Figure 4. Cages were deployed at some sites to deter vandalism/theft of RAD and CAM sensors.

In May 2024, ten MS4 sites in north OC were each instrumented with four BoSL sensors, per [Table 1](#). Sites I & J were vandalized within a day of installation and abandoned for the duration of the pilot test. Several other sites also had varying degrees of instrument interference. At Site B, several of the sensors were destroyed on 4 June 2024, but replacements were unharmed. At Site E, the CAM lens was spray-painted on 9 October 2024. In some instances (e.g. Site F), cages were deployed to protect the RAD and CAM sensors (shown in [Figure 4](#)).

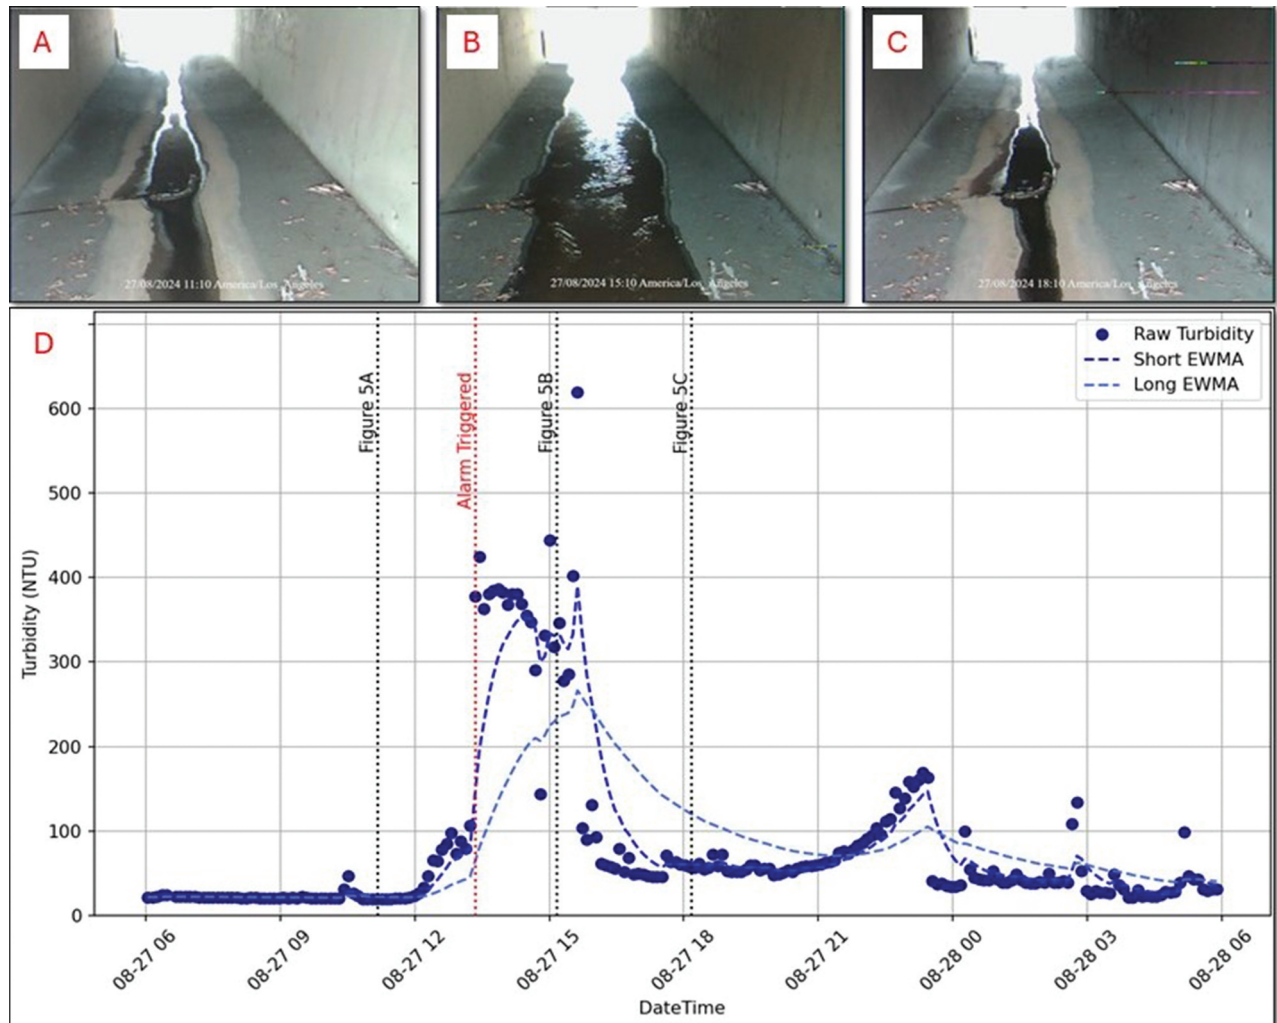
Figure 6. Detected discharge event at Site E in August 2024. A) CAM photo taken at 11:10 prior to main discharge pulse; B) CAM photo taken at 15:10 during the discharge; C) CAM photo taken at 18:10 after discharge has subsided; D) TURB data showing short- and long-term EWMA models with timing of CAM photos annotated.

The automated alarm system was fully online for the dry season pilot program between June 1 and October 1, 2024. Based on the previous experience of the dry season manual monitoring program, no transient discharges were expected (Schiff, Beck, and Fassman-Beck 2021). Contrary to this expectation, multiple alarms were received from each site. [Figure 6](#) shows an example alarm from the TURB sensor at Site E, coupled with visual evidence of discharge from the CAM.

The turbidity data shows a spike, causing the short- and long-term EWMA models to divorce, triggering an alarm. The continuous discharge trickle is seen in the CAM photos to increase in width before returning to the

trickling flow condition a few hours later. The turbidity alarm was triggered at 13:20 on 27 August 2024. Notably, this event raised neither a depth nor velocity alarm, despite clear increases in flow.

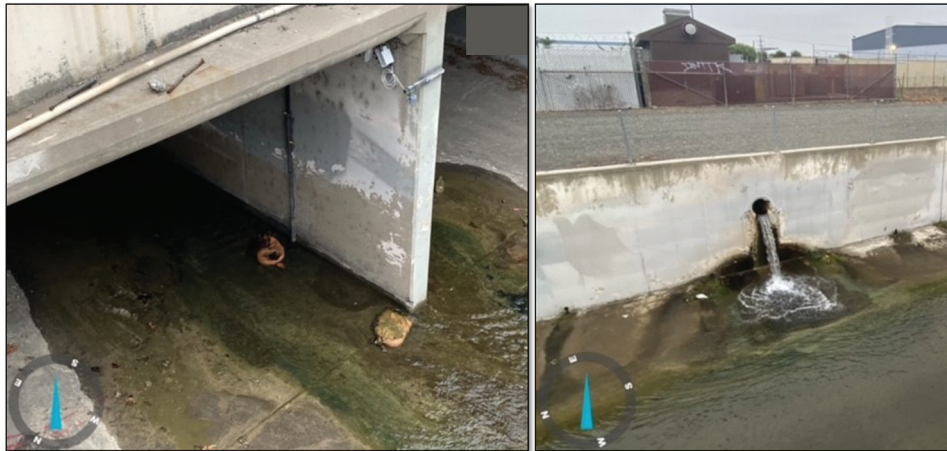
Figure 8. Evidence of a discharge during the all-Hands Week follow-up visit at Site C for alarm on October 16, 2024. The elevated discharge at the monitoring station (left) was traced to an outfall upstream (right). Photos used with permission from Craig Foster, City of Santa Ana.

alarm email is sent and the investigation team arrives on site, and was mostly a function of the time of day of the alarm. Figure 8 shows photo evidence (obtained by the investigation team) of the discharge at Site C.
