Re: *Resubmittal of the 2017 WY Monitoring Plan Update for Waste Discharge Requirements General Order R5-2012-0116-3 for Growers in the Eastern San Joaquin River Watershed*

Monitoring Plan Update

2017 WY

**Irrigated Lands Regulatory Program
Central Valley Regional Water Quality Control Board**

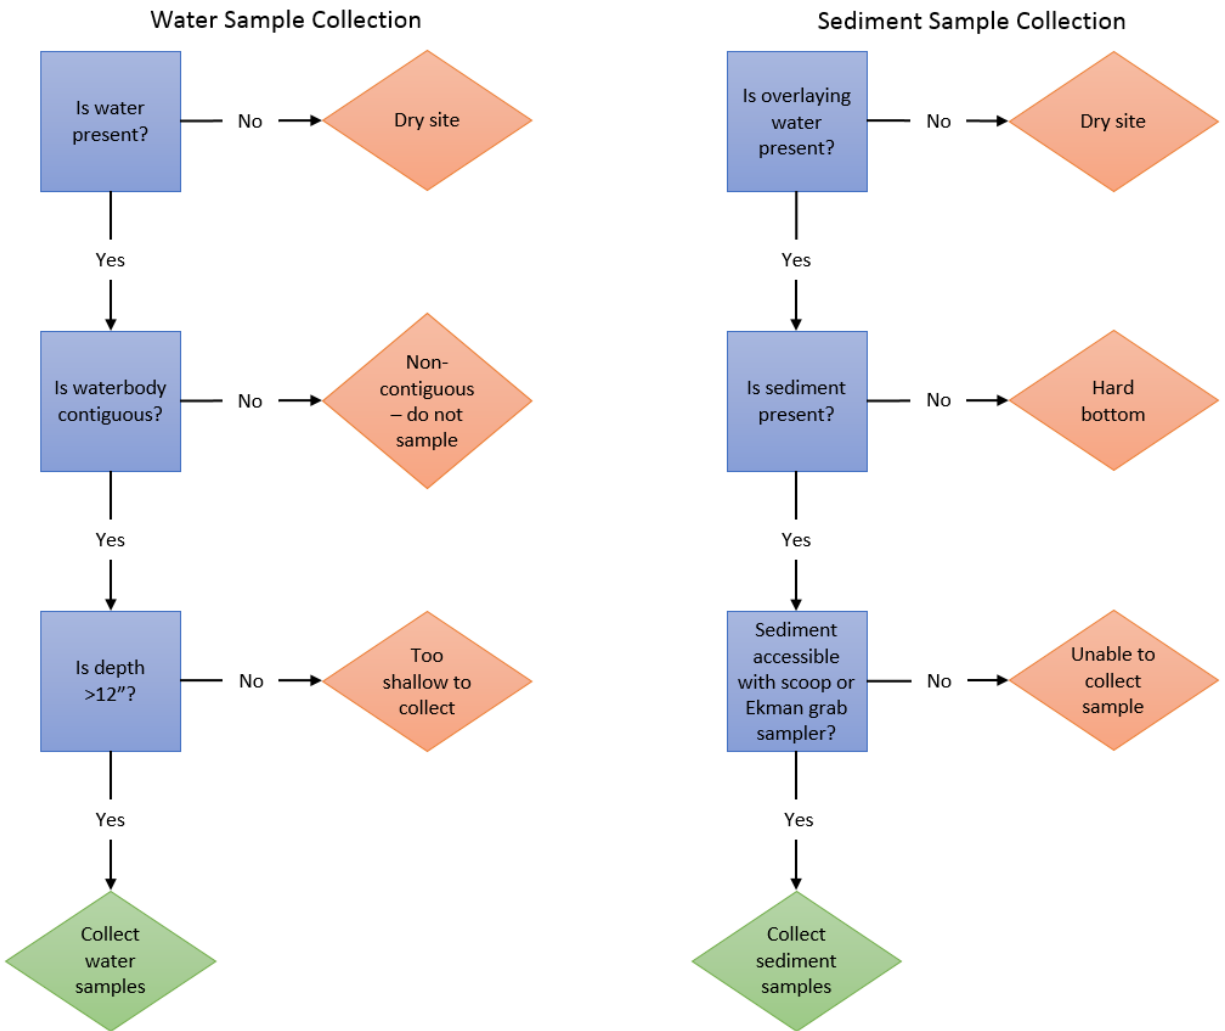
Figure 1. ESJWQC flowchart strategy for sample collection.

The purpose of this appendix is to outline the decision making process for sampling actions as result of conditions where there is little to no flow or when there is no water (Figure 1). The flowchart in Figure 1 outlines the potential sample site flow conditions that occur at monitoring locations in the ESJWQC region. Potential reasons for not collecting a sample include:

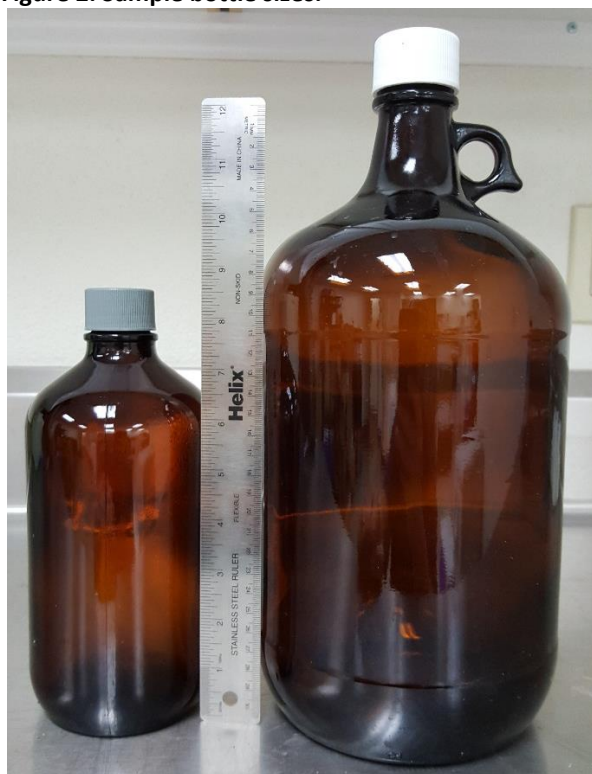
Figure 2. Sample bottle sizes.

The protocol for collecting water samples is to collect an environmental sample from the waterbody by submerging sample bottles 0.1 m (approximate 4 inches) below the surface of the water, uncapping the bottle, filling the bottle and re-capping it under the water with no headspace (see Appendix I-III of the ESJWQC QAPP). Sample bottles vary in size depending on the constituent that the sample will be tested for. However, the largest bottles are 8.5 inches (pesticide analysis) and 13.5 inches tall (toxicity analysis, Figure 2). Under certain conditions it is not possible to collect water samples according to approved protocols and criteria outlined in the QAPP due to situations that result in low volumns of water. These conditions and examples are outlined in the sections below.

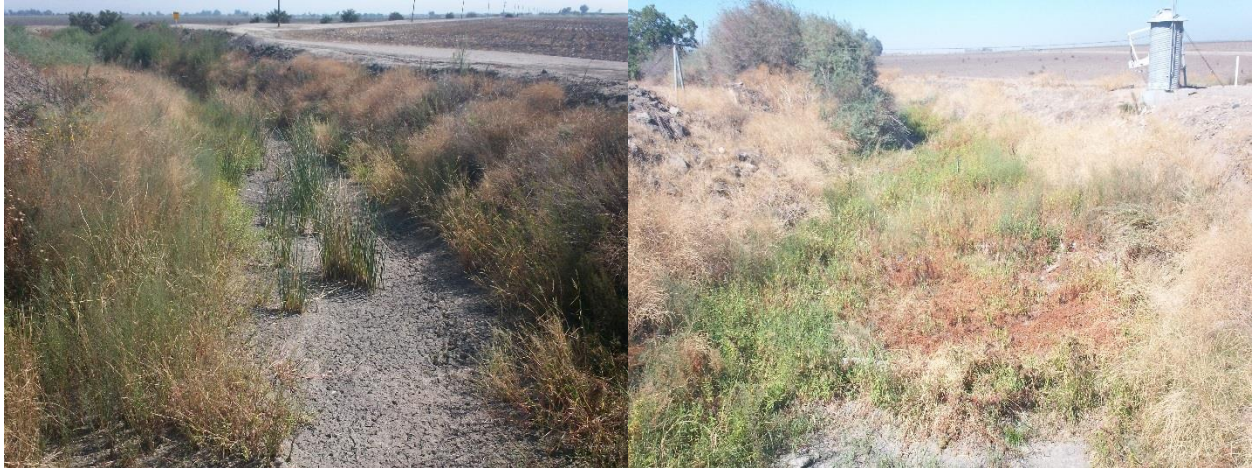
A waterbody is considered dry when no water is present upstream or downstream from the sample location. An example of this type of site condition is Duck Slough @ Gurr Rd which was dry on September 8, 2015 and no water or sediment samples could be collected (Figure 3).

Photo on the left is facing upstream (east) and photo on the right is facing downstream (west)

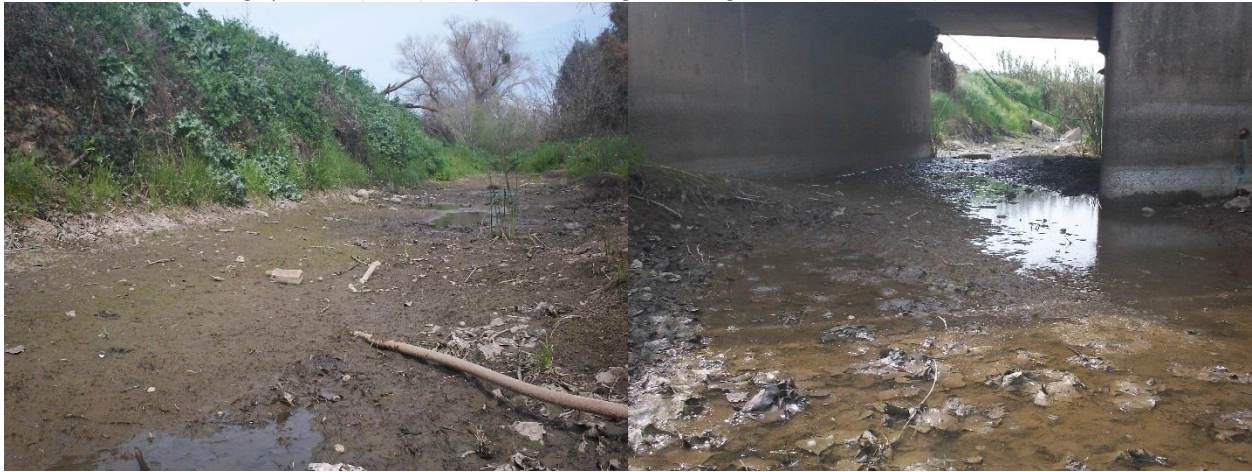
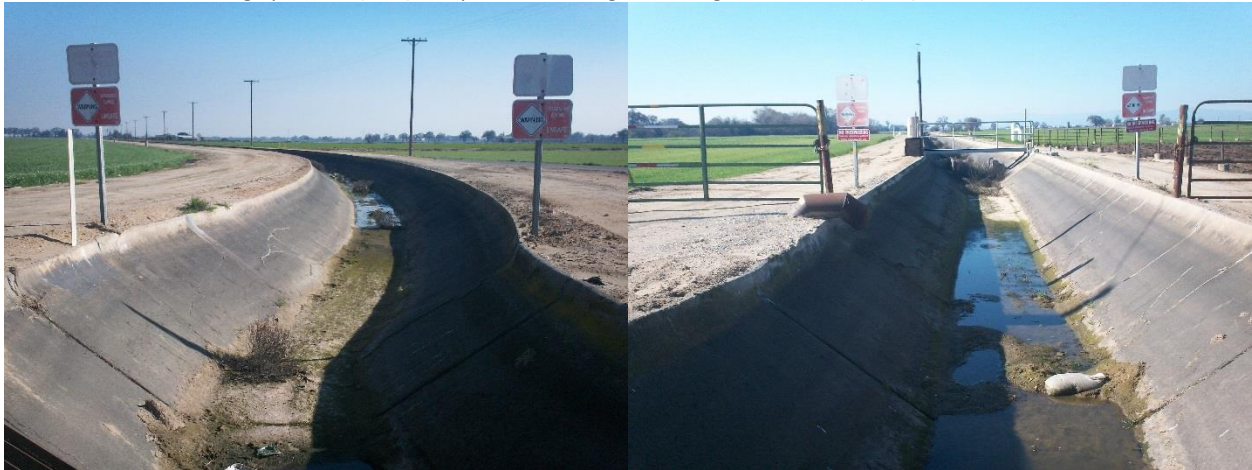
Figure 5. Non-contiguous waterbody at Lower Stevinson @ Faith Home Rd – January 13, 2015.

As mentioned in the ESJWQC Waterbody Characteristics section, many of the ESJWQC waterbodies only have intermittent flows, and have the potential to be non-contiguous or dry throughout the year. Results from samples collected from non-contiguous waterbodies are not indicative of the water quality of irrigation drainage. No samples will be collected if the waterbody is non-contiguous. An example of non-contiguous site condition is depicted in Figures 4 and 5.

Photo on the left is facing upstream (north) and photo on the right is facing downstream (south)

Photo on the left is facing upstream (east) and photo on the right is facing downstream (west)

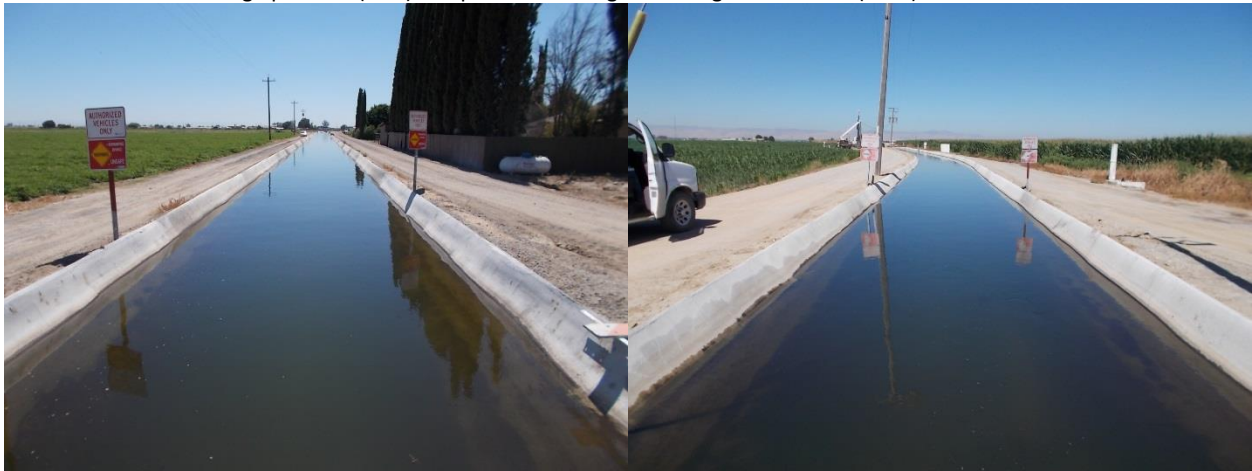
Figure 6. Normal conditions at Lateral 5 ½ @ South Blaker – July 12, 2016.

Figure 6 and 7 depict Lateral 5 ½ @ South Blaker Rd during normal conditions in the irrigation season and shallow conditions in the fall. Figure 8 depicts the sample bottle to collect the required sample relative to the depth of the water at two different sample sites.

Photo on the left is facing upstream (east) and photo on the right is facing downstream (west)

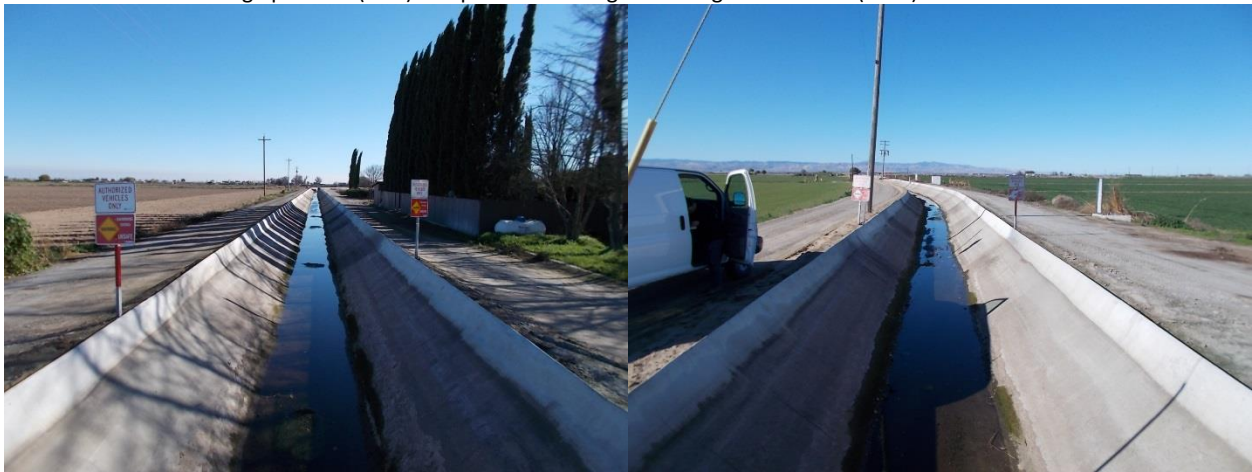
Figure 7. Too shallow to collect samples at Lateral 5 ½ @ South Blaker – December 15, 2015.

For waterbodies that measure less than 12 inches in depth, it is not possible to collect samples in accordance with sampling protocols. In the ESJWQC region, situations where the water is too shallow to collect generally occurs in irrigation water delivery canals, laterals, and drains during the fall and winter months when irrigation water deliveries are no longer occurring. These conditions may also occur during the summer and winter months in channels with intermittent flows.

Photo on the left is facing upstream (east) and photo on the right is facing downstream (west)

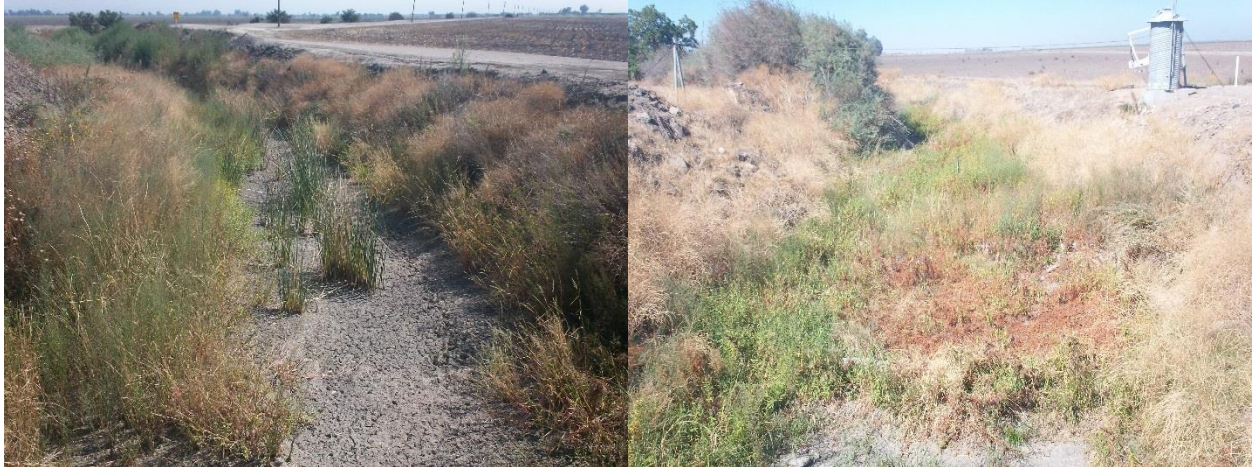
Figure 9. Dry site at Duck Slough @ Gurr Rd – September 8, 2015.

Photo on the left is facing upstream (east) and photo on the right is facing downstream (west)

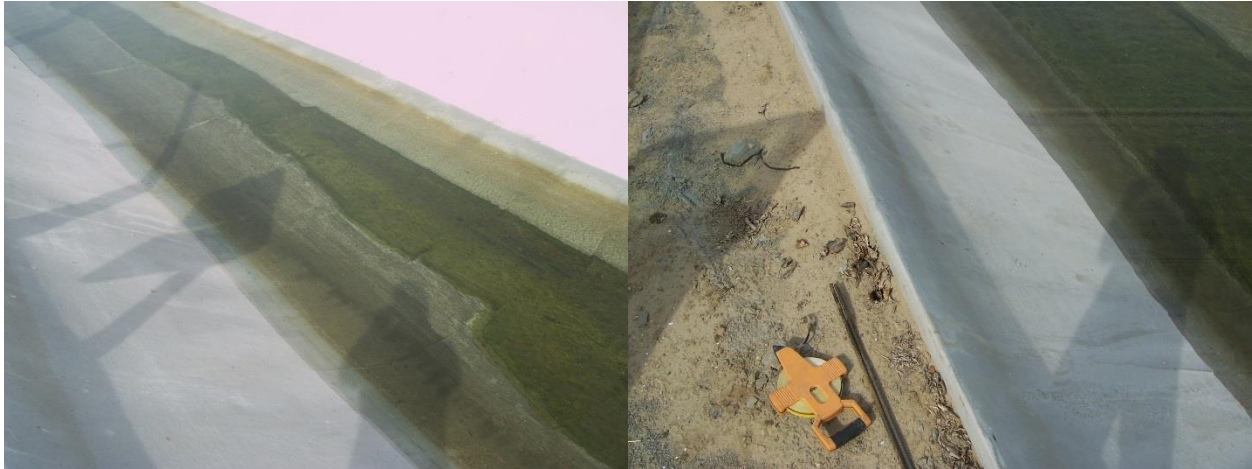
Figure 10. Hard bottom at Lateral 5 ½ @ South Blaker – March 10, 2016.

If sediment samples cannot be collected because sediment is not present, the site is evaluated to determine if the cause is temporary or permanent. If the cause is deemed temporary, and it is probable that sediment will re-accumulate over time, sediment collection is attempted during the subsequent scheduled sediment sampling events (March and September). If it is determined that sediment accumulation is not likely to occur, then a surrogate location will be chosen for sediment collection. Sampling will occur either during the next month’s monitoring event, if it is within the sediment collection timeframe, or the next scheduled sediment monitoring event.

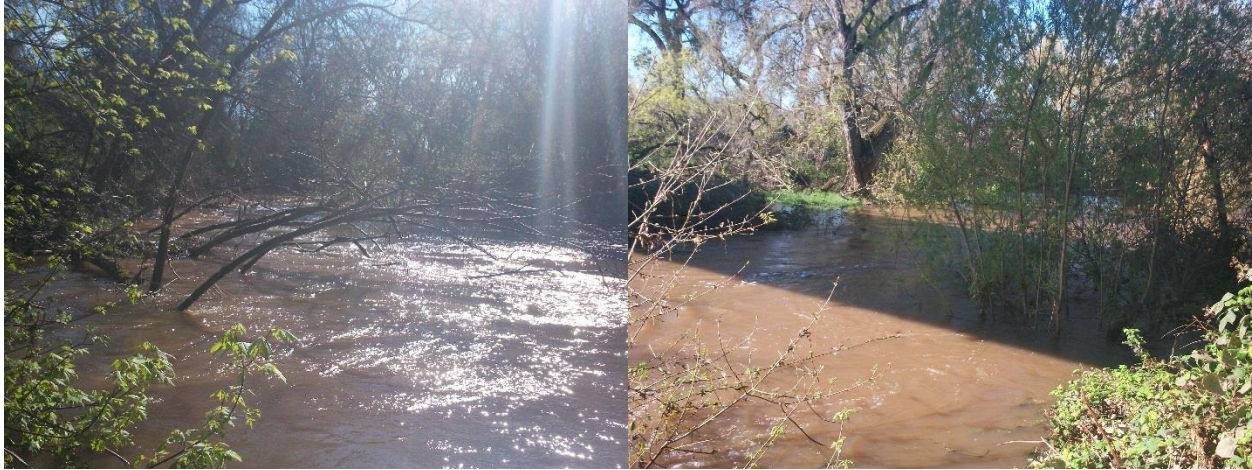
An example of no access due to high flows from a storm event is depicted in Figure 11 for Dry Creek @ Wellsford Rd on March 8, 2016. Due to the large amount of rain, flows in the creek were extremely high and the water's edge had reached the rip rap. Samplers were able to collect water samples from the bank, but it was not possible to reach any sediment with the stainless steel scoop. An Ekman grab sampler cannot be used from the bridge at this site because the dominant substrate is cobble and boulders around the bridge. Samplers returned the following month, when flows were down, and were able to collect sediment samples within the required timeframe (Figure 12).

Photo on the left is facing upstream (east) and photo on the right is facing downstream (west)

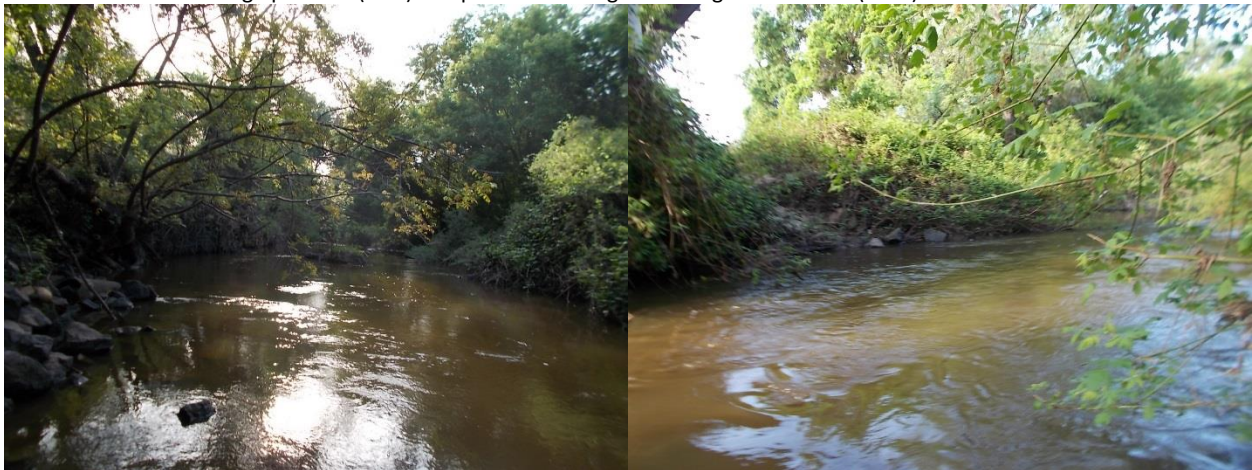
Figure 12. Sediment sample accessible at Dry Creek @ Wellsford the following month – April 12, 2016.

Photo on the left is facing upstream (east) and photo on the right is facing downstream (west)
