# Permeable Pavement Maintenance: A Review of Literature to Assess Clogging, Predict Maintenance Frequency, and Compare Maintenance Techniques

*Southern California Coastal Water Research Project*  
Technical Report 1280

**October 2022**

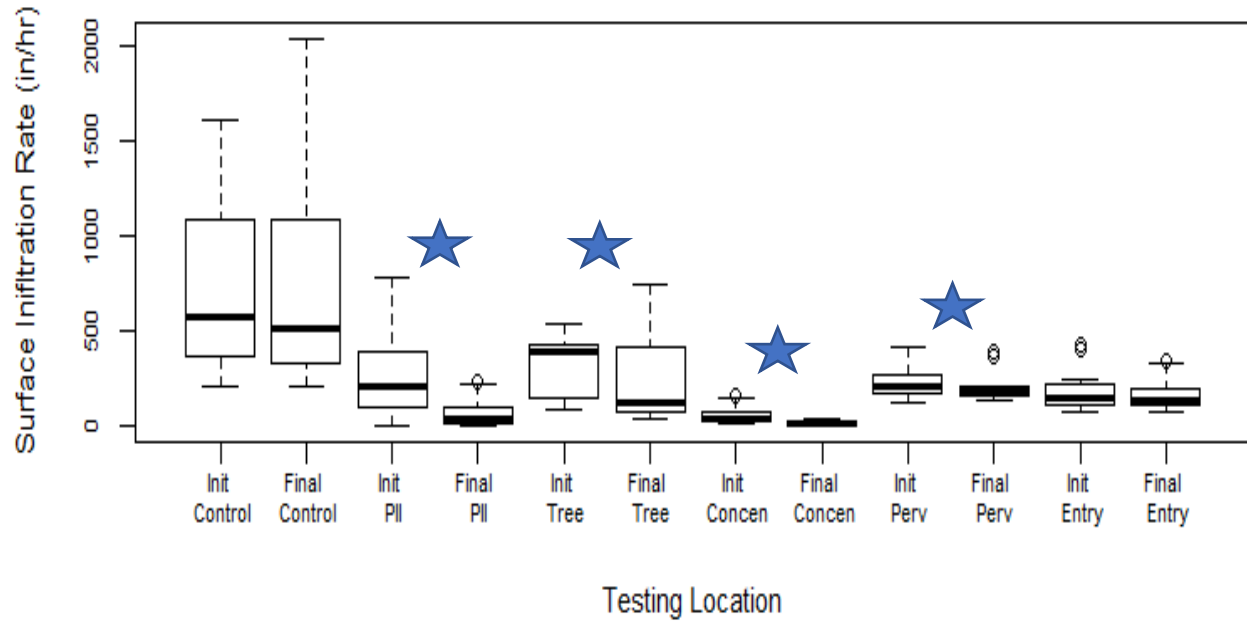
**Figure 2. Surface infiltration rate as a function of clogging stimuli (Winston, unpublished data). Initial data were collected 3 months prior to final data. Control locations are those without clogging stimuli, PII is the permeable / impermeable interface, concen is concentrated flow, perv is pervious areas draining to the pavement, and entry is an entryway into a parking lot. Stars show statistically significant loss of surface infiltration rate. Dark horizontal lines within each boxplot indicate the median value.**

In order to test for the effects of clogging stimuli on SIR, data were collected by the Winston research group on four permeable pavements in Northeast Ohio (Figure 2). Five to seven locations at each permeable pavement were selected based on potential clogging stimuli for repeat testing of SIR. Measurement of SIR was made in duplicate at these locations at an initial time point (“init”) and a final time point three months later. Control locations were permeable pavements without clogging stimuli present, while the locations with stimuli tested were the permeable / impermeable interface (PII; Figure 3), locations beneath trees, locations receiving concentrated flow, locations draining pervious areas, and entries into parking lots (Figure 4). Over the three-month period, the SIRs of the control locations did not significantly decline; conversely, significant loss in SIR was noted for locations near the PII, under trees, receiving concentrated flow, and with nearby pervious areas. These data suggest that clogging is spatially varied within a permeable pavement application and that maintenance needs are not homogenous from application to application. The findings concur with Drake and Bradford (2013), that post-maintenance SIRs vary spatially due to localized conditions within a given permeable pavement.

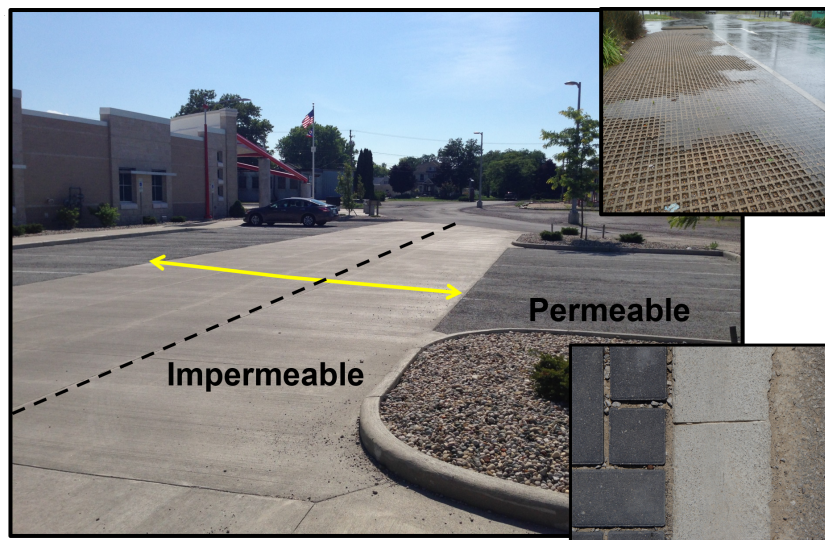
**Figure 3. The permeable / impermeable interface (PII) with several photos of clogging at these locations.**

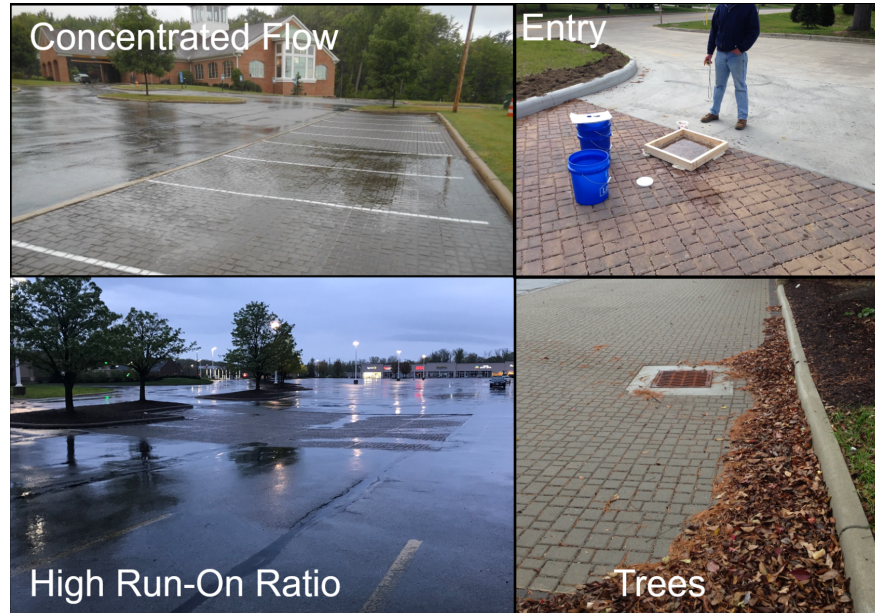
**Figure 4. Clogging stimuli tested at permeable pavement sites in Ohio.**

Unstable catchments describe areas with exposed soils which may exacerbate airborne deposition and run-on particulate concentrations, accelerating clogging in permeable pavements. The effects of an unstable catchment are reflected in the SIR at a PICP installation at the North Shore Events Centre parking lot in Auckland, New Zealand (Figure 5) (Fassman and Blackbourn 2010). The SIR measured in the end of the parking lot nearest to a builder's yard with exposed stockpiles of building materials was 21 in/hr, compared to measurements of 106-303 in/hr elsewhere. Construction areas pose substantial risk of sediment tracking and deposition. A qualitative example from Seattle, WA is presented in Figure 6, where pervious concrete sidewalks were installed in an early stage of constructing a residential neighborhood. Poorly covered stockpiles and poorly maintained erosion and sediment controls failed to protect the pervious pavement from exposure (Figure 6a), despite attempts at a dual-layer of protection (Figure 6b). If permeable pavement is installed as part of a larger construction project, it should be installed during the final phase of the construction to minimize the potential for clogging before the system comes online.

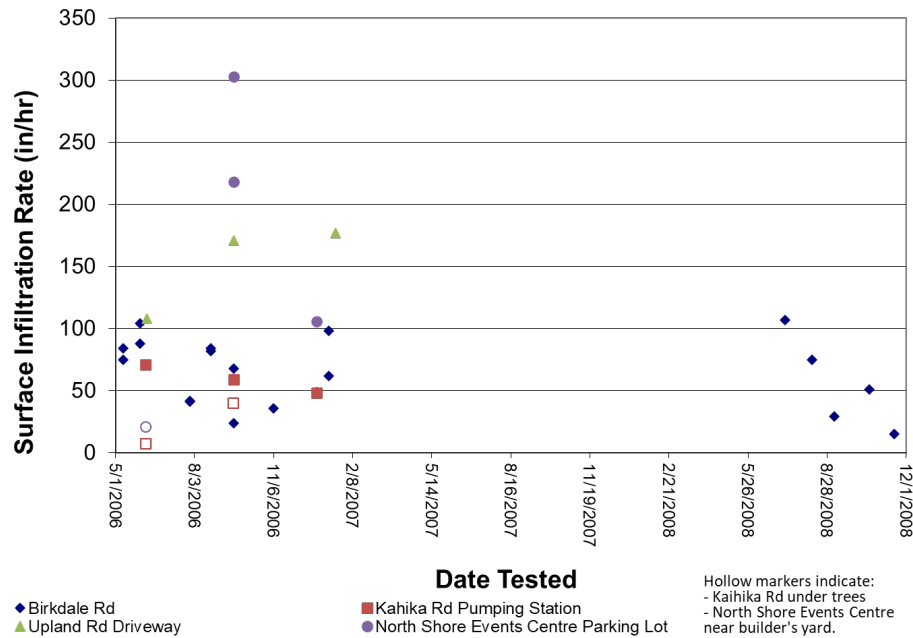
**Figure 5. SIR measured at 4 PICP installations in Auckland, New Zealand. The Birkdale Rd. PICP surface was removed and relaid in early 2008. Source: Adapted from Fassman and Blackbourn 2010.**

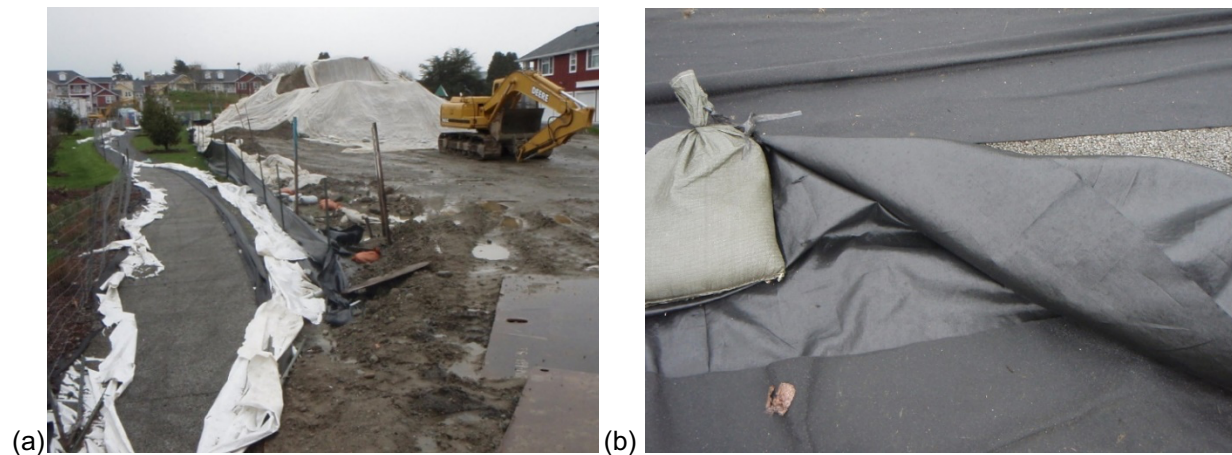
**Figure 6. Pervious concrete sidewalks in Seattle in 2008; (a) at high risk of clogging due to adjacent sediment stockpile and poor erosion and sediment controls; (b) attempts to protect pervious concrete during construction by wrapping in HDPE and geotextile secured with sand bags.**

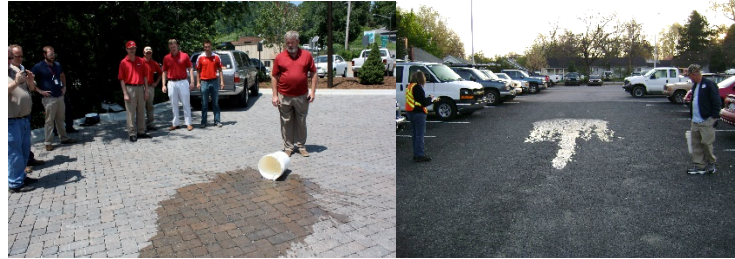
**Figure 8. Examples of a successful (left; note infiltration at point of water application) and a failed bucket test (right; note runoff plume).**

Visiting a permeable pavement during a rain event is one of the simplest ways to determine if restorative maintenance is needed. Surface ponding visible over a substantial portion of the permeable pavement during or after a rain event indicates substantial clogging and that restorative maintenance is needed. Another simple “bucket test” begins with dumping a 5-gallon bucket of water onto the permeable pavement surface. Restorative maintenance is needed if the water runs downslope creating a surface plume (Figure 8, right), rather than percolating through the pavement (Figure 8, left).

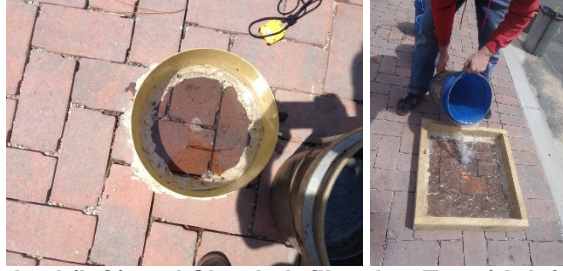
**Figure 9. ASTM C1701 standard (left) and Simple Infiltration Test (right) SIR measurement methodologies.**

Two typical methods are employed to quantify SIR. ASTM C1701/C1781, which is a single ring, constant head infiltration test (Figure 9; ASTM 2017; ASTM 2021), involves pouring 40 lbs of water through a 12-inch diameter ring affixed to the pavement surface with plumber’s putty. A constant head of 0.4-0.6 inches must be ensured. The time for water to infiltrate is measured and converted to an SIR. Some drawbacks of ASTM C1701/C1781 include: (1) 12-inch ring is not easily obtained, (2) the constant head is difficult to achieve in very high infiltration rate conditions, (3) the ring encircles a relatively small surface area, and (4) this test can take > 30 minutes to perform in heavily clogged locations.

The Simple Infiltration Test (SIT) employs a wooden two-by-four cut into four equal lengths and screwed together to make a square infiltrometer (Figure 9; Winston et al. 2016a). The infiltrometer is affixed to the pavement surface using plumber’s putty. Five gallons of water are quickly poured into the square to perform a falling head infiltration test. The time for the water to infiltrate is recorded and SIR is calculated. This square infiltrometer has a > 3 times larger surface area than the ASTM C1701/1781 methodology, providing an SIR representative of a larger area and a much quicker test duration (generally < 10 minutes). If the SIT test takes < 1 minute to run, the pavement is performing as intended and routine maintenance should be continued. At > 1 minute duration, restorative maintenance should be scheduled.

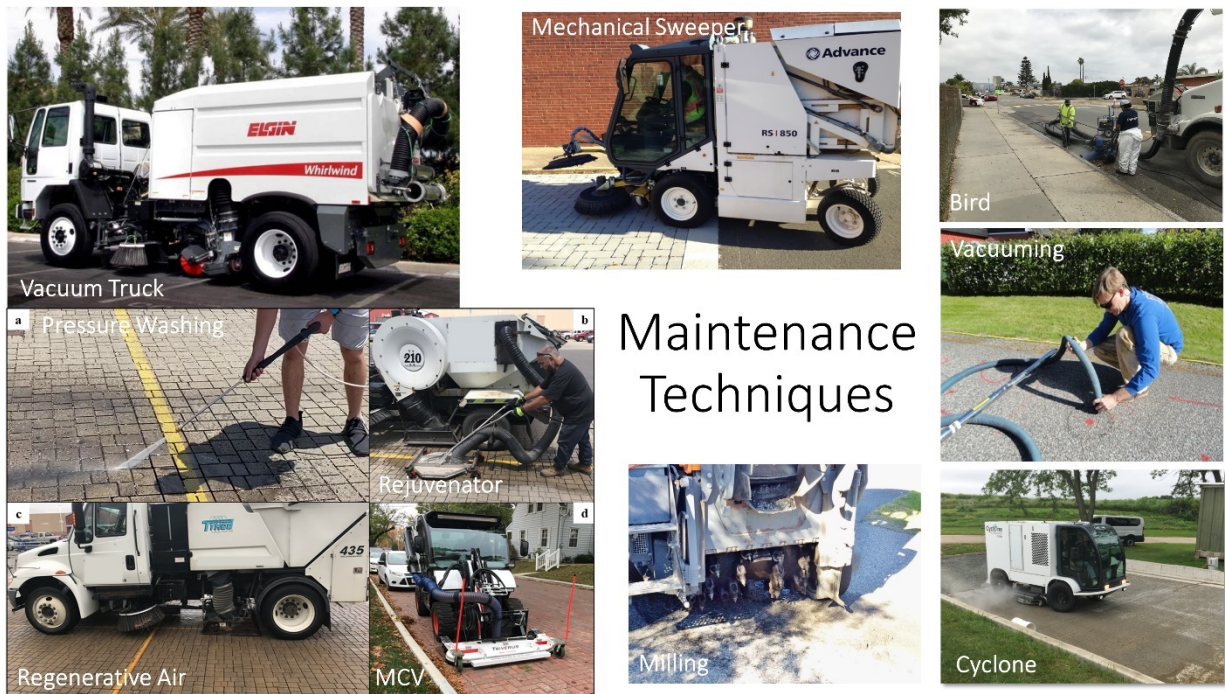
**Figure 11. Photographs of routine and restorative maintenance techniques for permeable pavements. Cyclone photograph courtesy Bill Selbig (WI USGS). BIRD photograph courtesy: Count of Ventura Public Works.**

Three general categories of street sweepers exist: (1) mechanical, (2) regenerative air, and (3) vacuum truck (Figure 11). Mechanical sweepers utilize the friction from bristles to mobilize debris and sediment into an internal hopper. Regenerative air street sweepers utilize a blower system that blows air down on one side of the truck to lift debris and sediment off the pavement and a suction system on the other side to convey it into the hopper. These two street sweepers are generally used for routine maintenance. The vacuum truck is a large vacuum-only sweeper (often with a boom on the back for catch basin cleanout) that can be used to apply large suction forces to the pavement surface.

Vacuuming of two heavily clogged PA roads was performed for 1 minute using a dustcontrol DC-50 handheld industrial vacuum (Figure 11). In both cases, significant improvements in surface infiltration rate were observed post-maintenance (Figure 14). However, post-maintenance SIR remained quite low (e.g., less than 5 in/hr for both roads). Thus, post-maintenance SIRs suggest that handheld vacuuming (with a shopvac or similar) can be useful to remove large debris (e.g., mulch particles that were accidentally stored on the permeable pavement) but not to dislodge debris from a clogged permeable pavement in need of restorative maintenance.

Handheld pressure washing has been tested on PA, PC, and PICP (Figure 11). Hu et al. (2020) note that pressure washing works to rejuvenate PC SIR, but that the ability to fully restore the SIR with this maintenance technique declined over time. Two heavily clogged PA roads in northern Sweden (Figure 14) along with a heavily clogged PICP in Reynoldsburg, Ohio (Figure 17) were used to test pressure washing as a maintenance measure. Significant improvements in average SIR were observed for the PA roads, but post-maintenance SIRs were highly varied between individual testing locations (i.e., ~1 and ~100 in/hr). Pressure washing also resulted in a substantial increase in median surface infiltration rate for PICP (~50 in/hr post-maintenance), but none of these trials produced post-maintenance SIRs greater than the 100 in/hr restorative maintenance threshold. Thus, handheld pressure washing can be used for spot routine maintenance (for instance in the case of mulch or soil being accidentally stored on a permeable pavement), but is not appropriate as a sole technique.

The Rejuvenator is a walk-behind street cleaning apparatus that was tested on a heavily clogged PICP system with a 27:1 run-on ratio in Reynoldsburg, Ohio (Figure 11). It consists of a 2 ft wide deck with rotating nozzles (3200 psi) and a 6-inch diameter suction hose affixed to a Tymco regenerative air street sweeper. This device was tested alone and in conjunction with preceding hand-held pressure washing. Both techniques produced significant improvement in PICP SIR and resulted in median SIRs at or substantially above the 100 in/hr restorative maintenance threshold (Figure 17). These treatments produced substantially better post-maintenance SIRs than pressure washing alone, which resulted in a median SIR of approximately 50 in/hr. These results again support the use of combined high pressure washing with vacuuming as the best currently available combination of restorative maintenance tools for permeable pavements (Chopra et al. 2010; Kazemi et al. 2017).

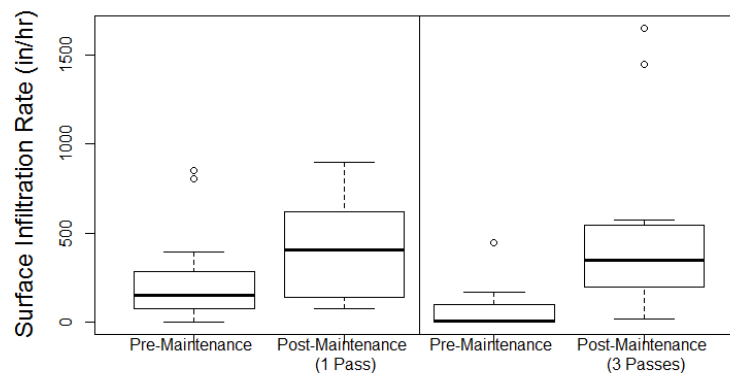
**Figure 13. Resulting pre- vs post-maintenance SIRs for a vacuum truck on a PICP parking lot in Ohio. Data collected on the right side of the vertical line were ~1 year after those on the left.**

A vacuum truck was tested for maintenance effectiveness on a PICP in Northeast Ohio; pre-maintenance SIR testing suggested that the pavement needed maintenance after the first year of

operation (Figure 13). One pass with a vacuum truck resulted in removal of the upper 1 inch of joint stone and clogging material from the PICP. Following replacement with clean joint stone, median SIRs of approximately 500 in/hr were measured, which were in the range of like-new conditions. One year later, the pavement had again clogged to the point of needing restorative maintenance (Figure 13). Following three passes with the vacuum truck, the pavement again had like new SIRs, suggesting that the vacuum technique can provide reliable restoration of SIR for PICP.

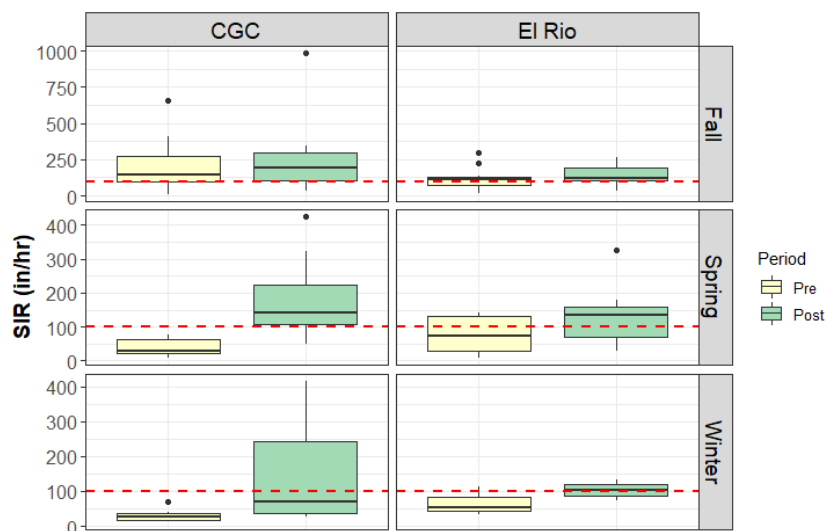
**Figure 16. Pre- and post-maintenance surface infiltration rate for the BIRD maintenance device by season and across two sets of permeable pavement applications in Ventura, CA. Red dashed lines represent the threshold for restorative maintenance for permeable pavements with run-on (100 in/hr).**

Data provided by the County of Ventura were used to compare pre- and post-maintenance SIR of pervious concrete (Figure 16). During most seasons at CGC and all seasons at El Rio, pre-maintenance SIRs were below the restorative maintenance threshold of 100 in/hr. All maintenance trials of the BIRD were successful in improving median infiltration rate, with

median SIRs at or exceeding the 100 in/hr threshold. The smallest incremental improvement (i.e., CGC in the fall) was for pavements that were already functioning above the threshold for restorative maintenance. Overall, the BIRD technology appears to successfully improve the hydraulic function of the PCs.
