# Hydrologic assessment of reference streams in the Los Angeles region

**SOUTHERN CALIFORNIA COASTAL WATER RESEARCH PROJECT**

Technical Report 1412

**April 2025**

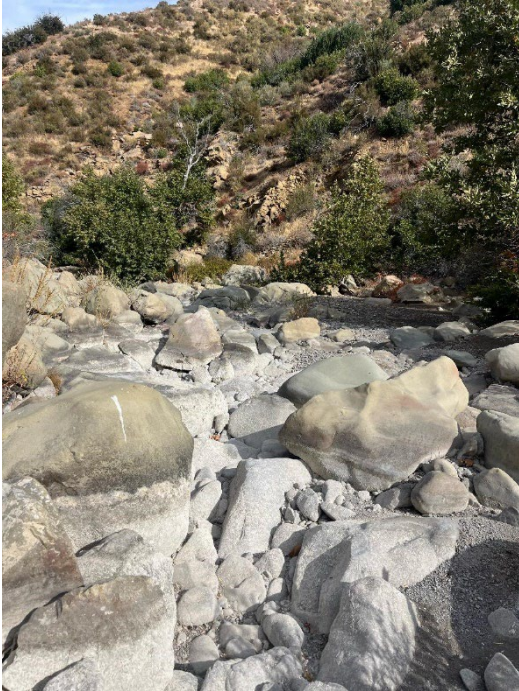
A. 403LNCASC (Lion Creek) on 10/30/2024

**Figure 5. Photos of sites in dry (A, B) and flowing (C, D) conditions**

Examples of flowing and dry conditions observed at these sites are shown in Figure 5.

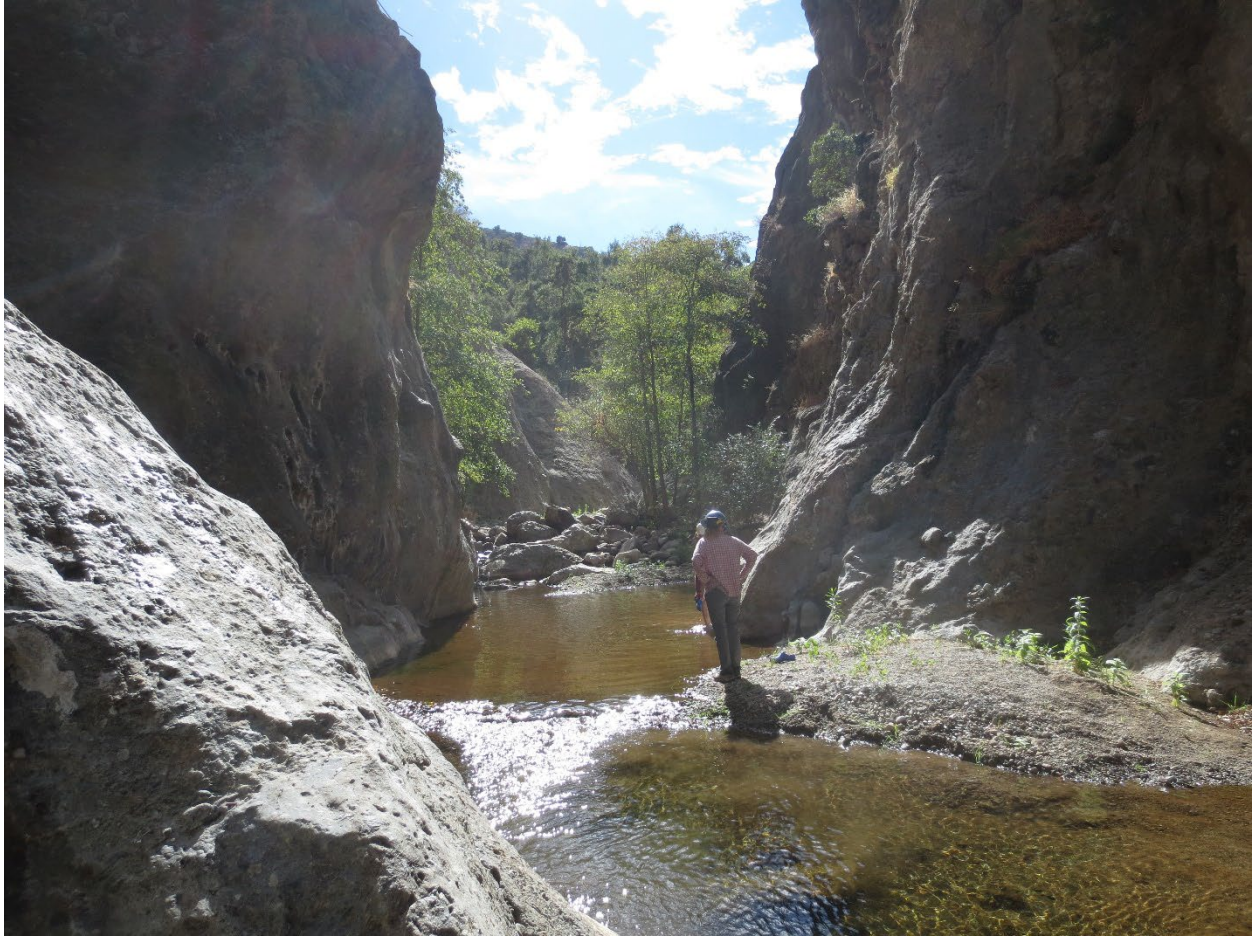
Figure 8. Flowing conditions at the Devil's Gateway on Agua Blanca creek, taken on 10/26/2024 by Alan Coles. Source: <https://www.hikelospadres.com/agua-blanca-trail.html#prettyPhoto>

Site 403WE0501 is located on Agua Blanca Creek, a few km downstream of the Log Cabin campground and the Devil's Gateway. Water reports for the Log Cabin campground (<https://www.hikelospadres.com/log-cabin-campground.html>) indicate continuous late-season flow in most years, including a flowing observation on 10/26/2024 (Figure 8). There is one dry observation on 10/26/2022 (Figure 9). Flow duration in Devil's Gateway is likely longer than at the target site due to geologic confinement that increases discharge of groundwater into the stream. Review of aerial imagery in Google Earth supported this interpretation.

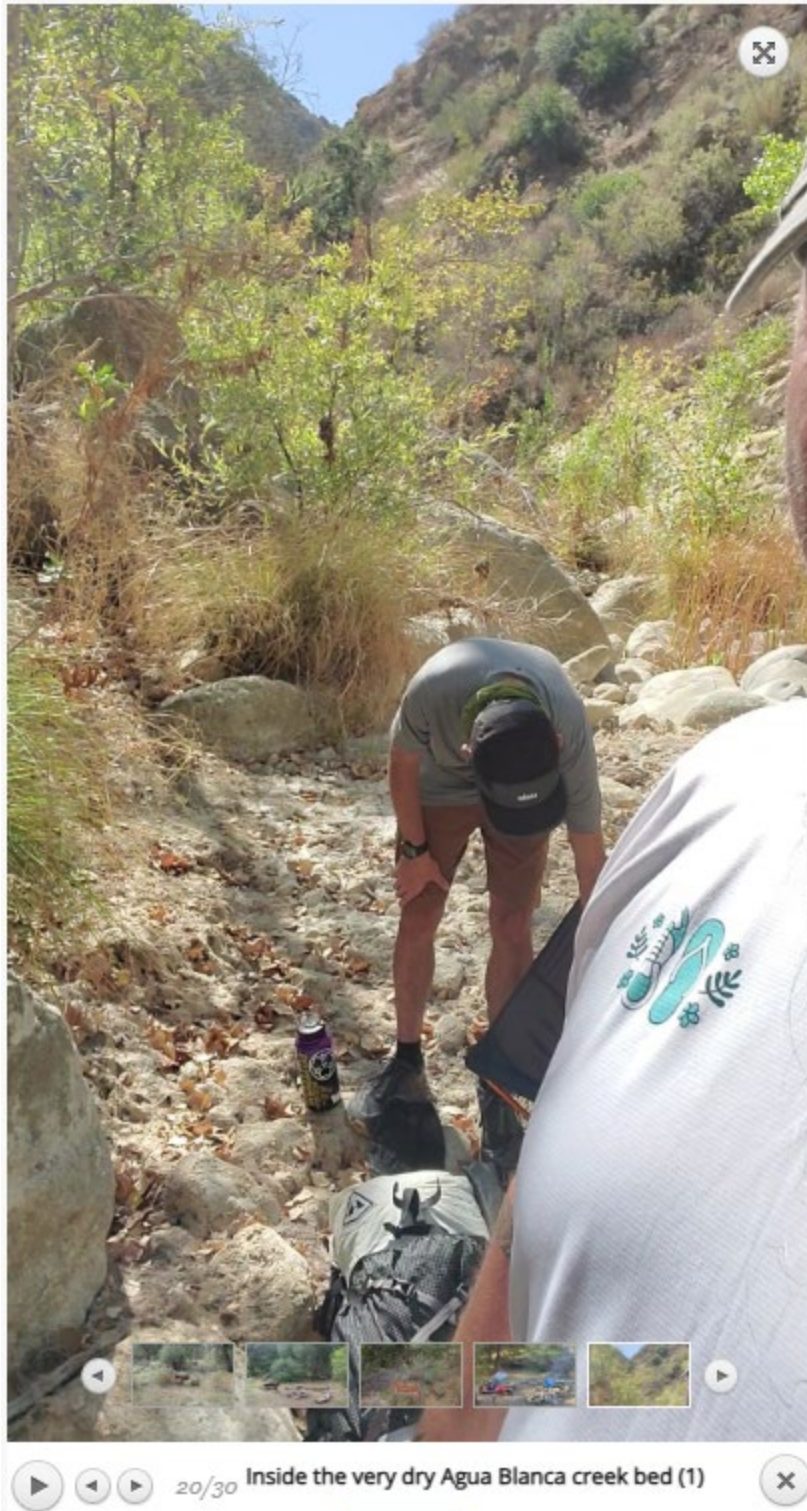
Figure 9. Dry conditions in Agua Blanca Creek, taken by Alan Gonzalez on 10/26/2022.  
Source: <https://www.hikelospadres.com/log-cabin-campground.html#prettyPhoto>

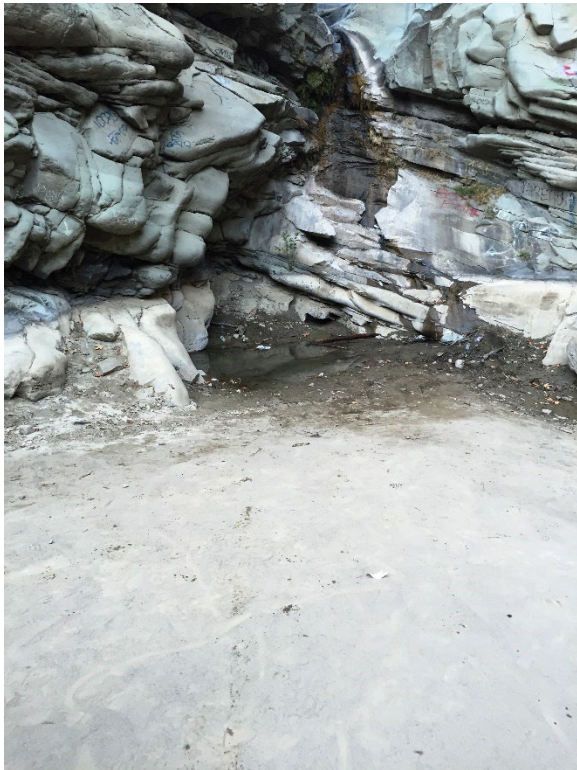
**Figure 10. Photo of trickling conditions of Santa Paula creek near the Big Cone campground, taken on 11/29/2015 by Ranger Heidi Anderson. The accompanying description reads: “Photo taken in November during an Ojai Ranger District trail project. Proof that the creek does dry up, as hard as that is to believe.” Source: <https://www.hikelospadres.com/big-cone-campground.html#prettyPhoto>.**

403STC024 is located on Santa Paula creek between the Big Cone and Cross campgrounds. No dry conditions were reported at the Big Cone campground, although trickling conditions were noted by a ranger on 11/29/2015 (Figure 10). Flowing conditions were noted on most dates at the Cross campground, except for 7/8/2022, when dry conditions were noted by an anonymous surveyor (no photos were submitted).
