Copper emissions from antifouling paint on recreational vessels

Southern California Coastal Water Research Project

Technical Report #405

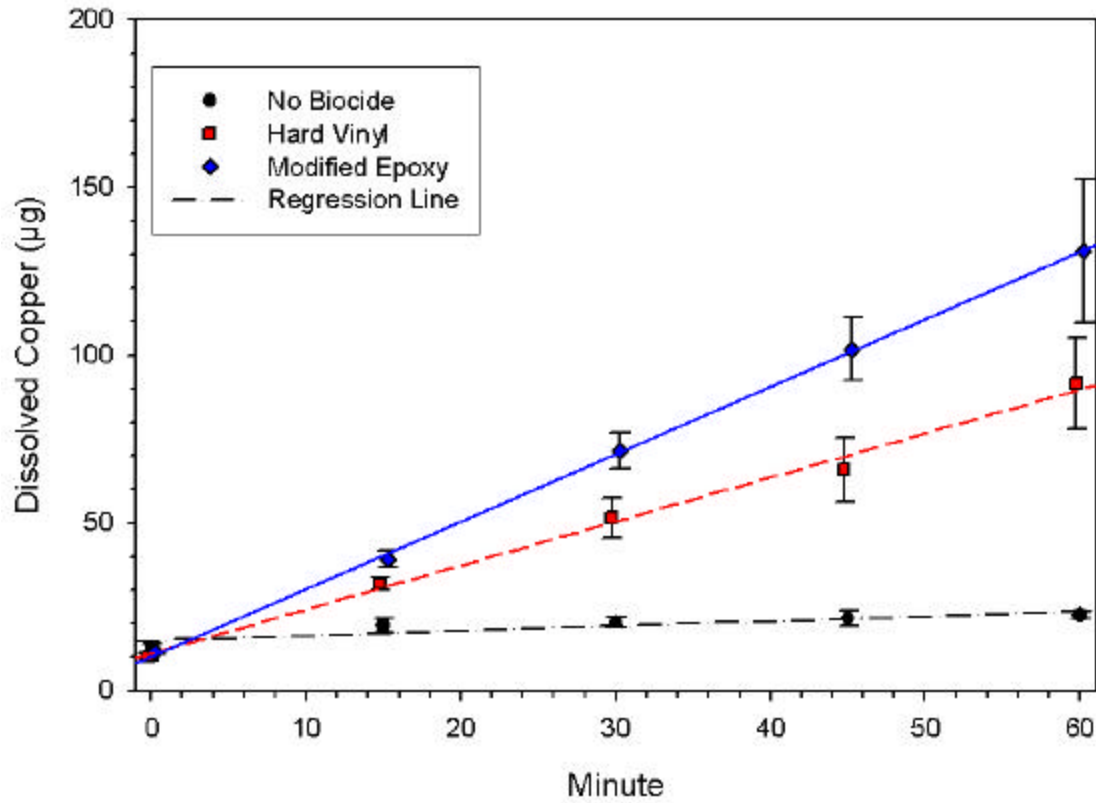
Figure 1. Passive leach rate curve for dissolved copper from a hard vinyl, modified epoxy, and biocide free antifouling paint. All data were collected 14 days after underwater cleaning.

The enclosed system was able to measure *in situ* passive dissolved copper leach rates from fiberglass panels (Figure 1). Dissolved copper mass within the recirculating dome system for hard vinyl coatings originated near 10 μg at time zero, then increased more than one order of magnitude to 130 μg after one hour. Sequential samples collected over this time period increased in a strong linear fashion. We used this relationship to fit curves that approximated passive leaching rates. The passive leaching rates for modified epoxy resulted in a very similar curve as hard vinyl coatings. In contrast, the biocide-free coatings had a very flat curve, demonstrating minimal leaching from this coating type.

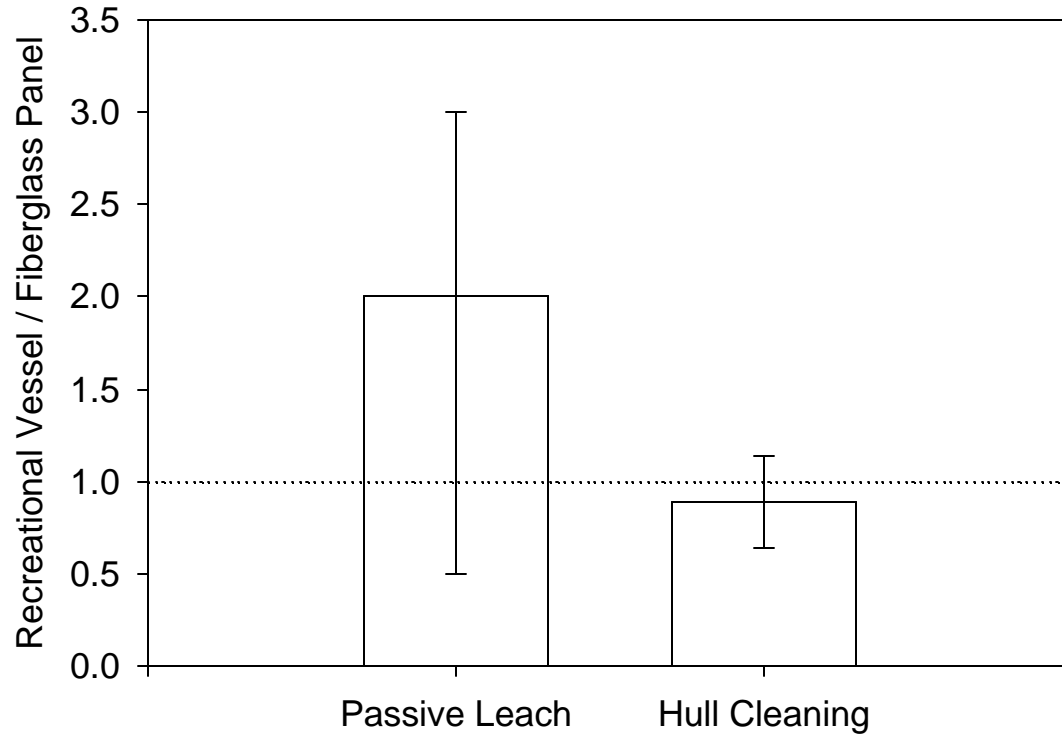
Figure 3. Ratio of mean (min, max) dissolved copper flux rates for passive leaching or hull cleaning activities from recreational vessels relative to fiberglass panels used in this experiment. Data for passive leaching from recreational vessels from Valkirs *et al* (2003).

One point of concern for our study design was extrapolation of our results from fiberglass panels to the hulls of recreational vessels. This concern appears unfounded, though, because our measurements compared favorably to measurements from recreational vessel

hulls (Fig 3). Valkirs et al. (2003), using the *in situ* methodology used in our study, reported passive leach rates on seven different recreational vessels of varying coating formulations with different copper content, time since application, and time since cleaning. The mean passive leach rate of the recreational vessels was approximately double the fiberglass panels (8 vs. 4 $\mu\text{g}/\text{cm}^2/\text{day}$), but the range of measurements for the vessels encompassed the mean of our panel system. In fact, the range of measurements for the seven different recreational vessels was within the range of measurements for the fiberglass panels (2-26 $\mu\text{g}/\text{cm}^2/\text{day}$) over our one month test period. Likewise, the flux rates measured during hull cleaning events using fiberglass panels were comparable to results measured from recreational vessels (Fig 3). Similar to isolating fiberglass panels in a dockside tub system, we were able to measure replicate vessels by isolating them from the marina environment using a boat bag. The mean cleaning flux rate measured for the fiberglass panels and the boat bag systems were within 12% of each other. The range of hull cleaning flux rates from recreational vessels appeared much smaller than the passive leaching flux rates, perhaps because the vessels were all similar in size, coating formulation, time since application, and time since cleaning.
