APPENDIX A – HYDROMODIFICATION SITE CROSS-SECTIONS, BANKS, AND PHOTOGRAPHS

PURPOSE AND MEASUREMENT PROTOCOL

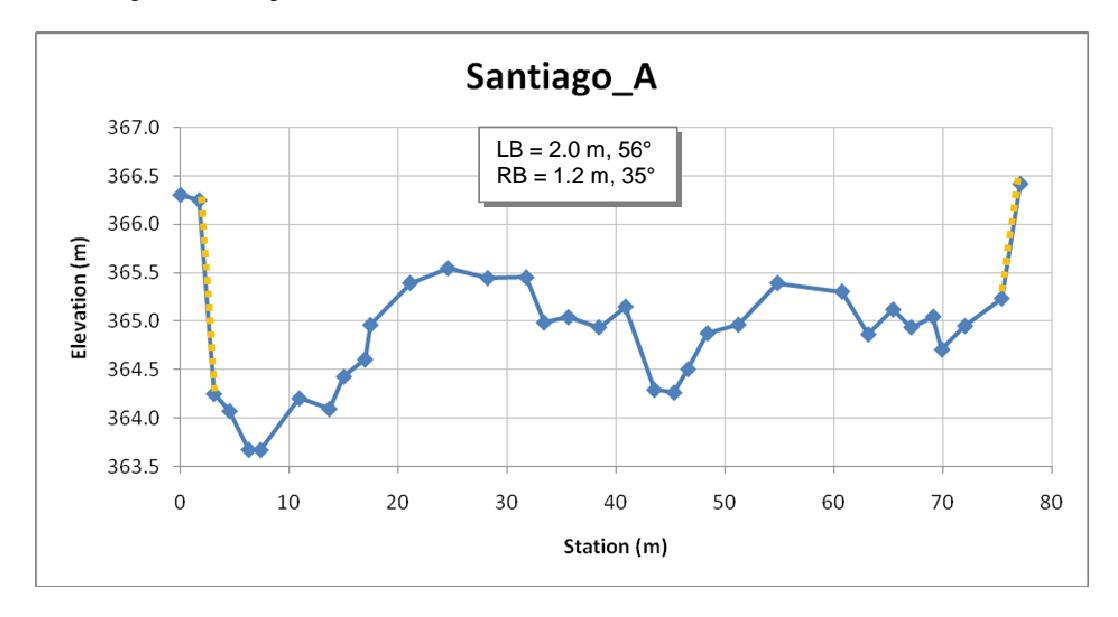
Figure A.1 – Santiago_A

LB U-MW-C

Near Santiago_A looking downstream

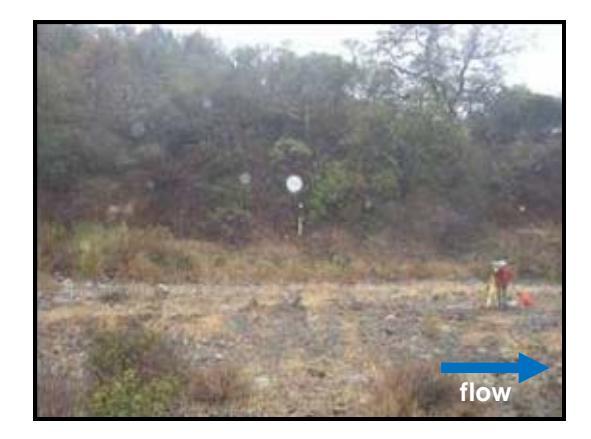
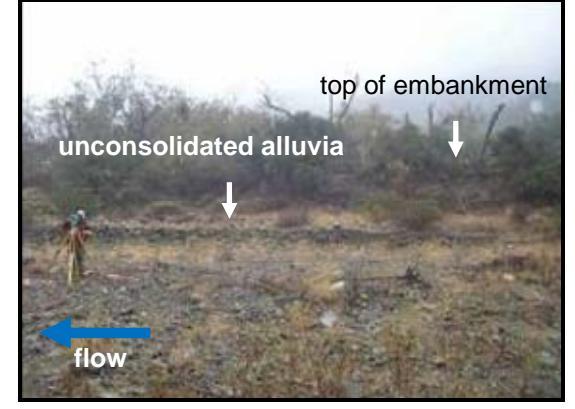
Figure A.2 – Santiago_B

Note(s): Flood control embankment constructed on right bank (date unknown)

LB S-CONFND

RB S-CONSTR (upper) and U-MW-UC (lower)

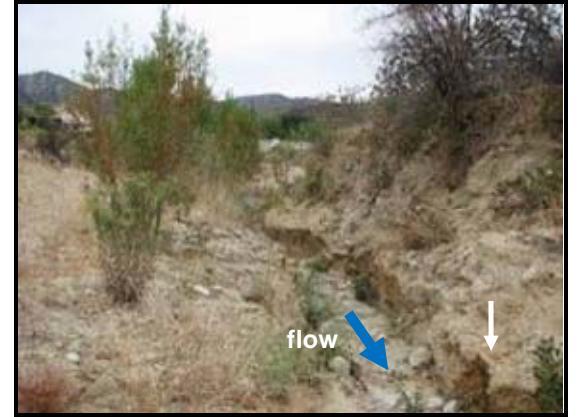
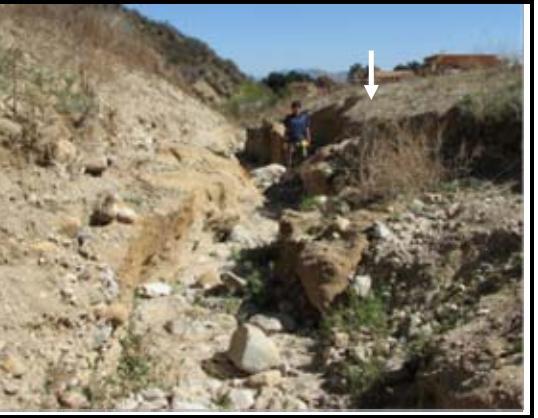
Figure A.3 – Hasley1_A

Note(s): Site was graded and realigned/partially channelized during development circa 2002.

LB U-MW-PC

RB U-MW-PC

Near Hasley1_A looking upstream

Near Hasley1_A looking downstream

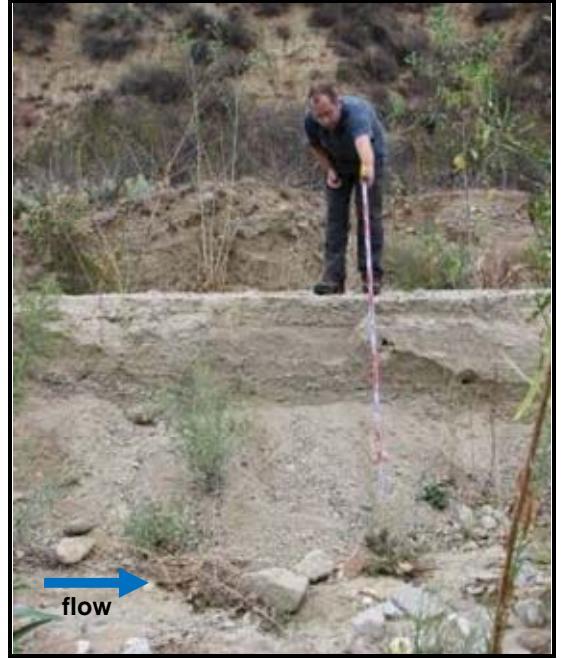
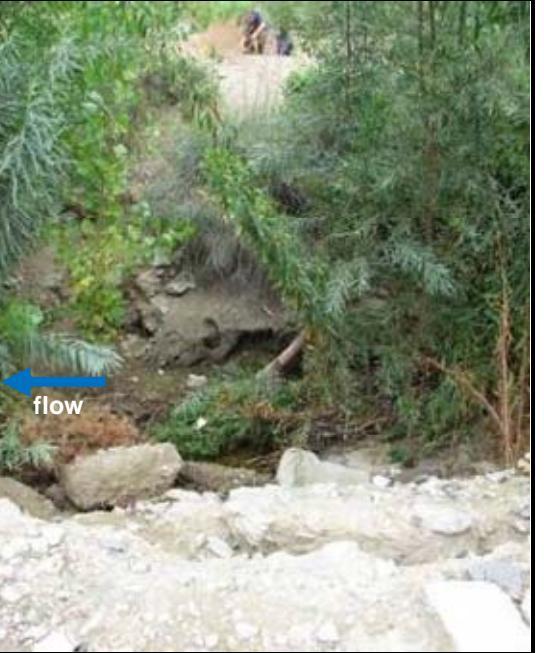
Figure A.4 – Hasley1_B

Note(s): Site was graded and realigned/partially channelized during development circa 2002.

LB U-MW-PC

RB U-MW-PC

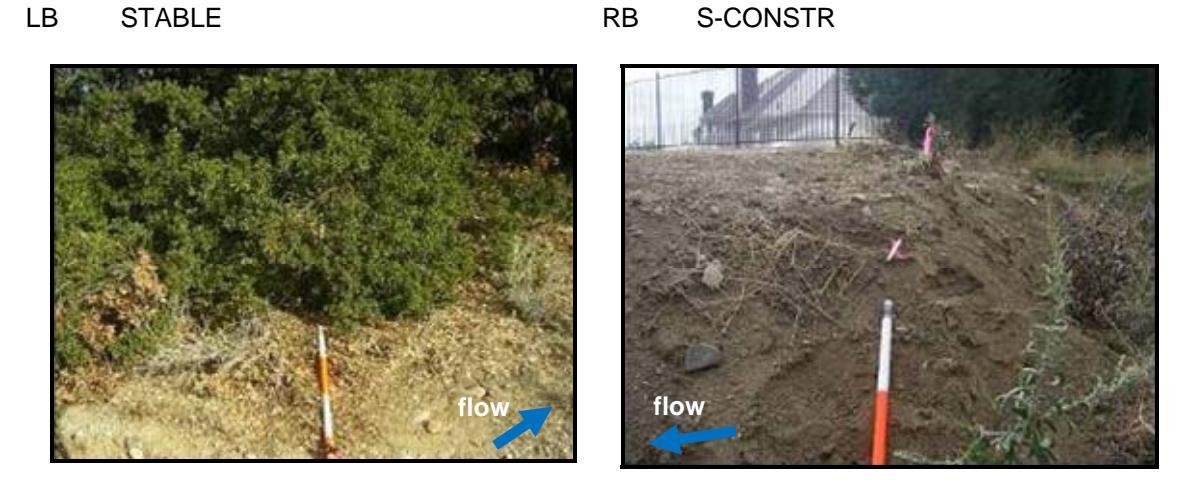
Figure A.5 – Hasley1_TRIB

Note(s): Right bank is unconsolidated fill (i.e., built up higher than original floodplain for lot creation)

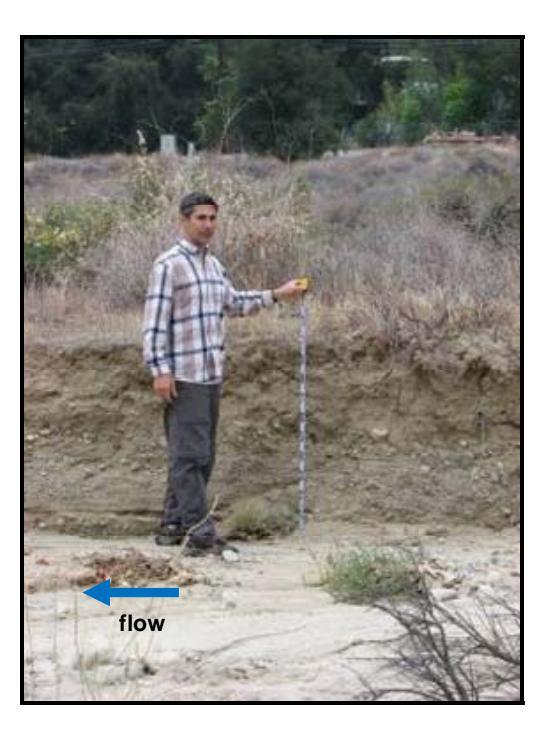
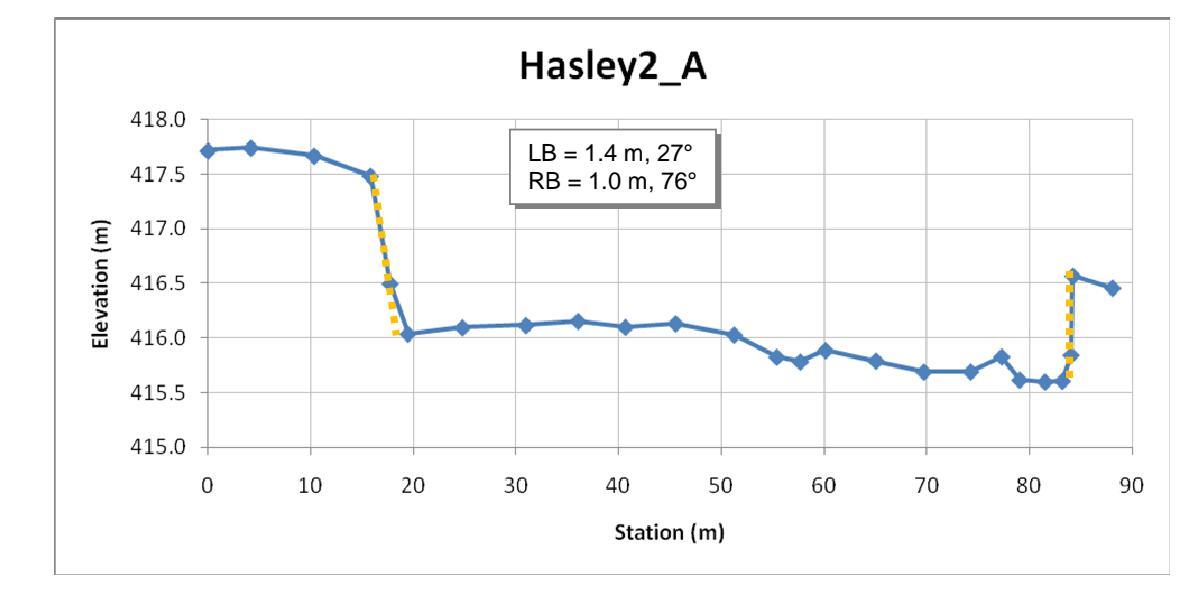
Figure A.6 – Hasley2_A

LB U-FAILED

Near Hasley2_A (survey captured geometry of a recently failed bank ($<30^{\circ}$ vs. pictured $>75^{\circ}$))

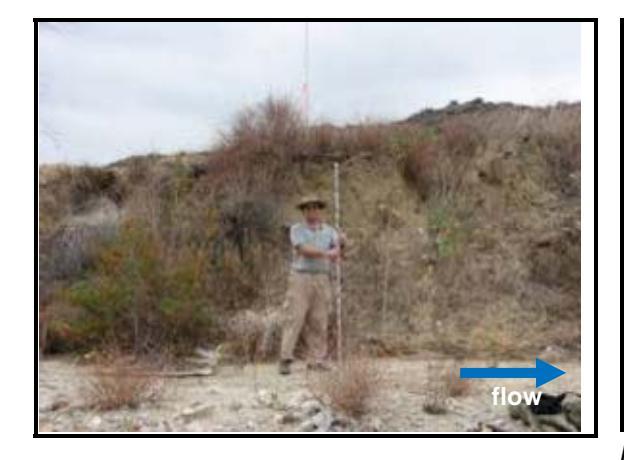
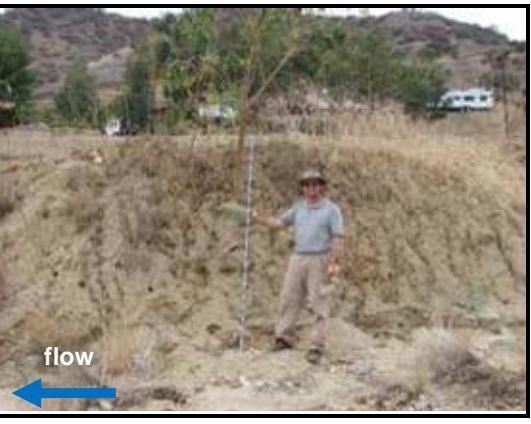
Figure A.7 – Hasley2_B

LB U-MW-C

Rilling evident, but no mass wasting, possibly graded

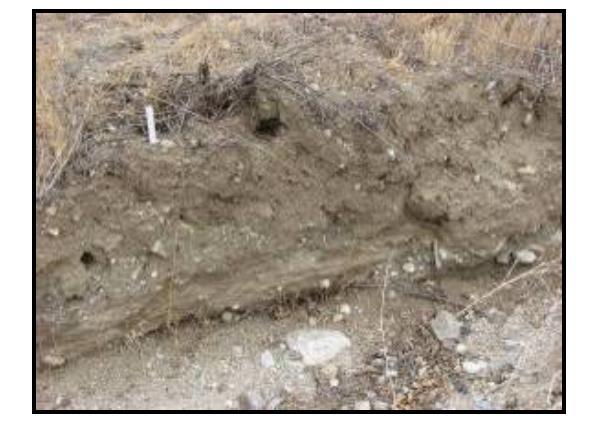
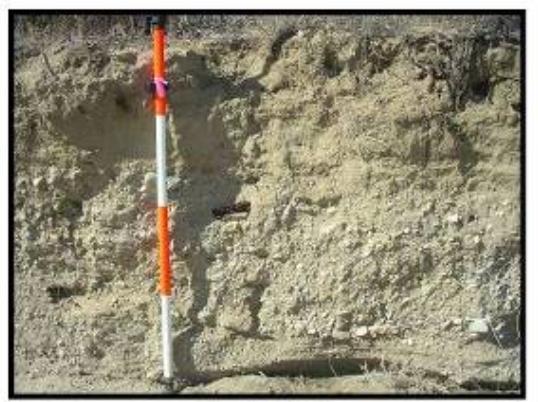
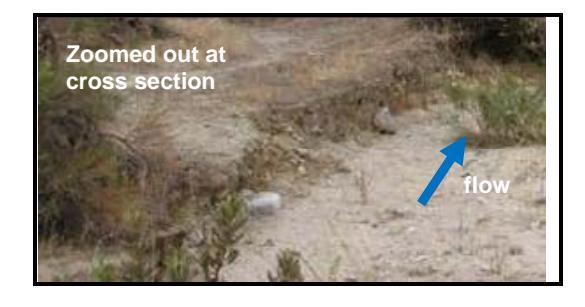
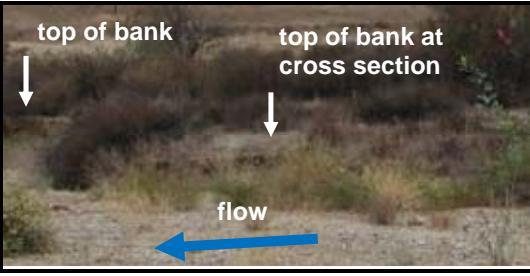
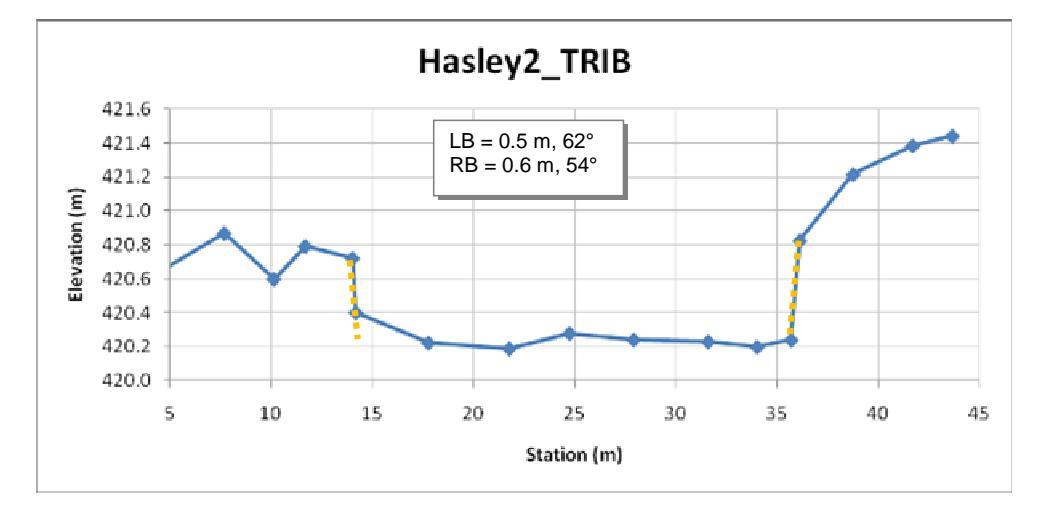
Figure A.8 – Hasley2_TRIB

U-MW-PC

LB U-MW-PC

Near Hasley2_TRIB, 6-in ruler for scale (just downstream, ~1.5x taller, similar composition)

IMGP0984 Near Hasley2_TRIB (just downstream, ~2x taller similar composition)

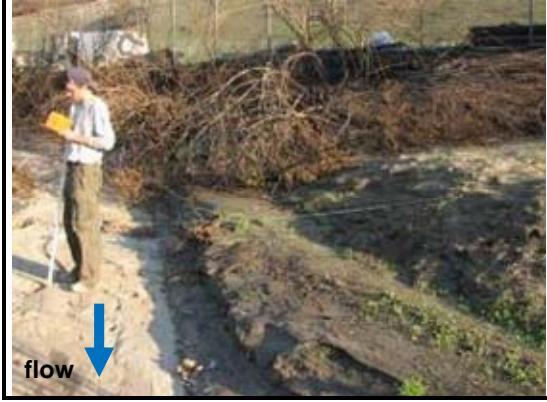
Figure A.9 – Hicks_A

LB STABLE-PC (upper) U-MW-UC (lower) RB

Unconsolidated bed of pre-incised channel

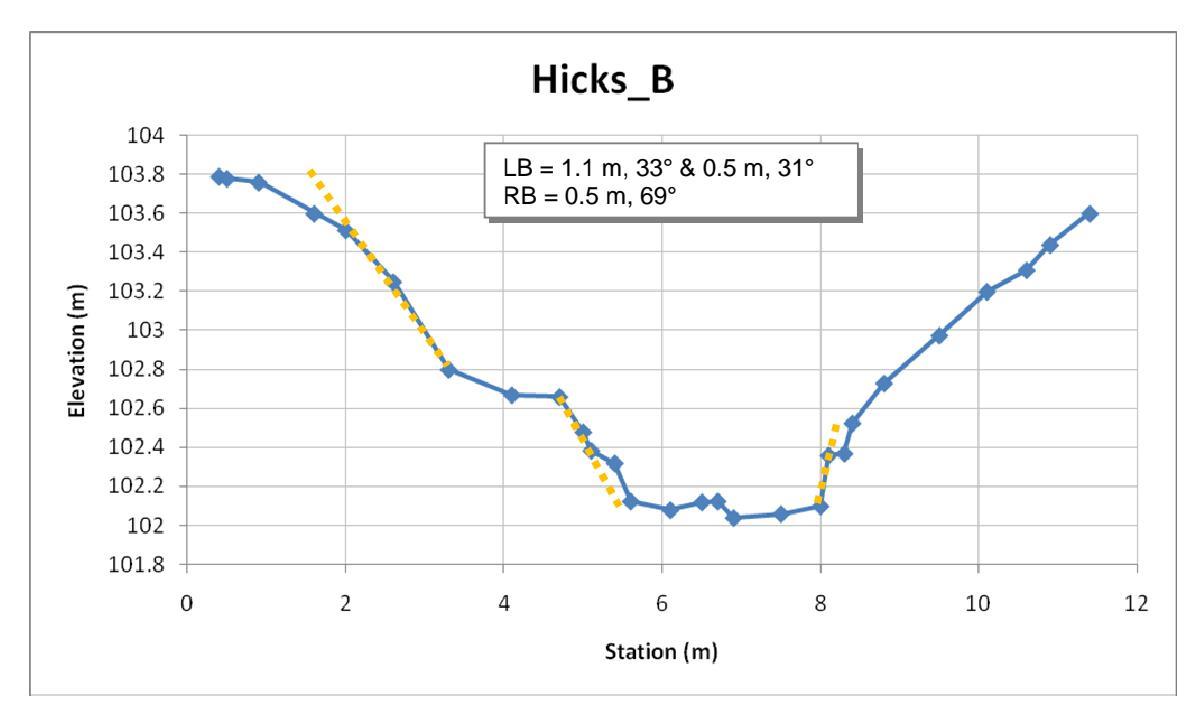
Figure A.10 – Hicks_B

LB U-FAILED (upper) and U-FAILED RB U-MW-PC (lower)

Fluvial activity across failed surfaces makes it difficult to re-project pre-failure geometry

Historic MW (dotted arrows) converges with recent MW (solid arrows) just downstream of survey. Just upstream of cross section, MW through pre-incised bed

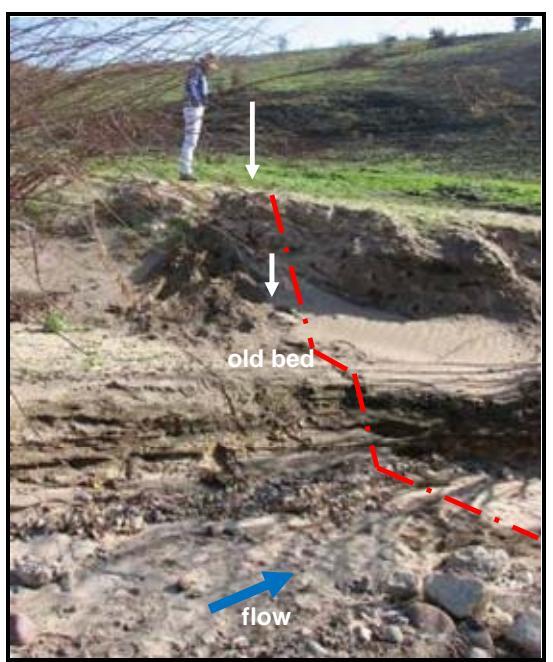
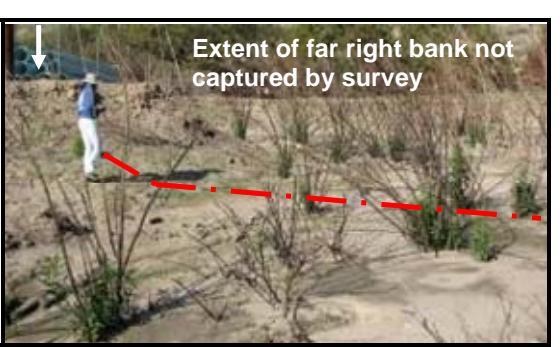
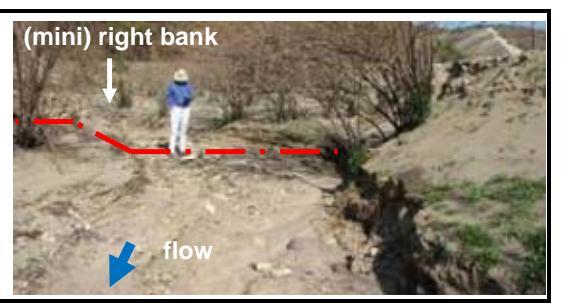
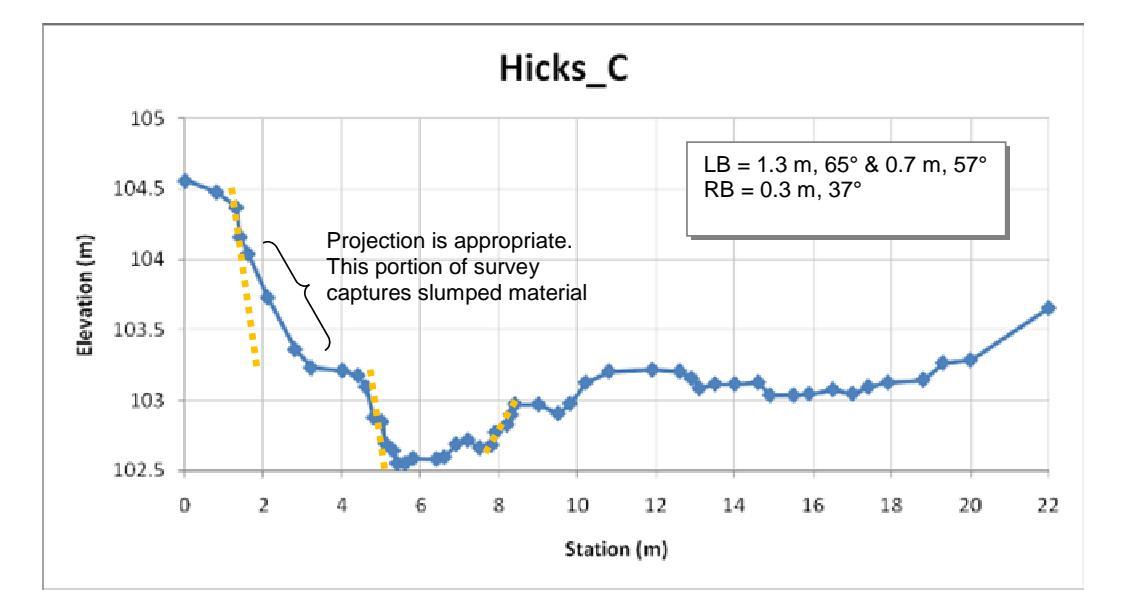
Figure A.11 – Hicks_C

U-MW-PC (upper) and U-MW-PC LB (lower)

Fluvial erosion is significant (bend), but mass Looking upstream wasting is ubiquitous

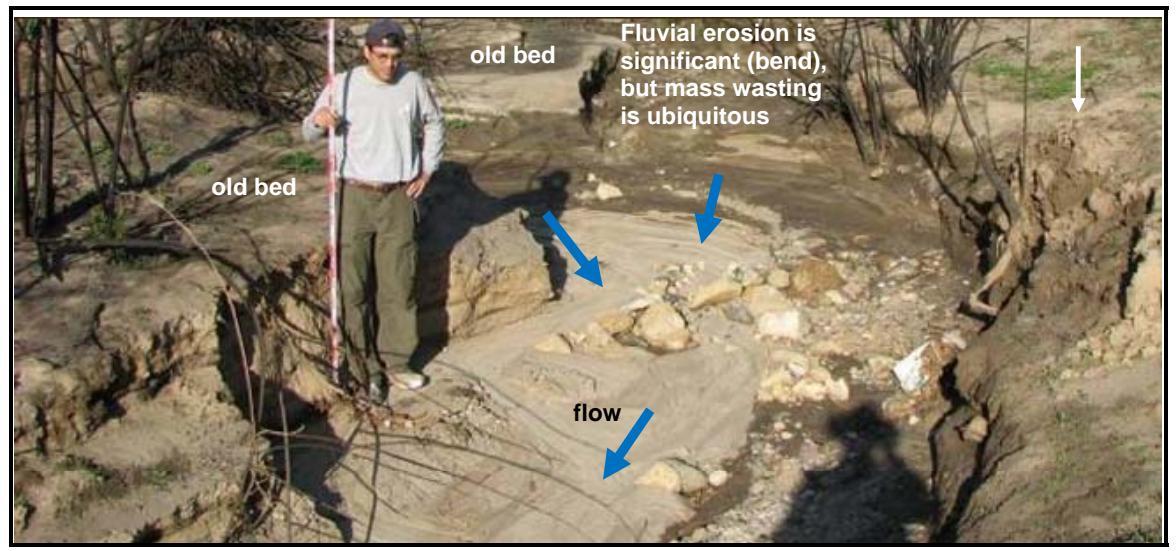
Figure A.12 – Hicks_D

LB U-MW-PC

RB U-MW-PC

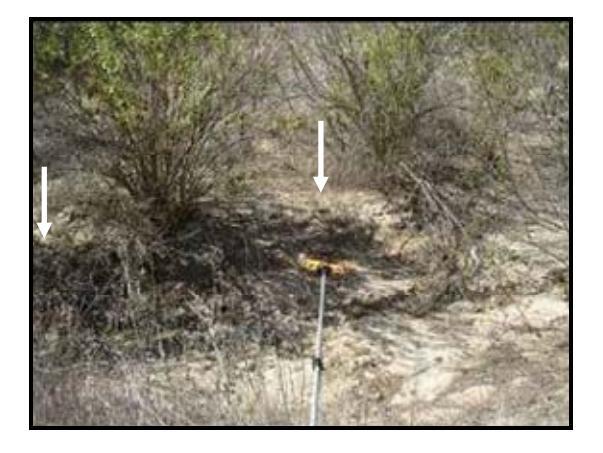
Figure A.13 (continued) – Hicks_E

The scarp in the pre-fire (2007) photograph of the right bank below is consistent with the post-fire (2008) photograph on the previous page.

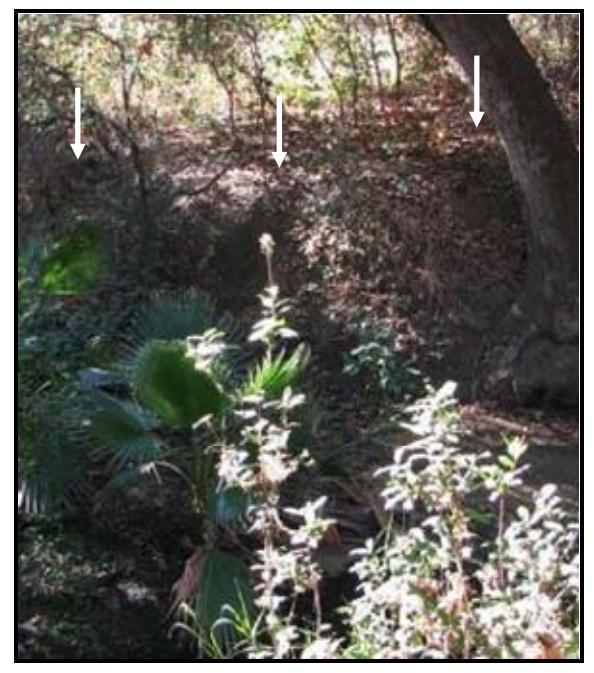
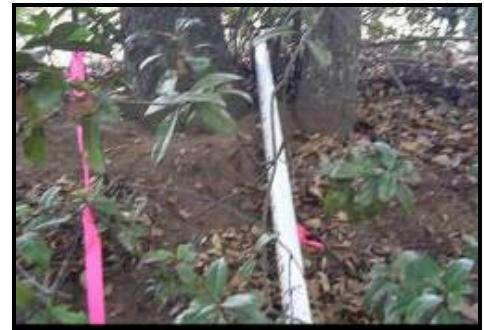
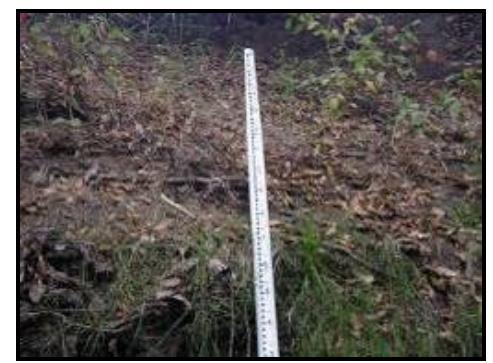
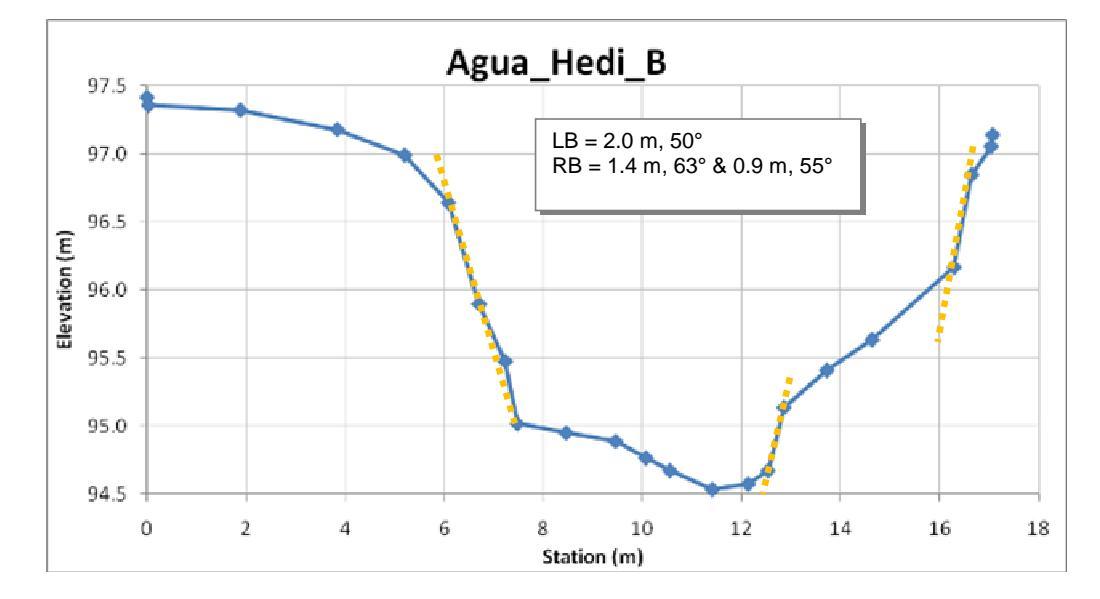
Figure A.16 – Agua_Hedi_B

LB U-MW-C

RB U-MW-C (upper) U-FLUVIAL (lower)

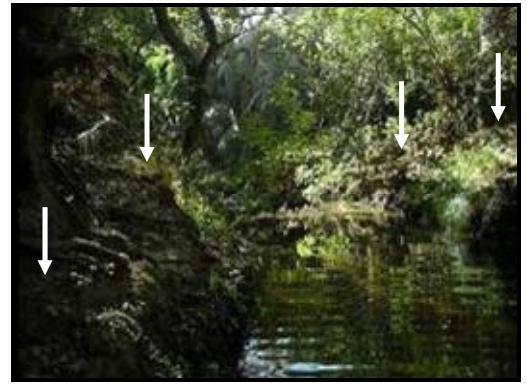
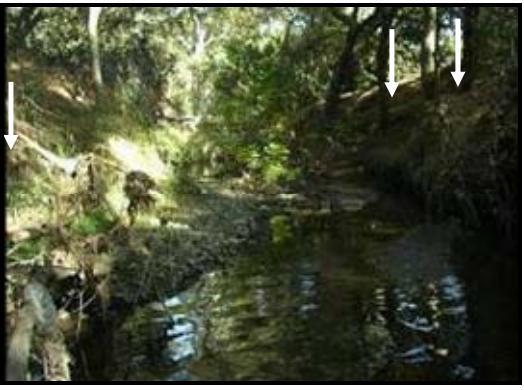
Figure A.17 – Agua_Hedi_C

LB U-MW-C

RB U-MW-C (upper) and U-MW-C (lower)

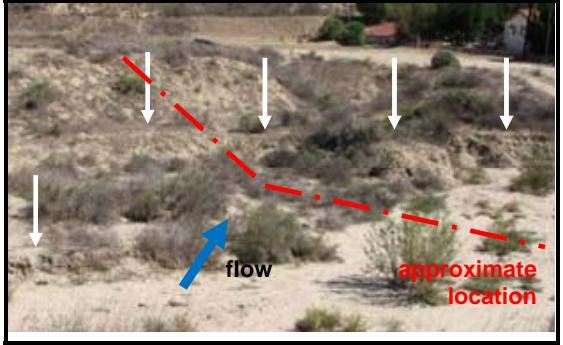
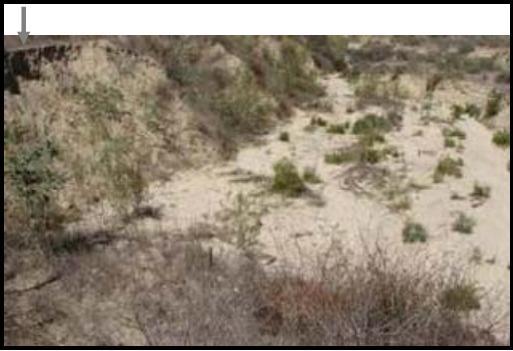
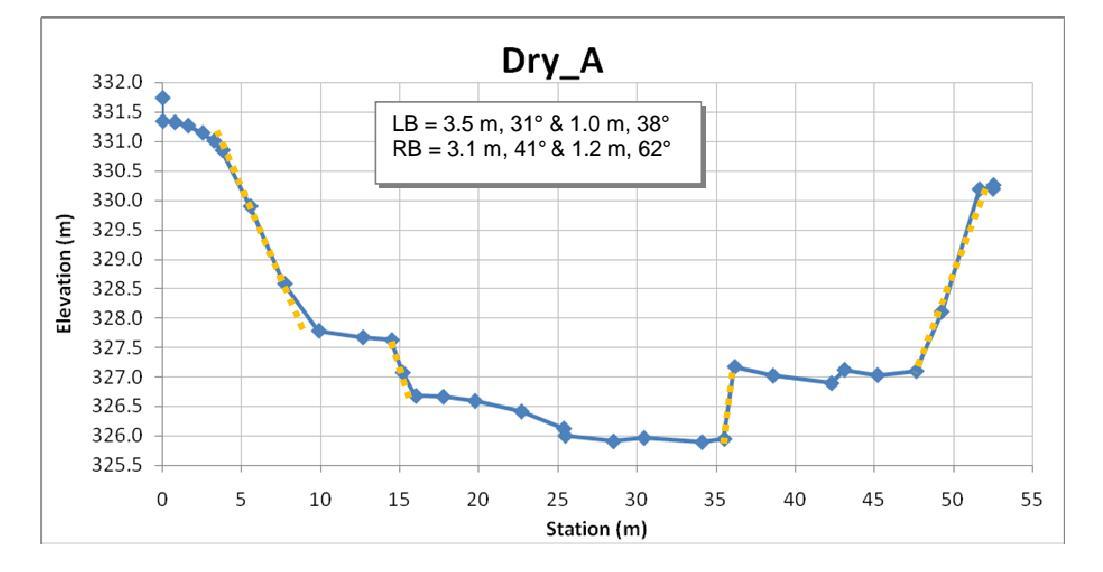
Figure A.18 – Dry_A

LB STABLE (upper) and U-FAILED (lower) RB

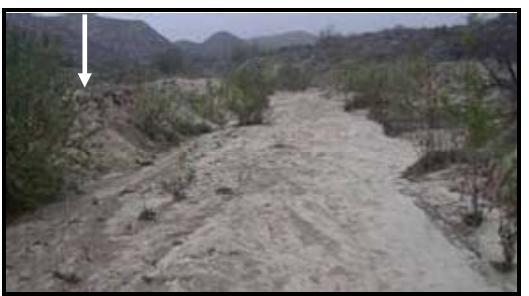
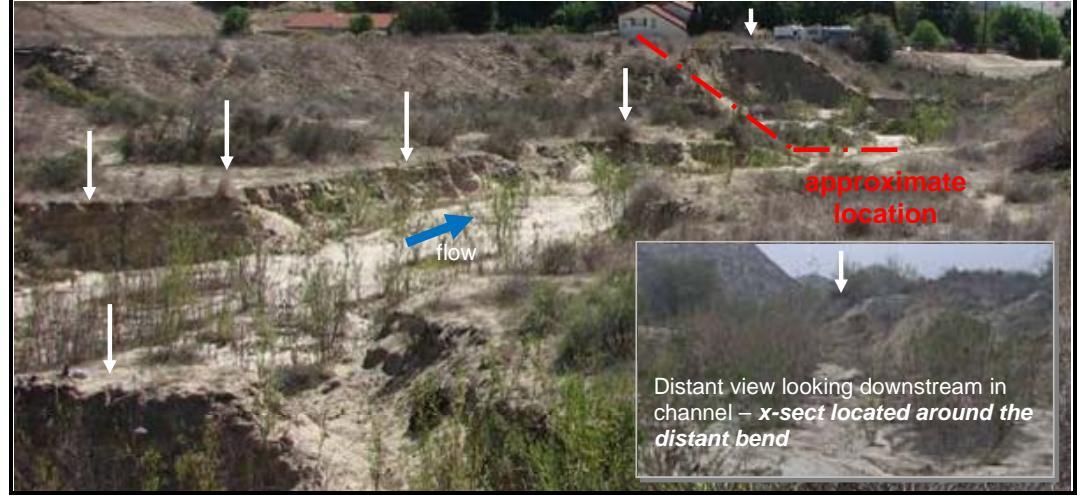
LB STABLE (upper) and U-FAILED (lower)

STABLE (upper) and U-MW-C (lower)

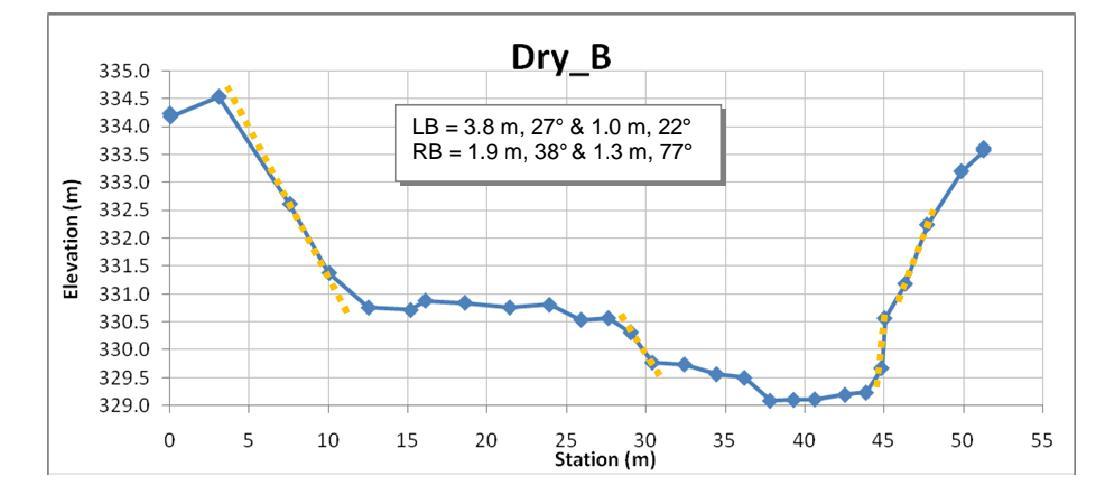
Figure A.19 – Dry_B

Distant view looking downstream

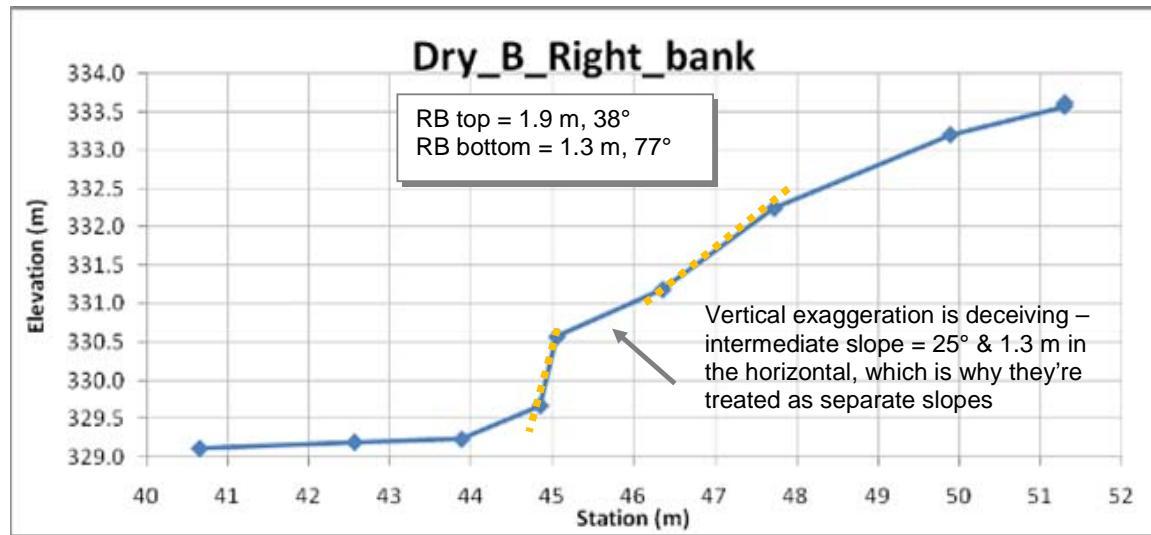
With such a wide cross-section, this view is intended to more easily delineate the various bank slopes and break points.

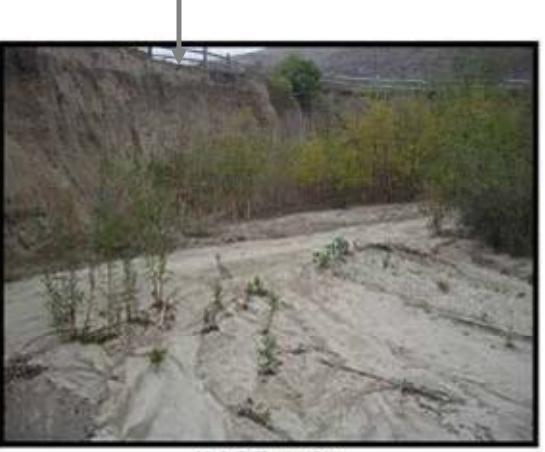
Figure A.20 – Dry_C

U-MW-C

STABLE

IMGP1122 Looking downstream

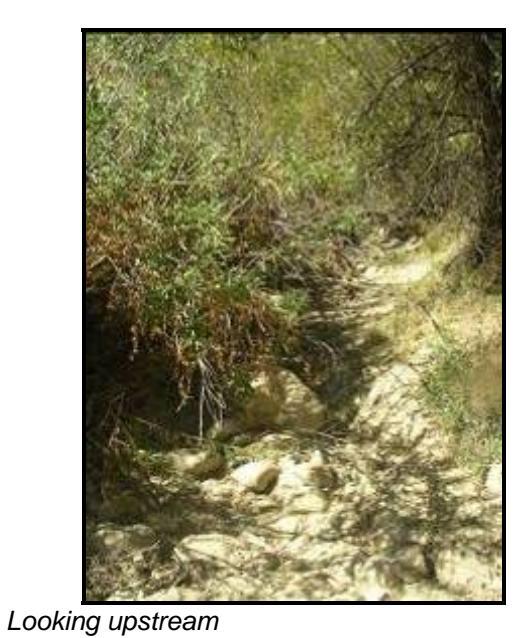
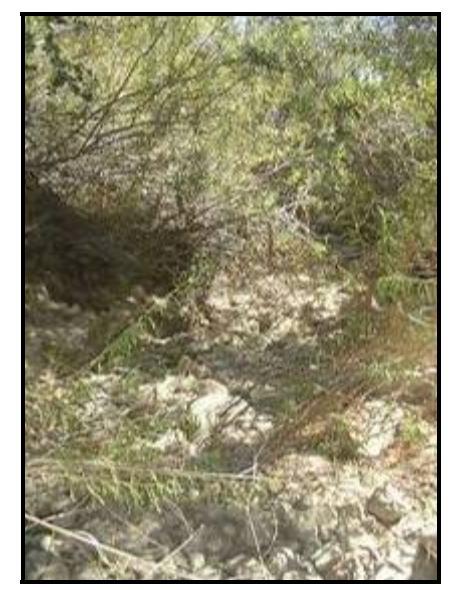
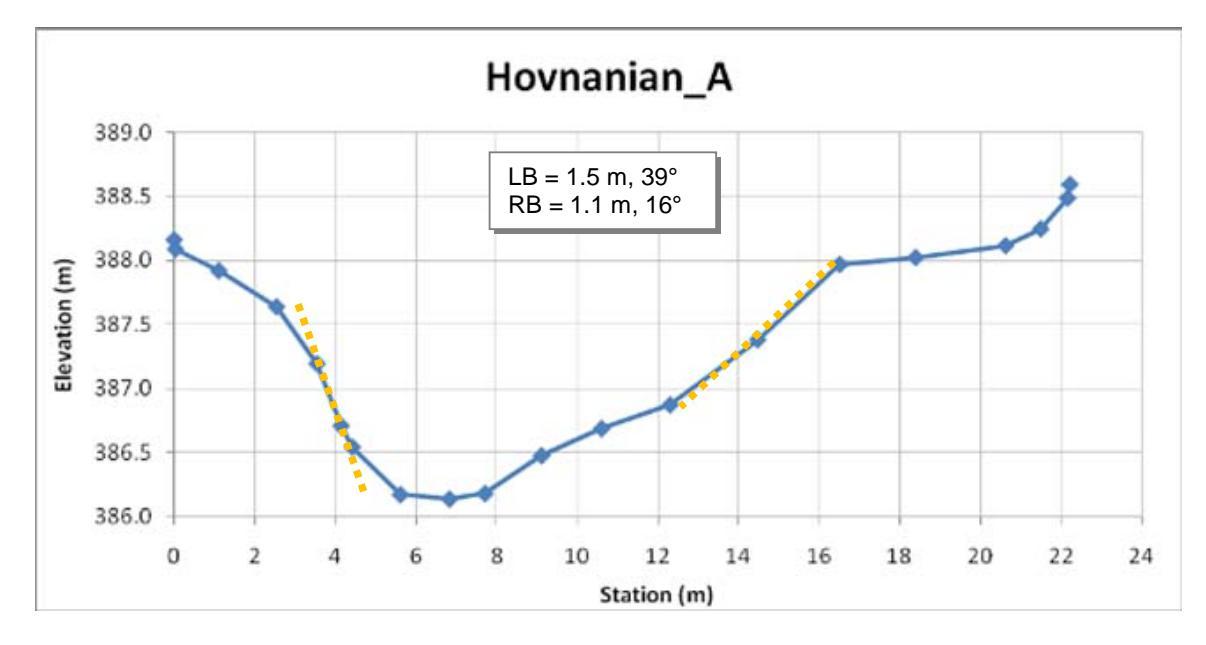
Figure A.21 – Hovnanian_A

LB STABLE

RΒ STABLE

Looking downstream

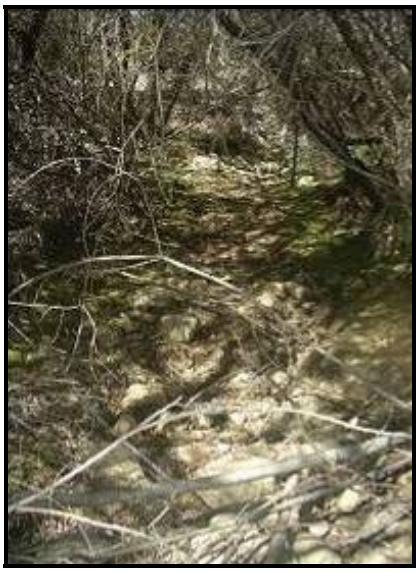
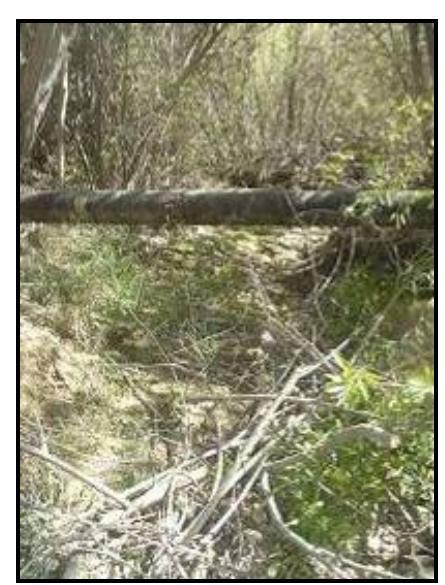
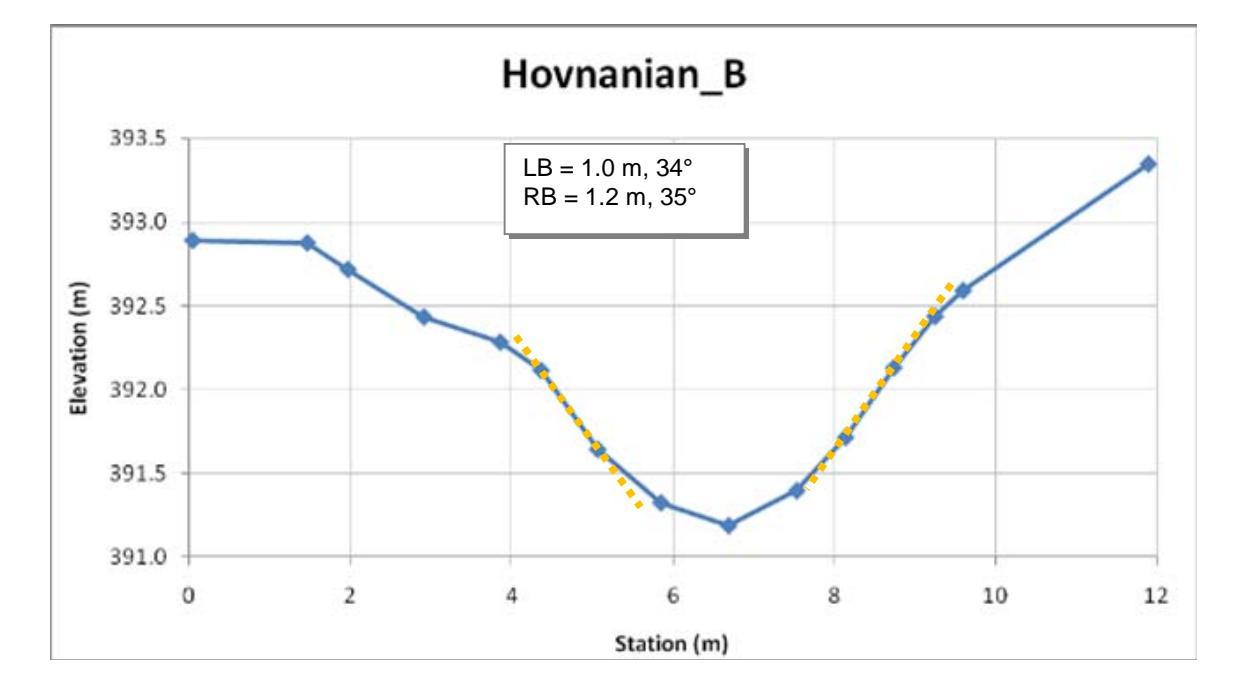
Figure A.22 – Hovnanian_B

STABLE

LB STABLE

Looking upstream

Looking downstream

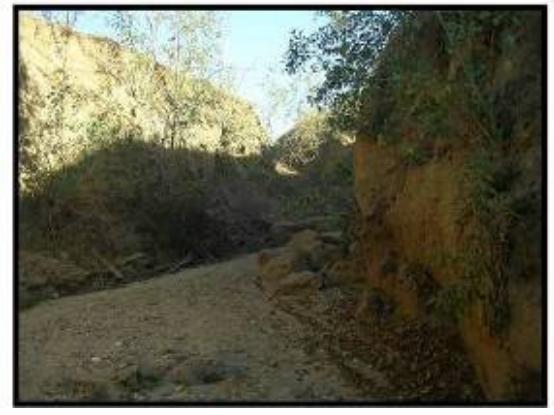
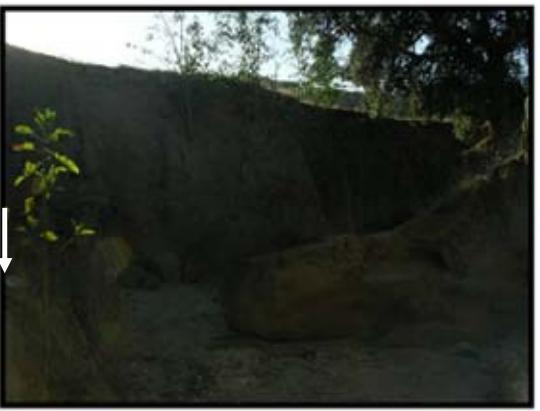
Figure A.23 – Santimeta_A (San Timetao)

LB U-MW-C

RB U-MW-C (upper) and U-MW-C (lower)

Looking upstream

Looking downstream

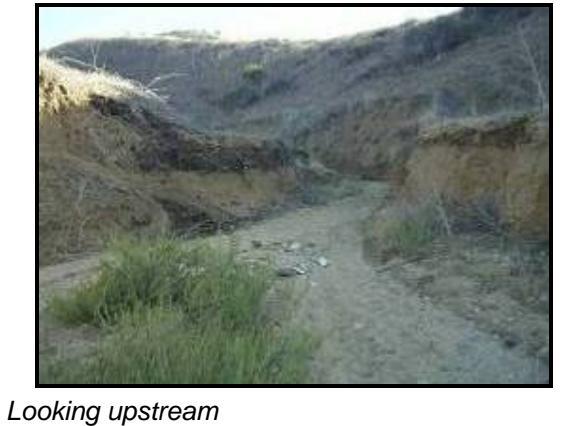
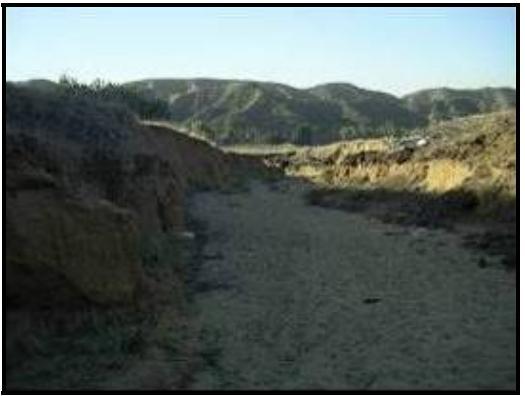
Figure A.24 – Santimeta_B (San Timetao)

U-MW-C

LB U-MW-C

Looking downstream

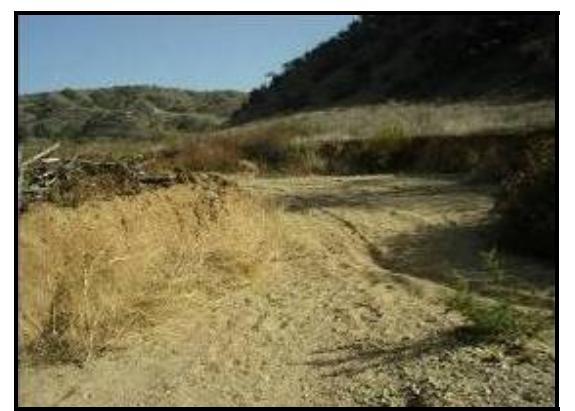
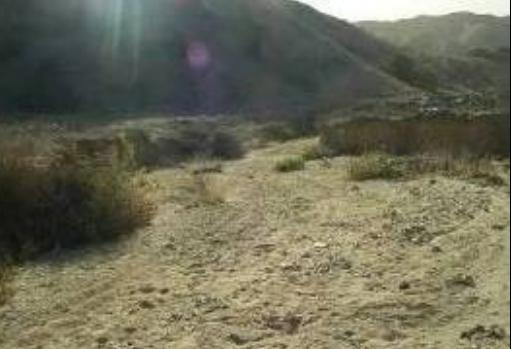
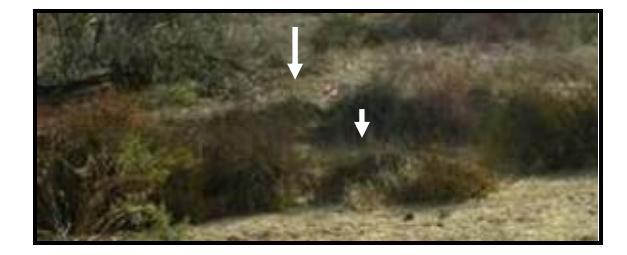
Figure A.25 – Santimeta_C (San Timetao)

U-MW-C

LB U-MW-C

Looking upstream

Looking downstream

View of left bank

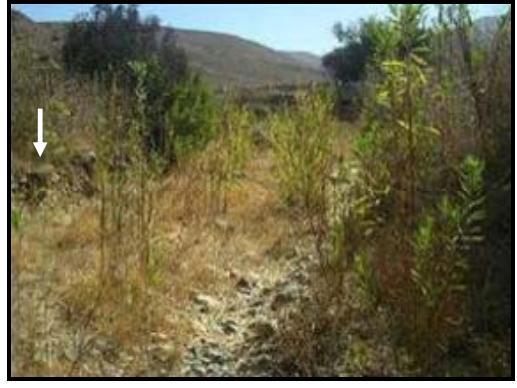
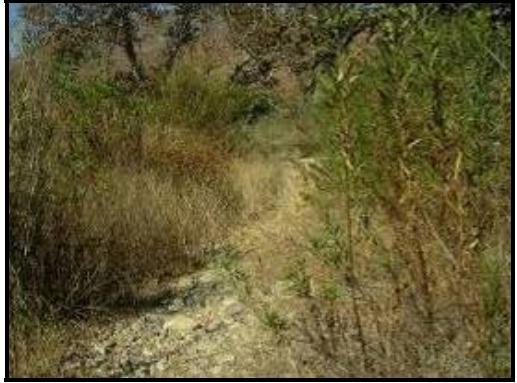
Figure A.26 – Ltl_Cedar_A (Little Cedar)

LB U-MW-PC

Incising through poorly consolidated alluvia downstream of bridge (forced confinement)

RB U-MW-PC

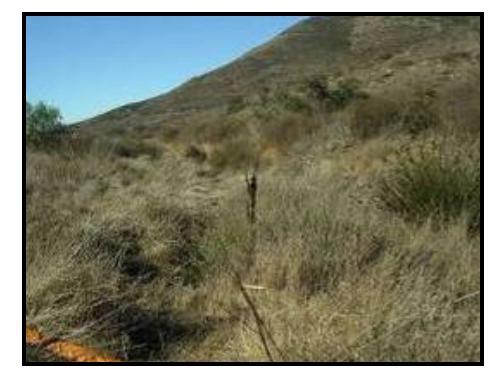
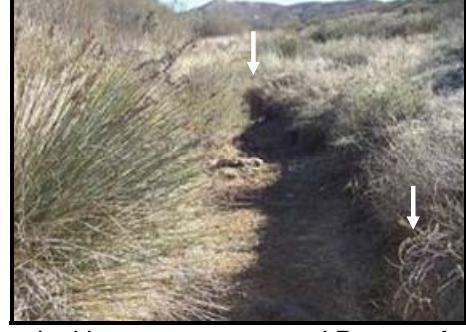
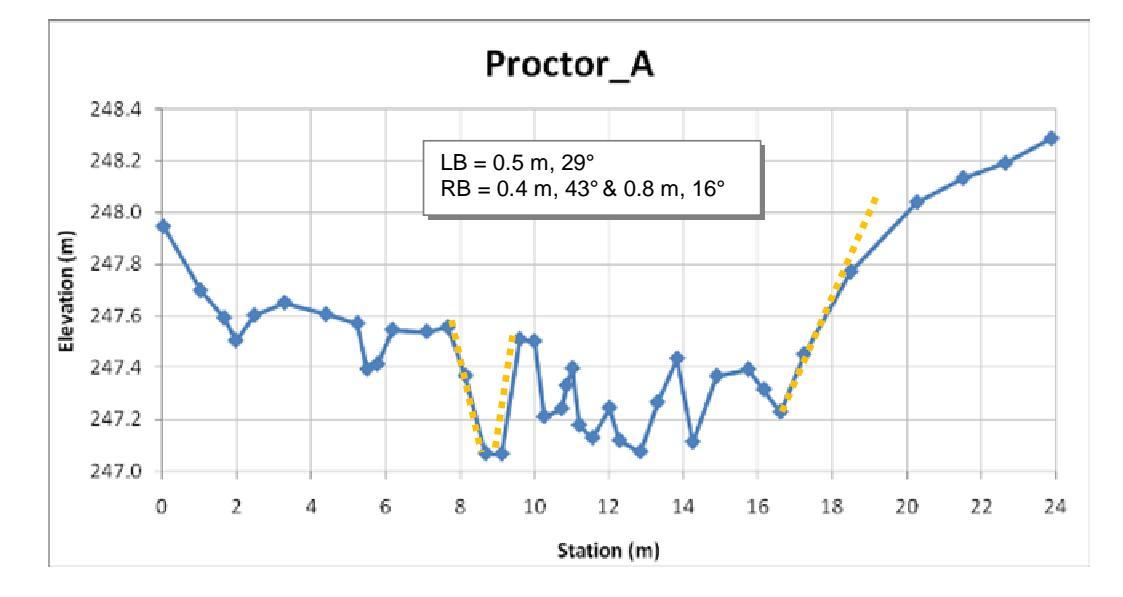
Figure A.28 – Proctor_A

LB U-FAILED

RB U-MW-UC (lower) and STABLE (upper)

View from downstream section looking upstream toward Proctor_A

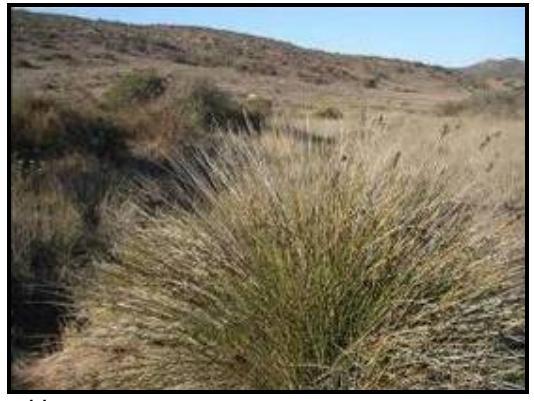
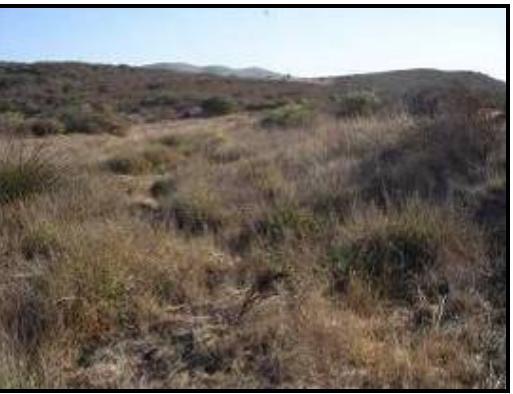
Figure A.29 – Proctor_B

LB STABLE (upper) and U-MW-UC (lower) RB

STABLE (upper) and U-MW-UC (lower)

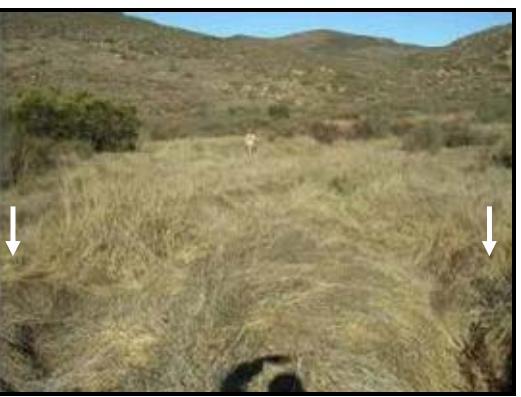
Figure A.30 – Proctor_TRIB

LB STABLE (upper) and U-FAILED (lower) RB

Looking downstream

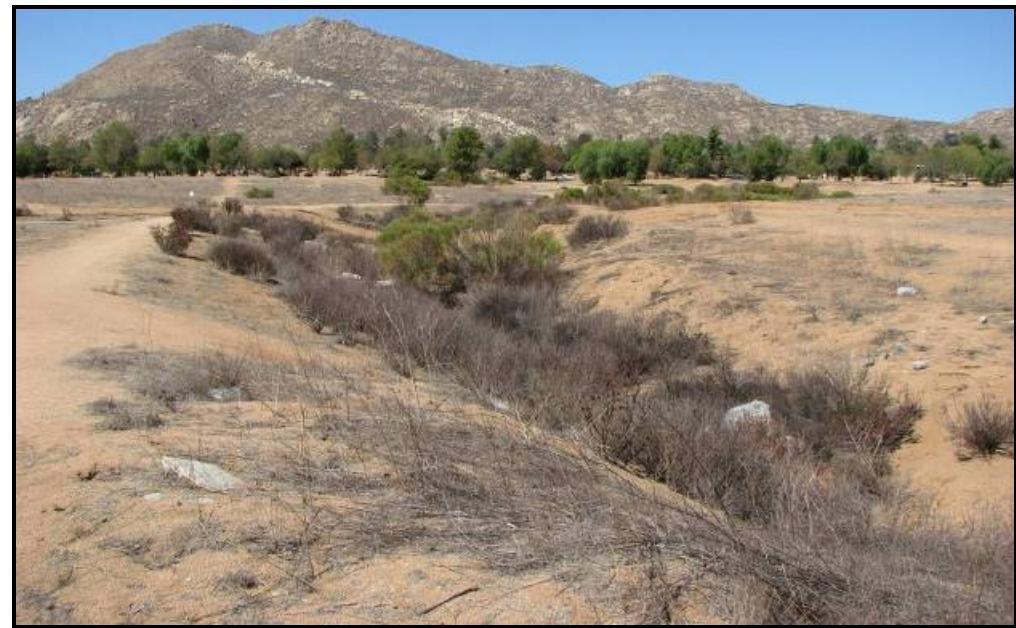
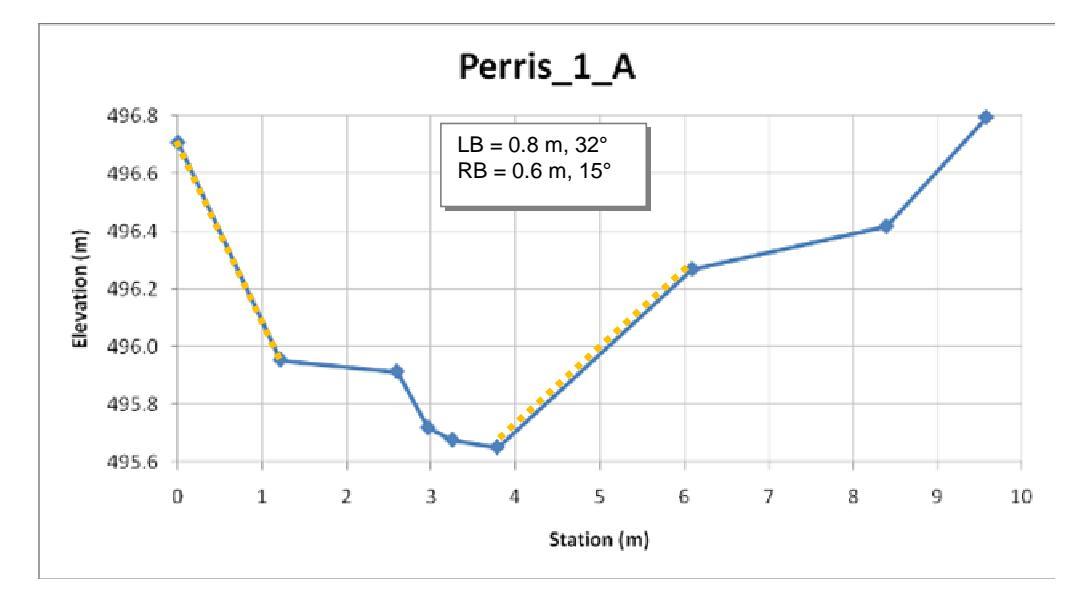
Figure A.31 – Perris_1_A

LB STABLE-PC RB STABLE-PC

Looking upstream near location of Perris_1_A

This portion of Perris_1 was graded (date unknown) to redirect flow to a single culvert at the bottom of the reach
