APPENDIX A – HYDROMODIFICATION SITE CROSS-SECTIONS, BANKS, AND PHOTOGRAPHS

PURPOSE AND MEASUREMENT PROTOCOL

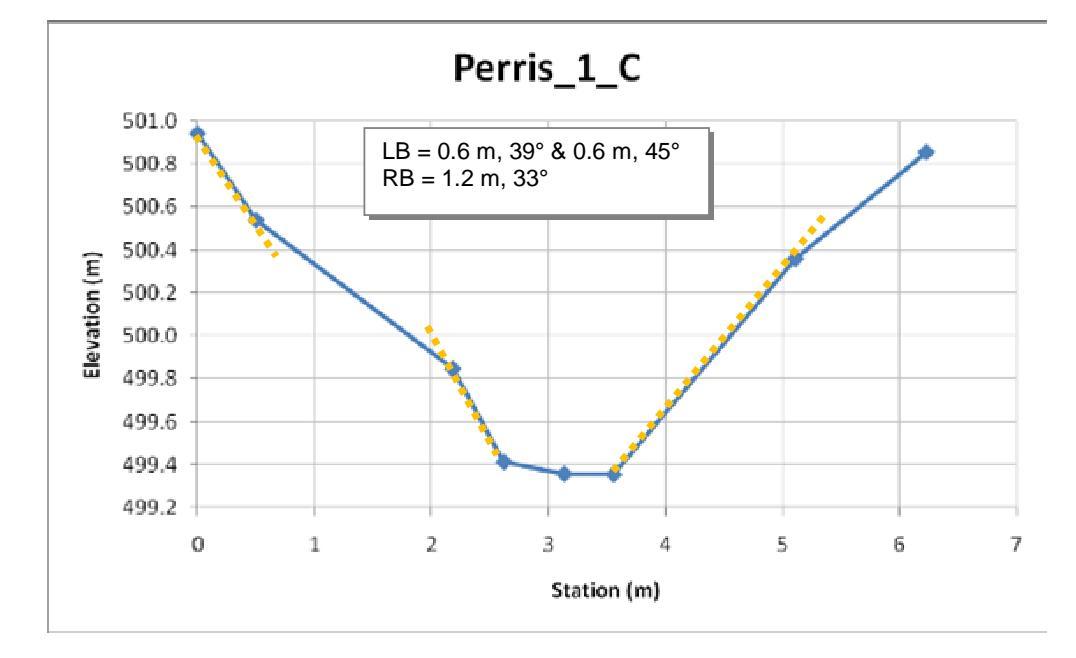
Figure A.33 – Perris_1_C

LB U-MW-PC (upper) and U-MW-PC RB U-MW-PC (lower)

Looking upstream near location of Perris_1_C

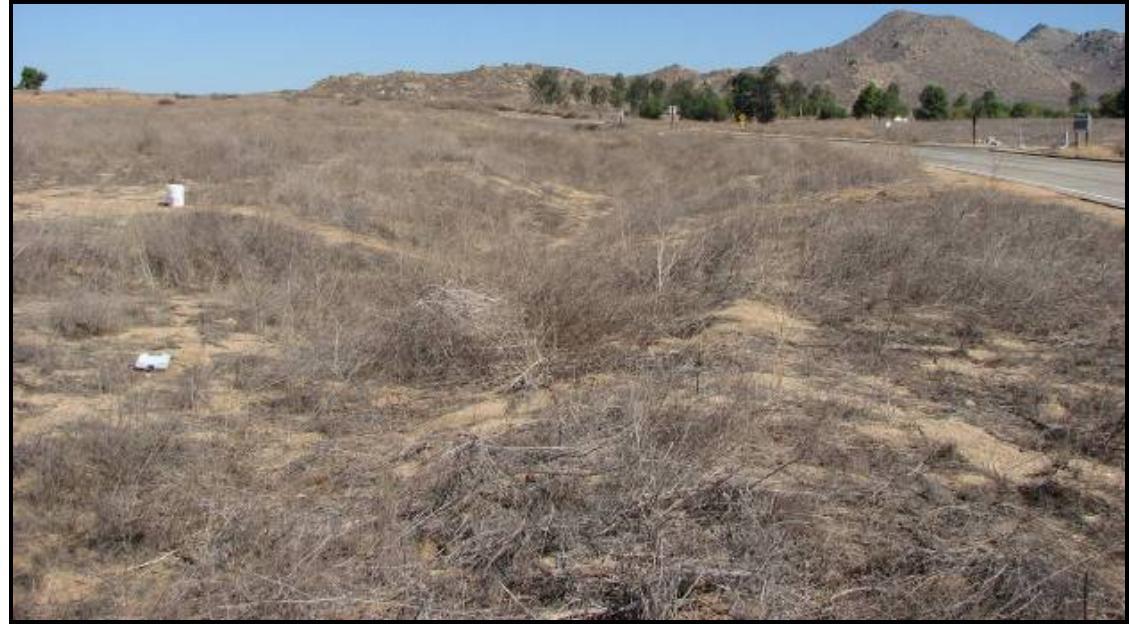
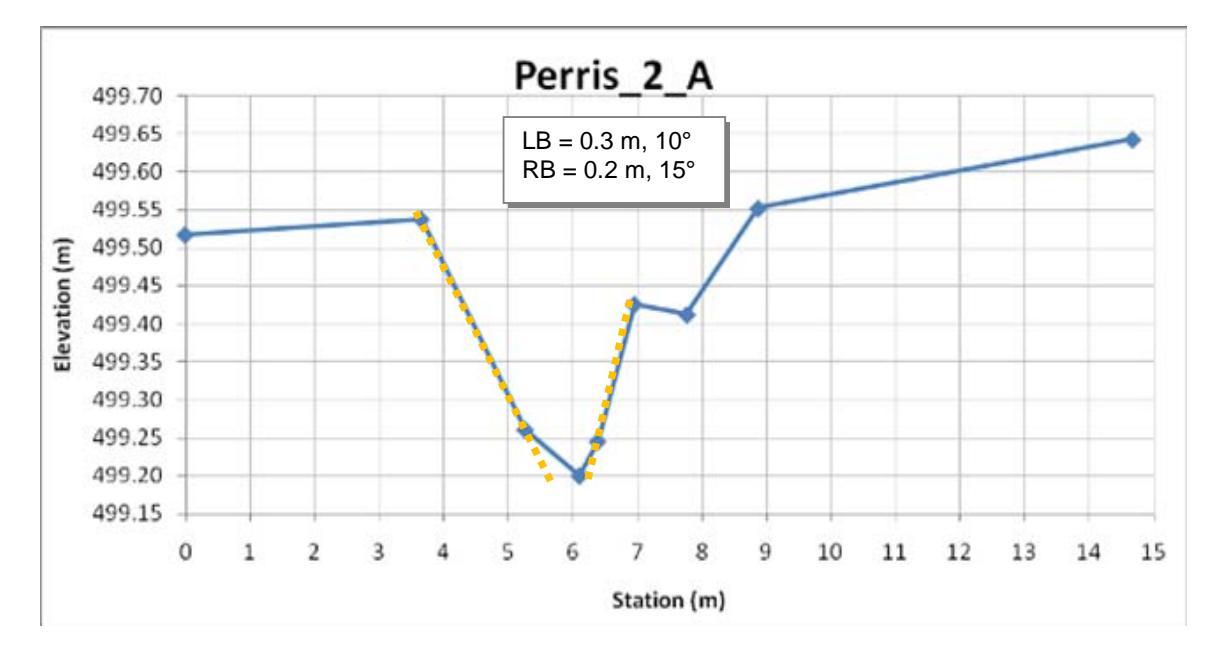
Figure A.34 – Perris_2_A

LB STABLE-PC RB STABLE-PC

Looking upstream near location of Perris_2_A

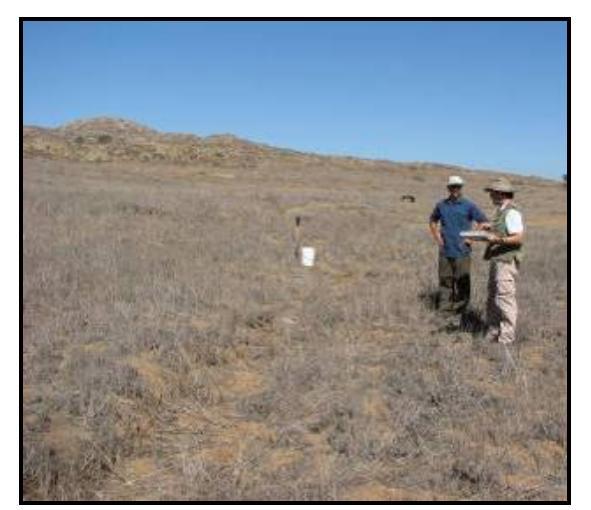
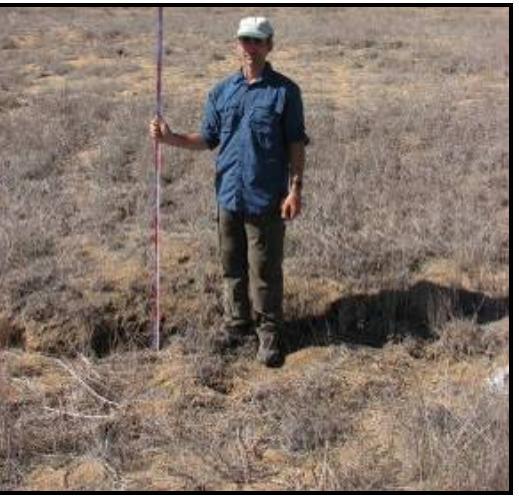
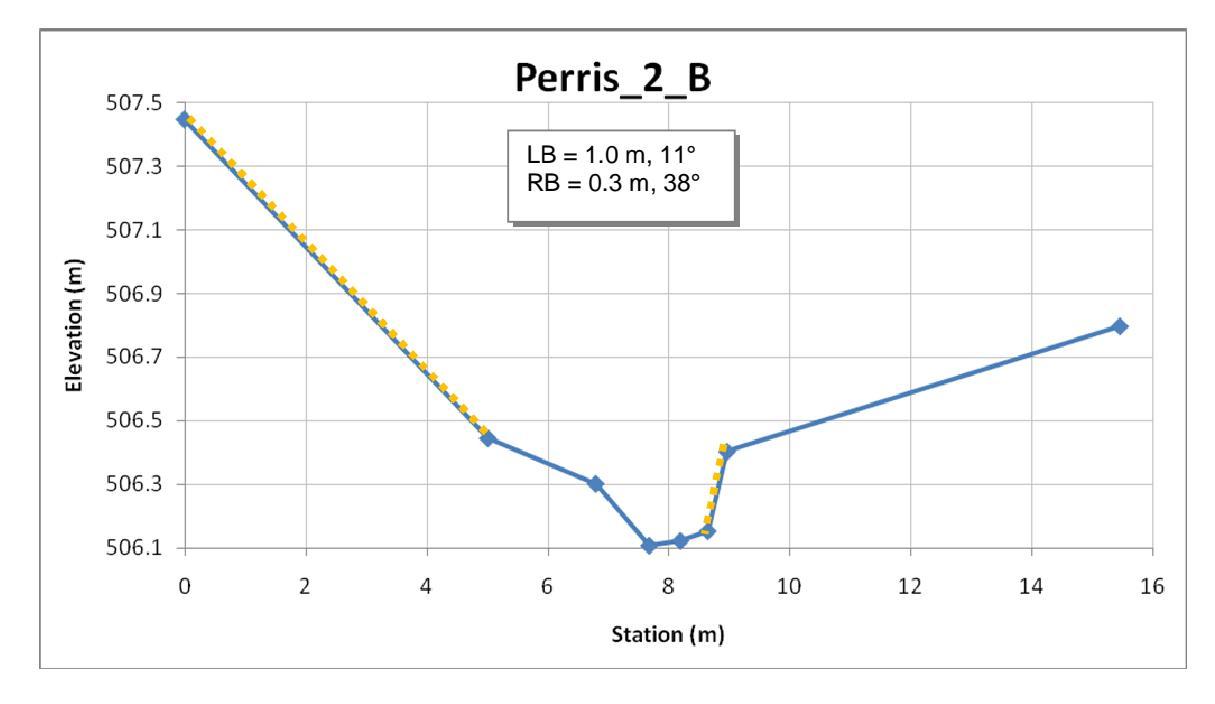
Figure A.35 – Perris_2_B

LB STABLE-PC

Looking upstream near location of Perris_2_B

View of right bank near location of Perris_1_C

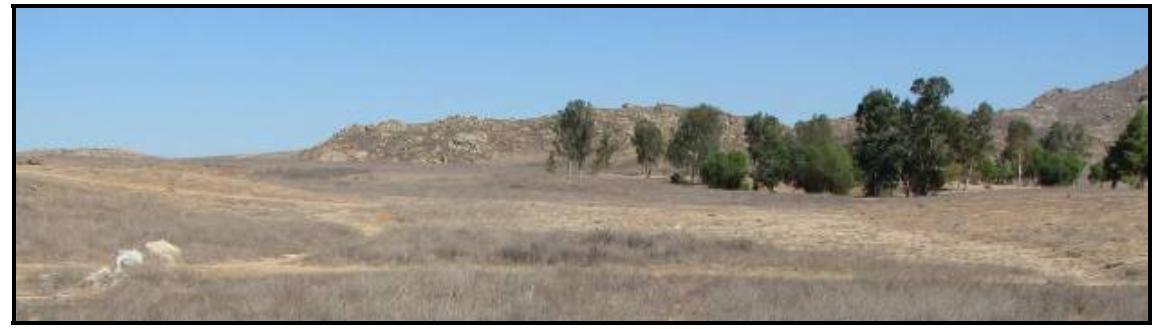
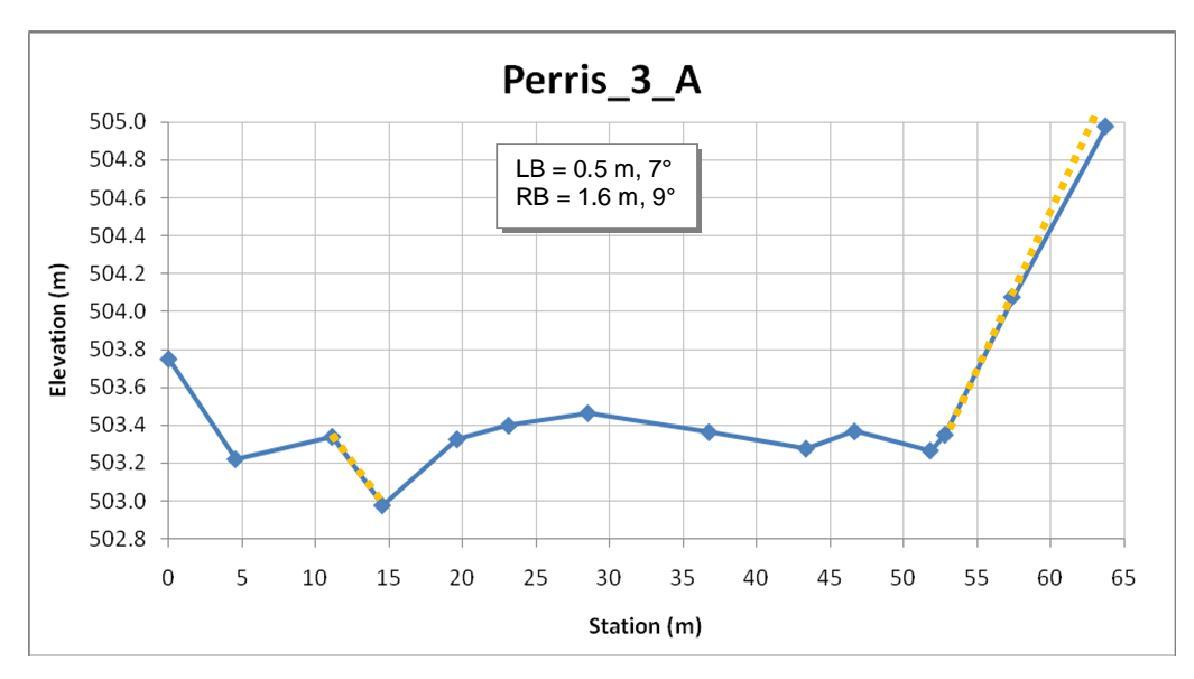
Figure A.36 – Perris_3_A

- LB STABLE-UC
- RB STABLE-PC

Looking upstream near location of Perris_3_A

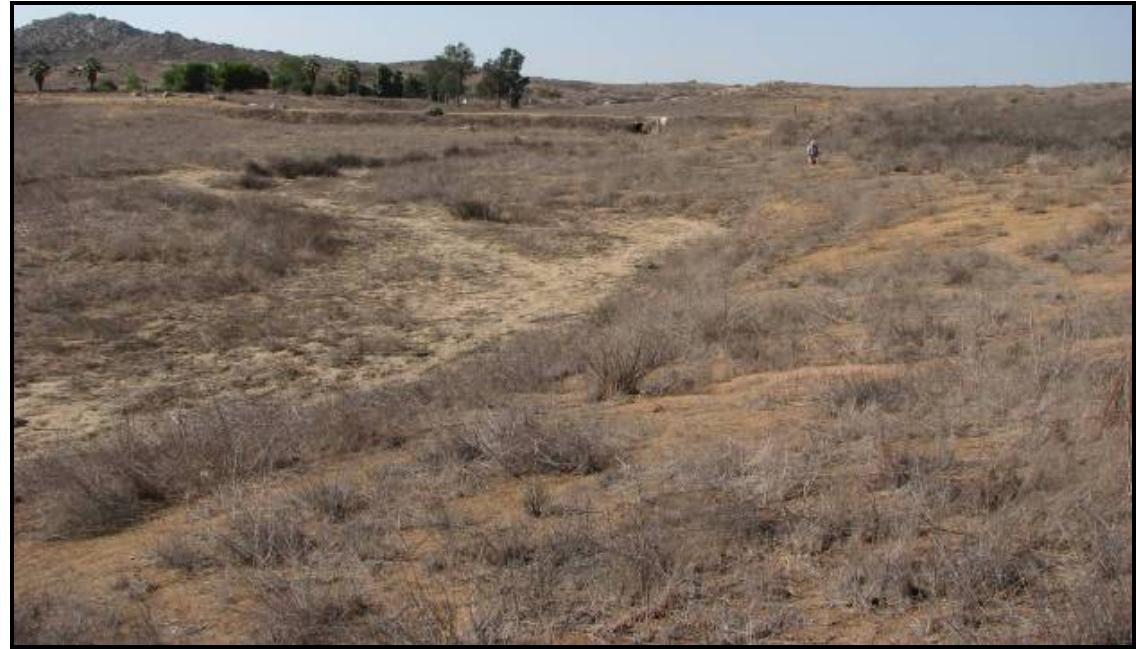
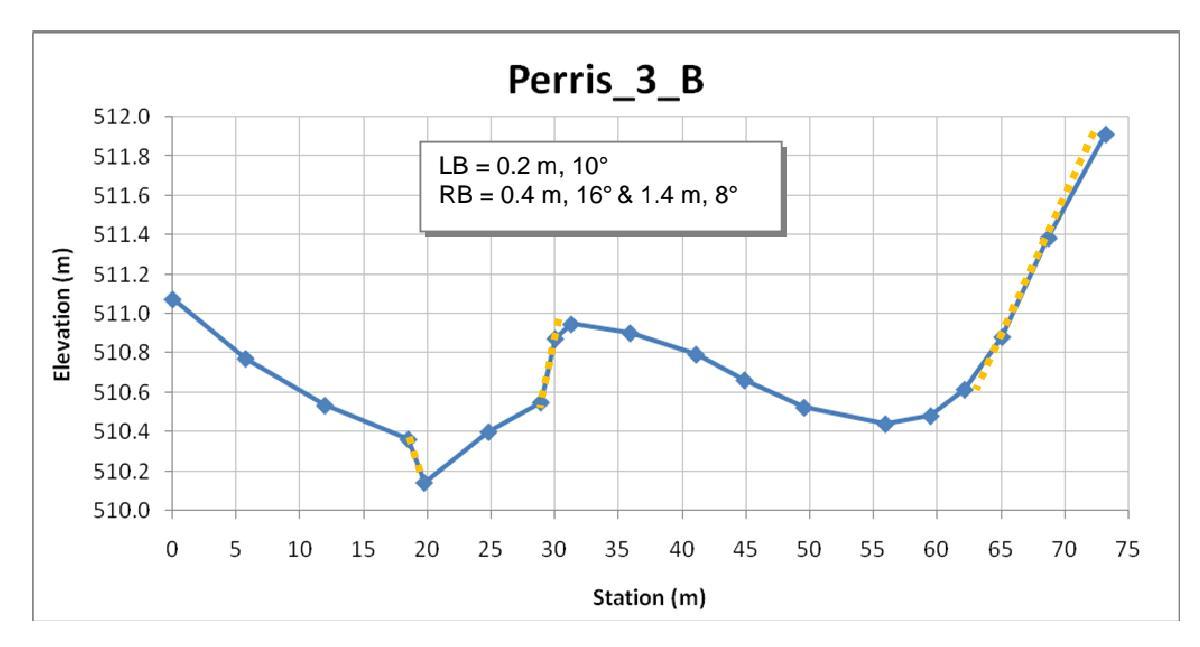
Figure A.37 – Perris_3_B

STABLE-UC (lower) and STABLE-PC

LB STABLE-UC

Looking upstream near location of Perris_3_B

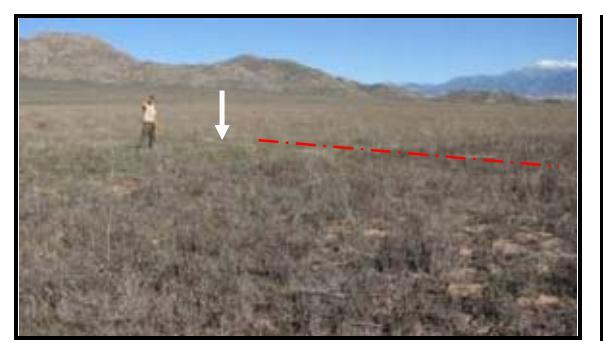
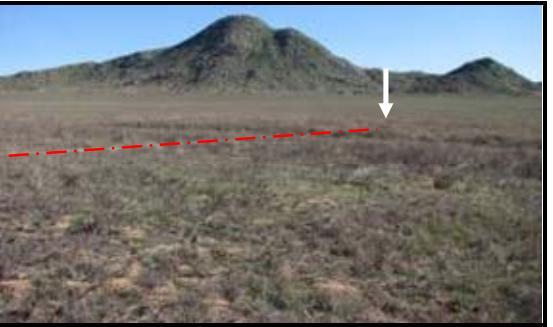
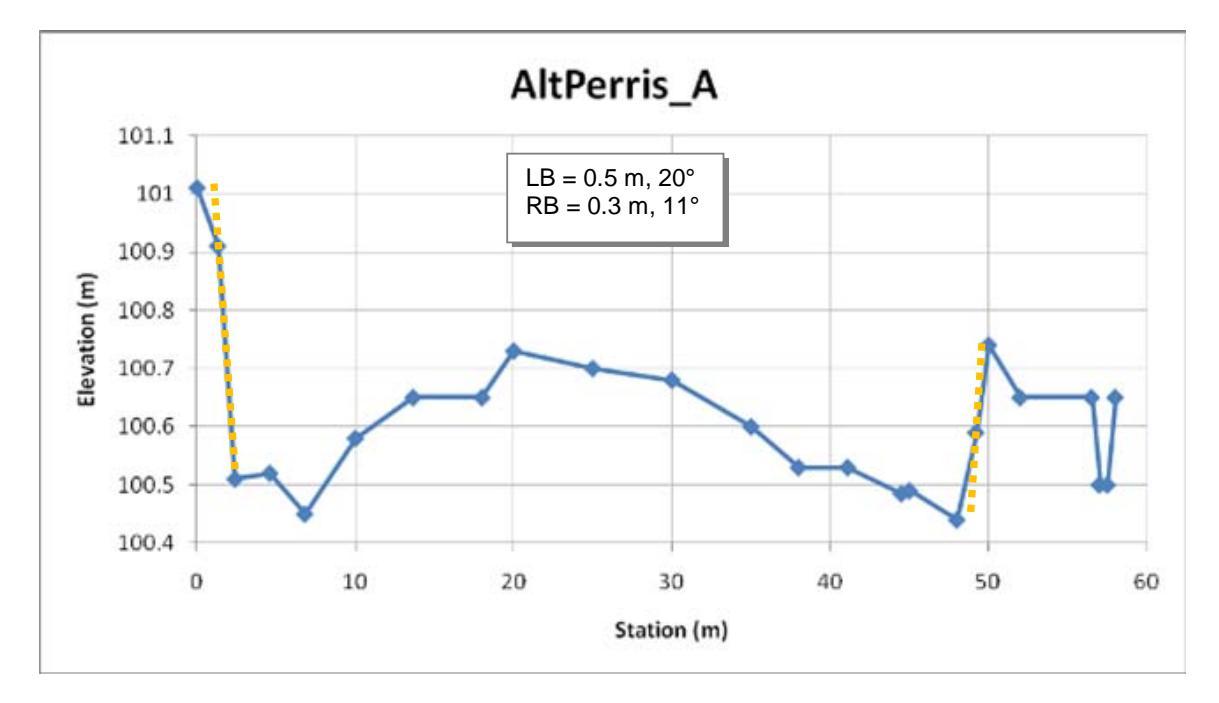
Figure A.38 – AltPerris_A

STABLE-PC

LB STABLE-PC

Looking upstream (including right bank) of AltPerris_A

Looking upstream (including left bank) of AltPerris_A

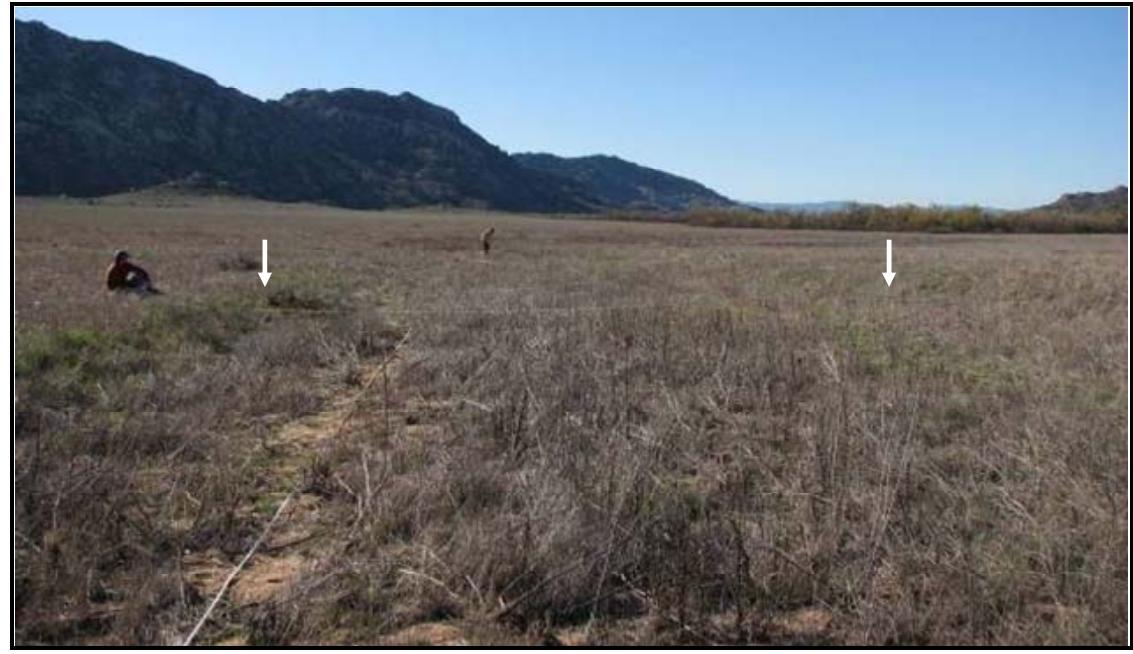
LB STABLE-PC RB STABLE-PC

Looking downstream at AltPerris_B

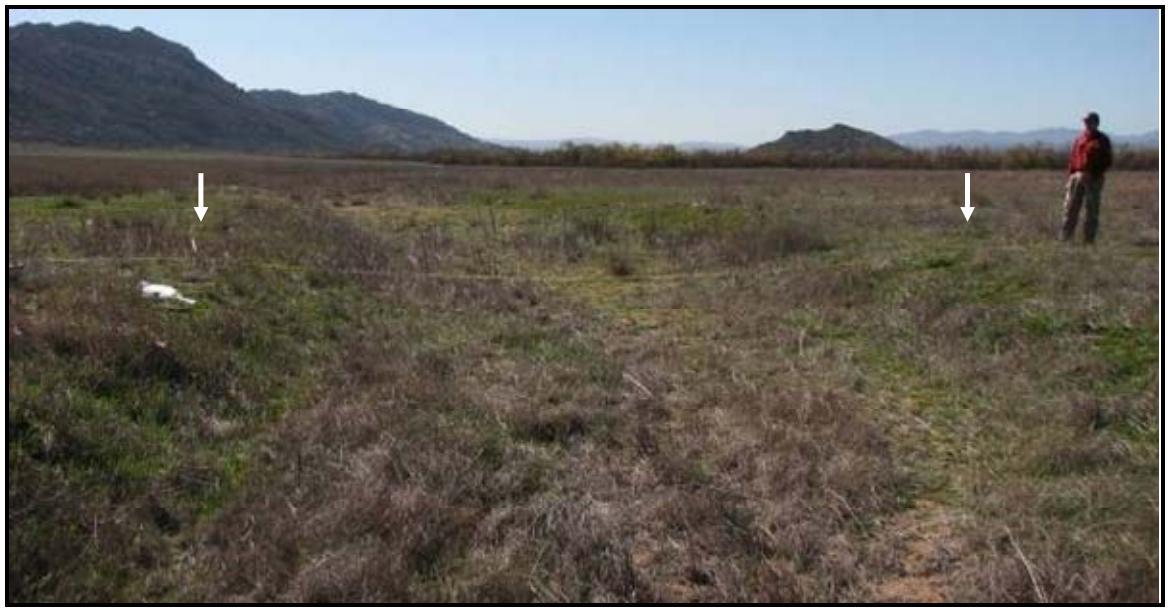
Looking upstream at AltPerris_C

LB STABLE-PC RB STABLE-PC

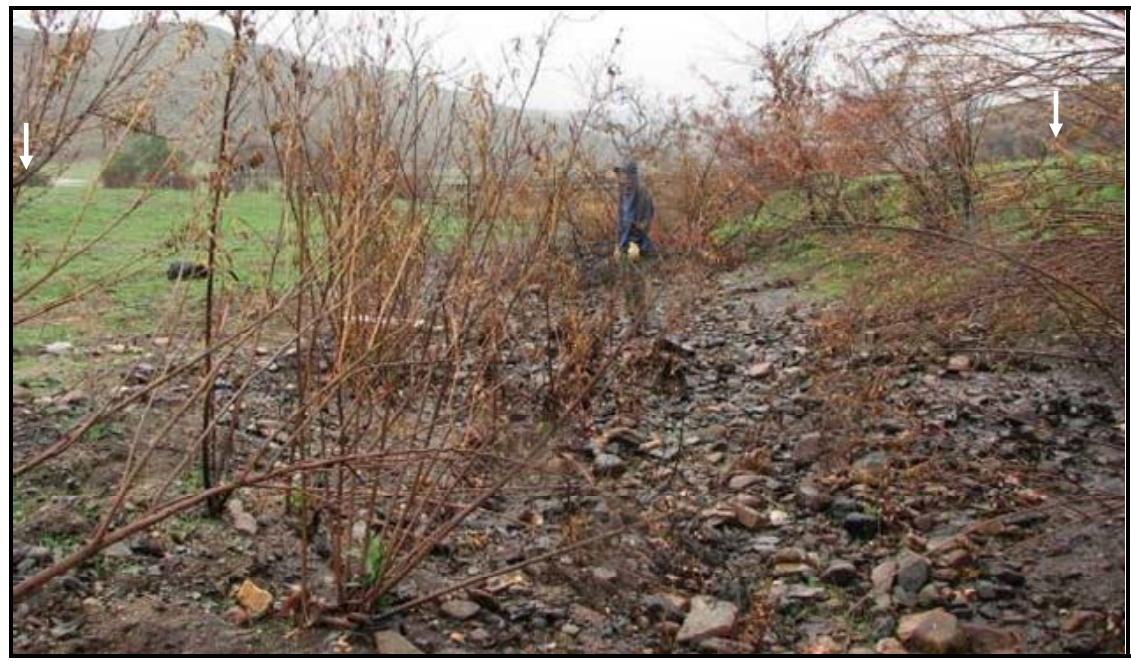
Looking upstream at Dulzura_A

LB STABLE-PC

RB STABLE-UC (lower) and STABLE-PC (upper)

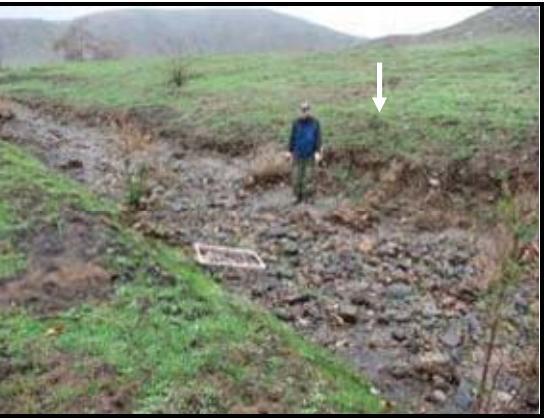
Looking downstream at right bank of Dulzura_B

LB U-FAILED

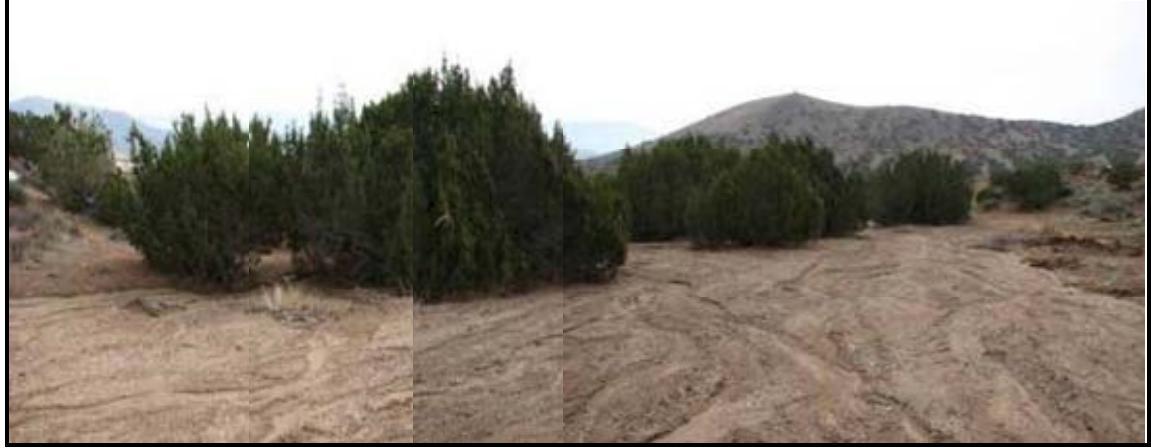
Looking downstream at Acton_A

LB STABLE-PC RB STABLE-PC

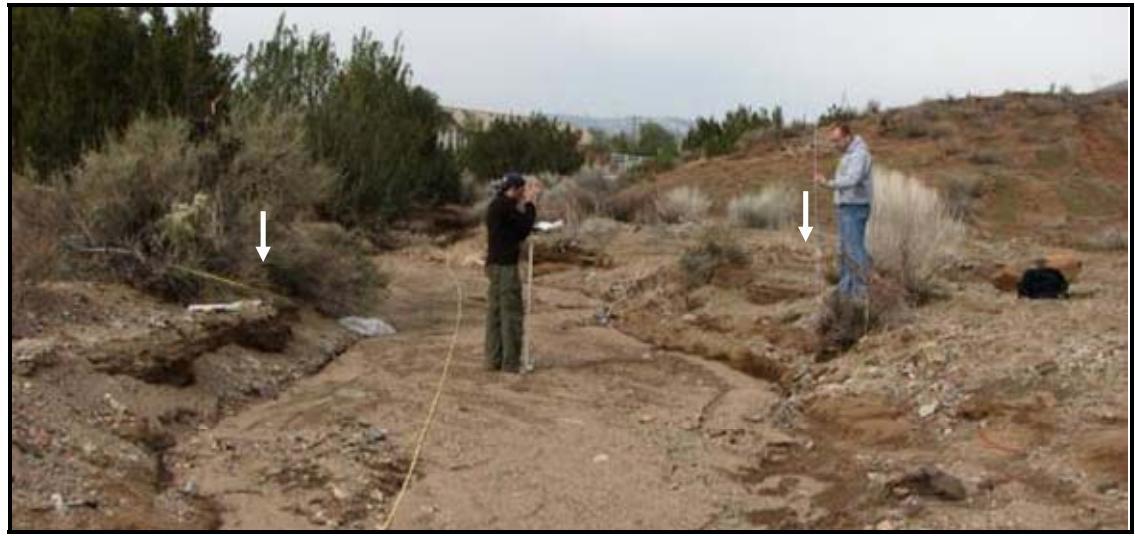
Looking upstream at Acton_B

LB U-MW-PC RB U-MW-PC

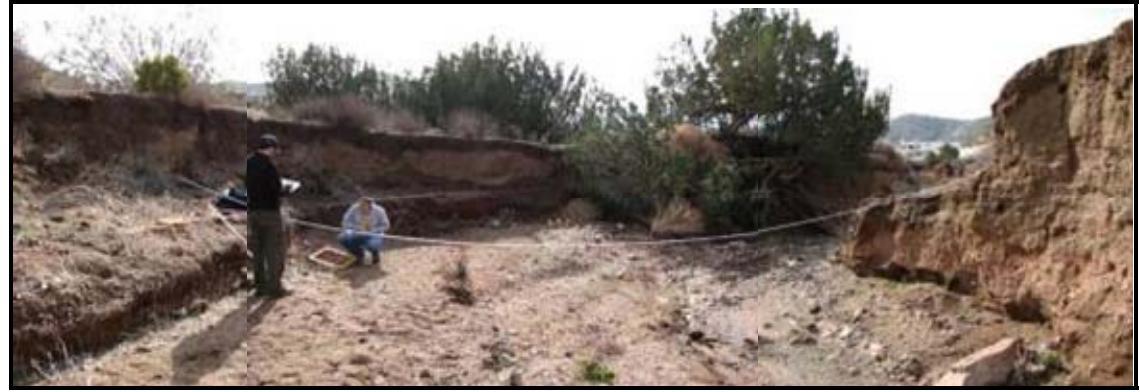
Looking downstream at Acton_C

LB U-MW-C (upper) and U-MW-PC (lower) RB U-MW-C

Lower left bank appears to be at edge of old channel bank and bed. It's not fully unconsolidated, but not nearly as consolidated as the outer banks.

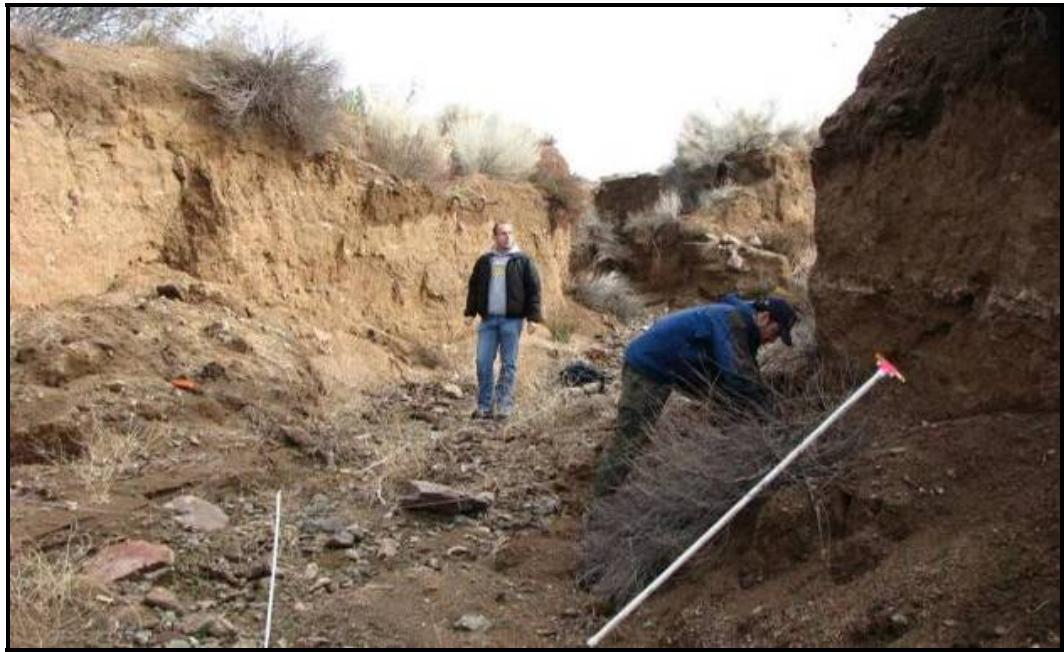
Looking upstream at Acton_D

LB U-MW-C RB U-MW-C

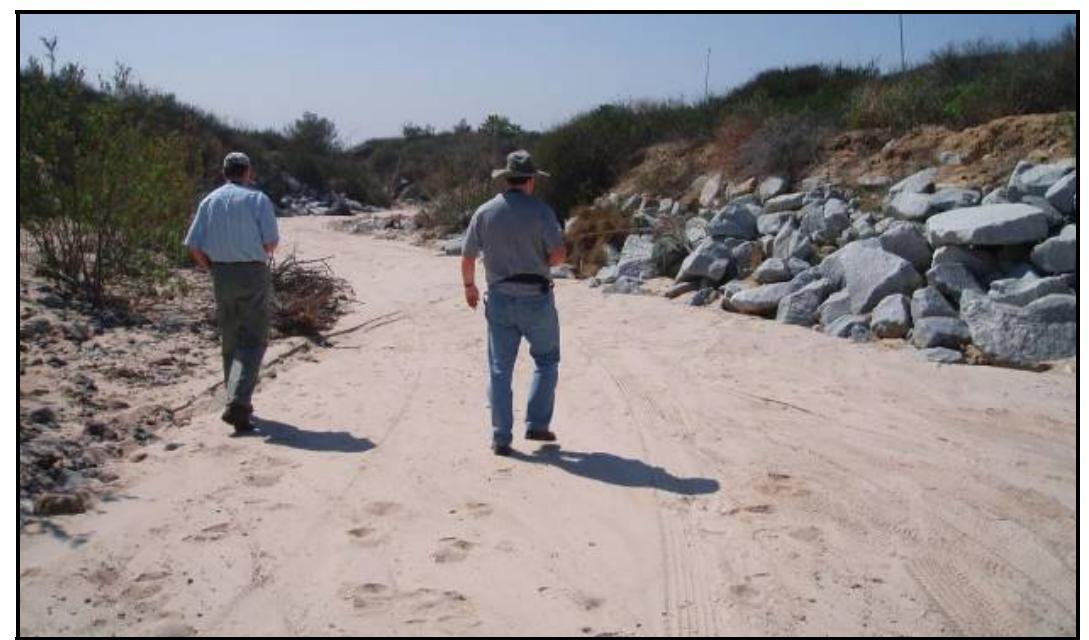
Looking downstream near Borrego_A

LB S-CONSTR RB S-CONSTR

Cross section was drawn from aerials and photographs - not surveyed

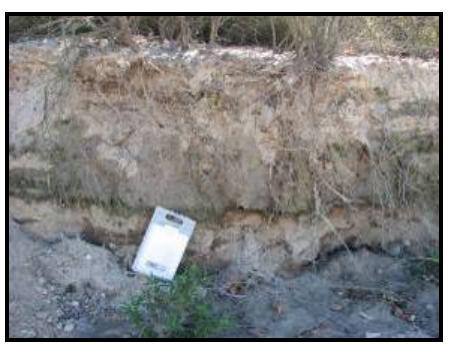
Lleft bank of Borrego_B

LB U-MW-C

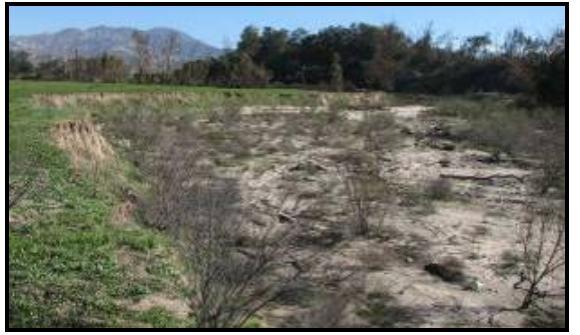
Looking upstream at right bank of Borrego_B

RB U-MW-C

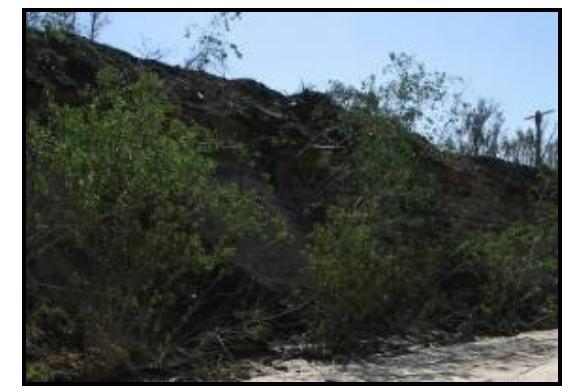
Looking downstream at left bank of Borrego_C

LB U-MW-C

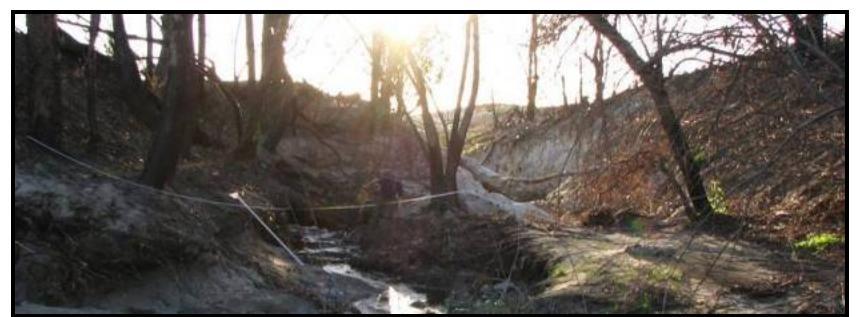
Looking downstream at Borrego_E

LB U-MW-C (upper) and U-MW-PC (lower) RB

U-FAILED (upper) and U-MW-PC (lower)

Incised section is classified as PC (poorly consolidated) instead of UC (unconsolidated) because, although they are a part of a historic bed, tree locations indicate that the tops of these banks have been at that elevation for 20+ yrs, which is considerably different from the way we've been applying the UC rating.

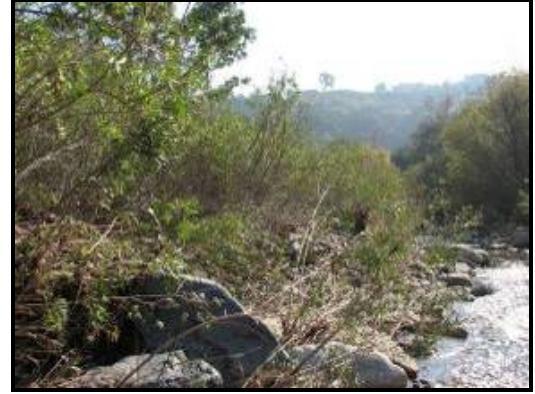
Looking downstream at left bank of right main channel of Topanga_A

LB U-MW-UC (left) and STABLE-UC (right)

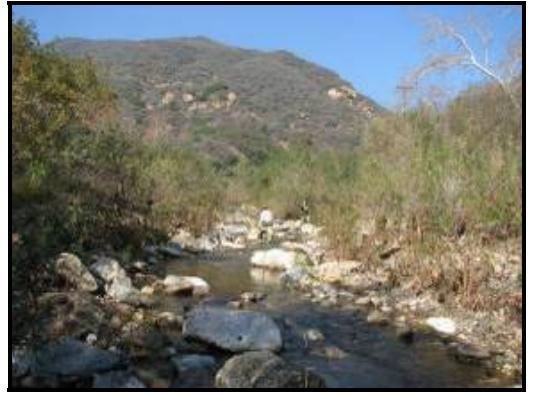
Looking upstream the right main channel toward Topanga_A (left main channel hidden by vegetated island)

RB U-MW-UC (left) and STABLE-UC (right)

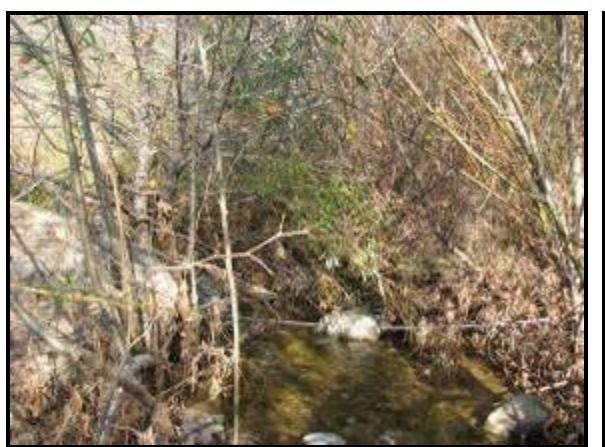
Looking upstream at base of left bank of Topanga_B

LB U-CONFND

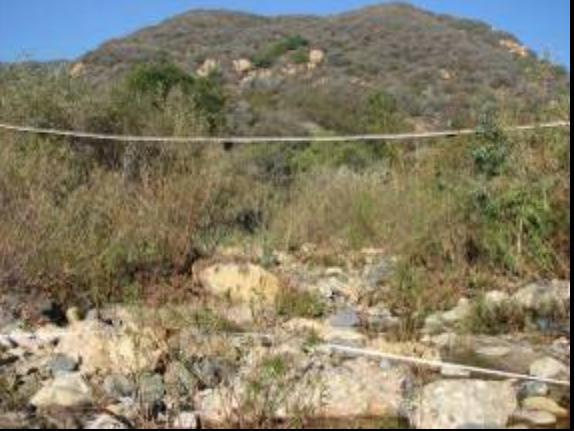
Looking upstream toward Topanga_B with view of right bank

RB STABLE-UC

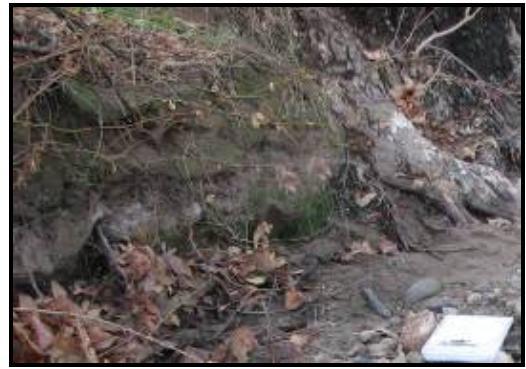
Close up of left bank

LB U-MW-C

Although fluvial is a factor (downstream of a bend, along with scouring at tree), MW is extensive upstream and to a small extent downstream

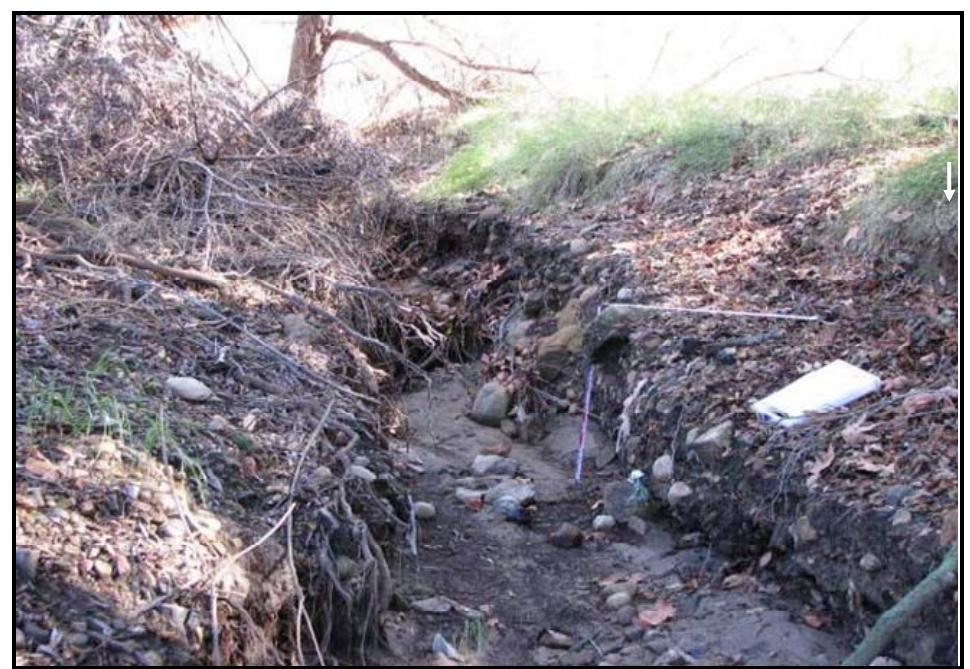
LB U-MW-UC RB U-MW-UC

Looking upstream at Challengr_B – incision w/ MW through poorly consolidated alluvia (old bed), with beginnings of MW of original left bank (white arrows)

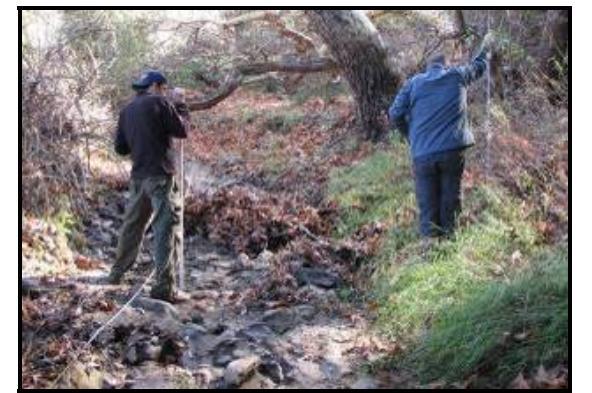
Looking upstream at Challengr_C with view of left bank

LB STABLE

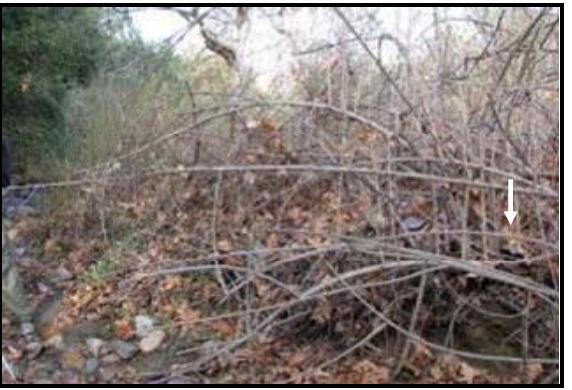
RB STABLE

Looking downstream at Challengr_C with view of right bank – MW evident just upstream

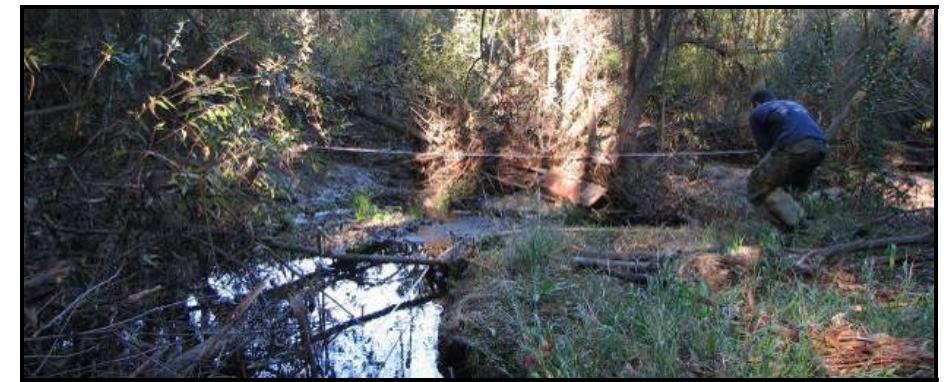
LB STABLE-UC RB STABLE-UC

Looking downstream at McGonigle_A (main channel) MW through unconsolidated alluvia

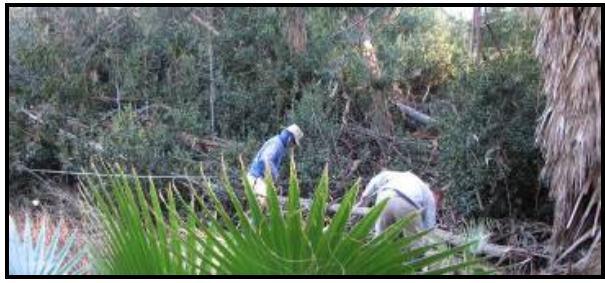
Looking toward far right bank of McGonigle_A

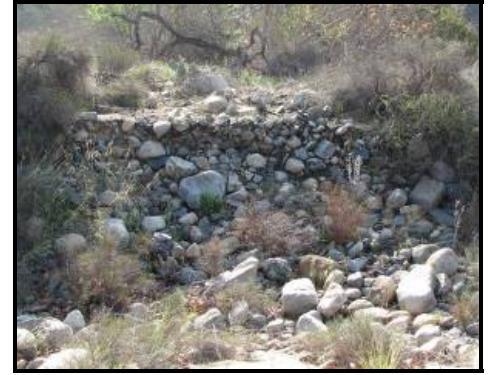
LB U-MW-UC

Representative of left bank of main channel of SanJuan_A – MW of unconsolidated alluvia

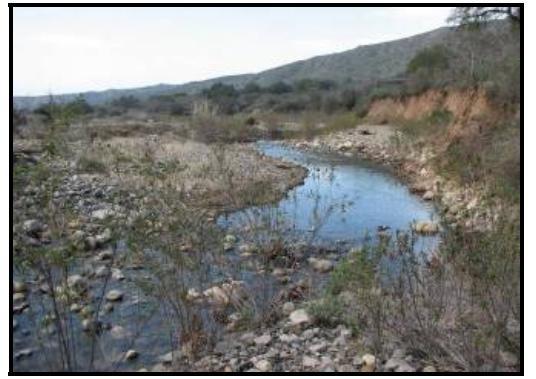
RB U-MW-C

Looking downstream at SanJuan_A with view of far right bank

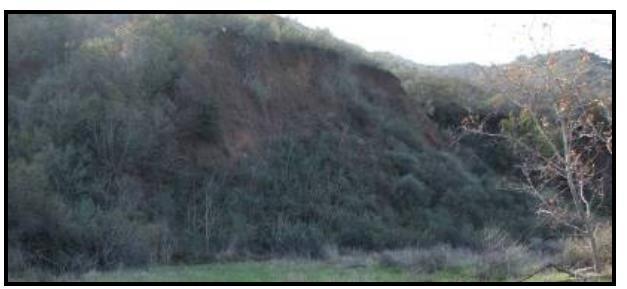
View of far left valley wall - not captured by the survey

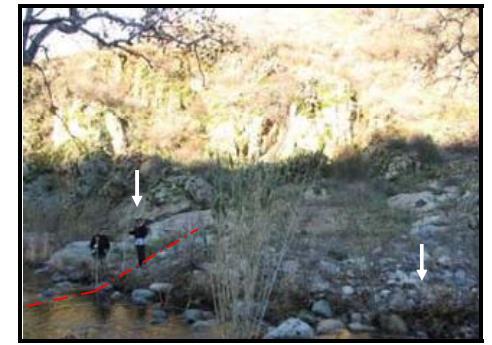
RB S-CONFND

Looking downstream at right bank of SanJuan_B

Although slight MW is evident in the photo of the left bank (left), it is just downstream of the surveyed cross-section, and not representative of the shot geometry. Similarly, the right bank photo (above) shows slight MW through unconsolidated alluvia upstream of the surveyed cross-section, which is itself stable.

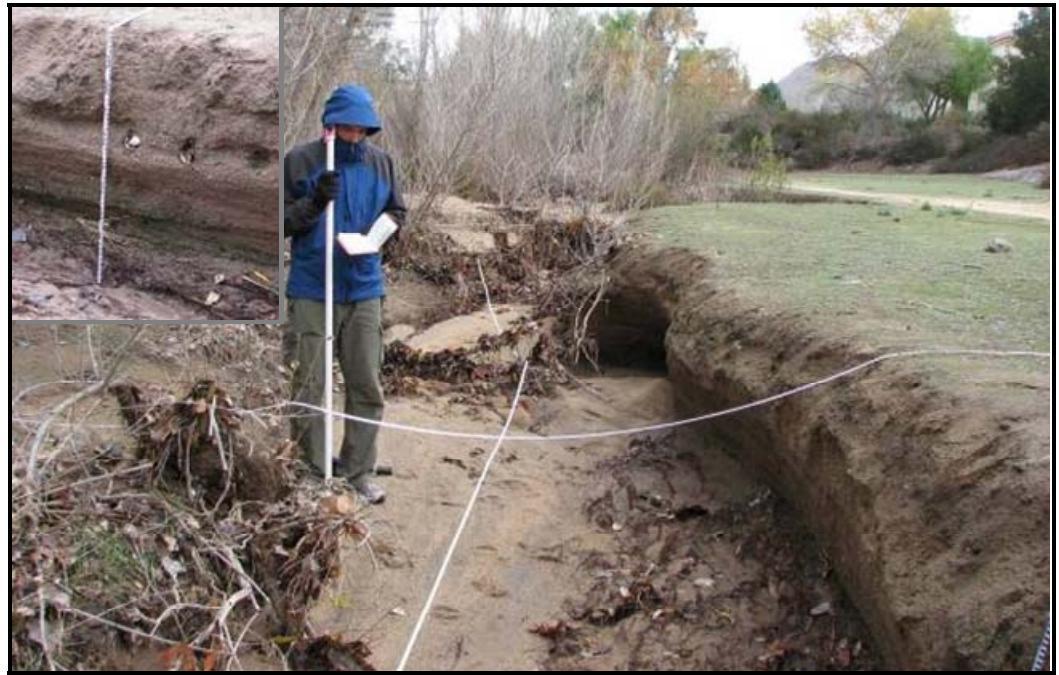
LB U-MW-PC RB U-MW-UC

Looking upstream at Pigeon_A – site was graded during development in the 1980's. Left bank does not appear to be fill (inset) – seems poorly to moderately consolidated. Right bank composed of more alluvial material (unconsolidated)

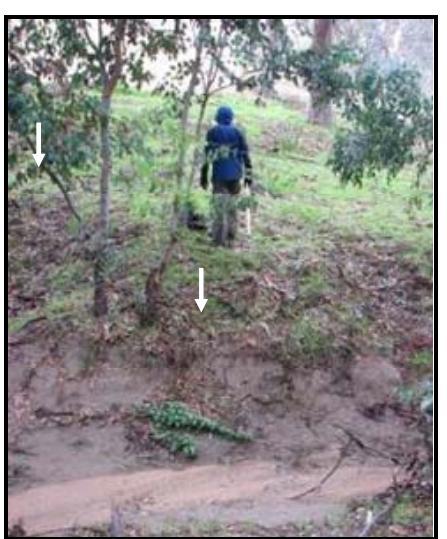
LB U-MW-PC

View of left bank of Pigeon_C

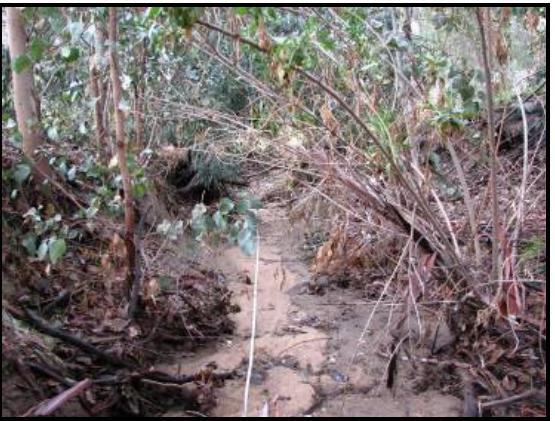
Just downstream of Pigeon_C – MW evident both banks

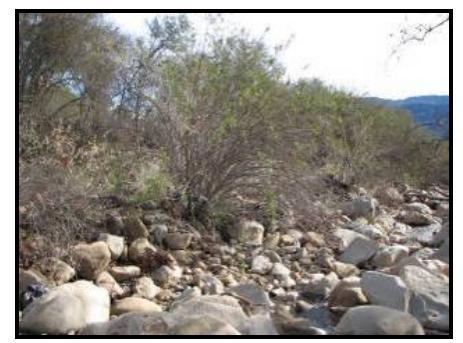
LB STABLE-UC

Looking downstream with view of left bank of Stewart_A

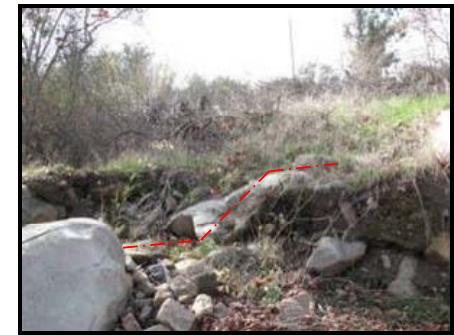
RB S-CONFND and S-CONFND

Looking downstream with view of right bank of Stewart_A – survey captured geometry of boulder embedded in bank (rather than unconsolidated MW just up and downstream

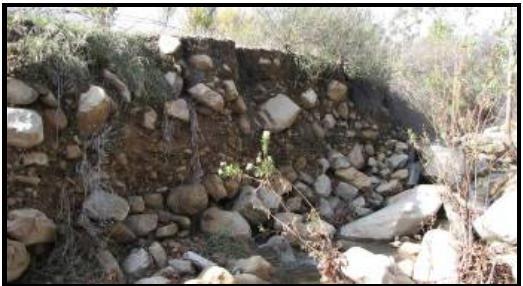
MW in unconsolidated right bank (left) just upstream from cross-section. ~ 2 m @ 70°

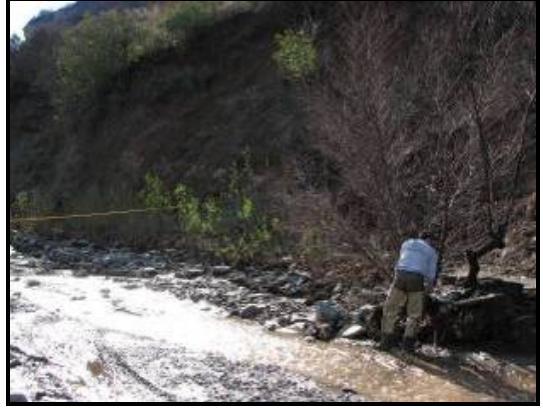
LB U-CONFND (upper) and U-MW-UC (lower)

Looking upstream with view of left bank (valley wall) of Santiagbd_A

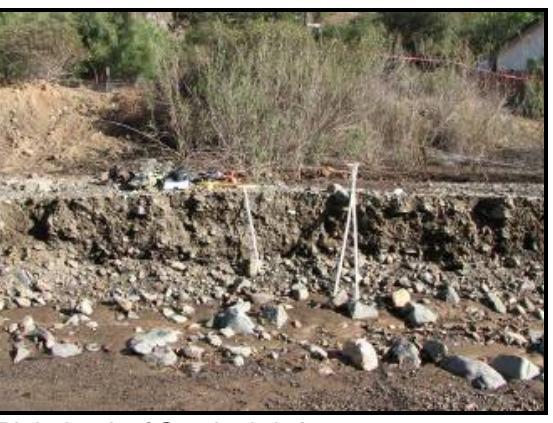
STABLE (upper) and U-MW-UC (lower)

Right bank of Santiagbd_A

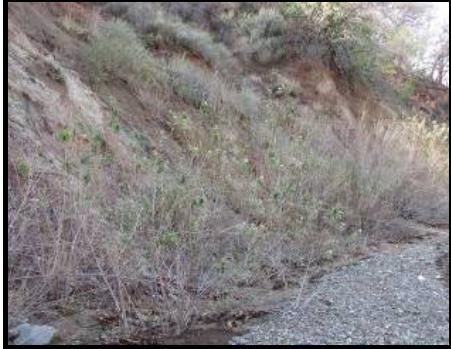
LB U-CONFND (upper) and STABLE-UC RB (lower)

Looking downstream with view of the left bank (valley wall) of Santiagbd_B

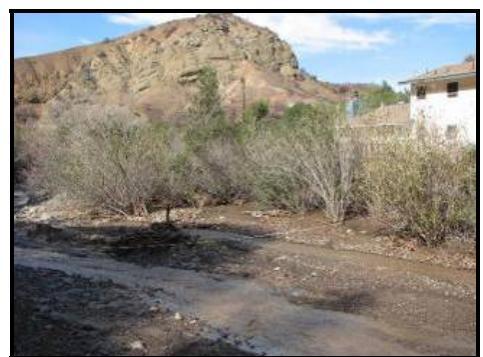
STABLE (upper) and U-MW-UC (lower)

Looking downstream with view of right bank of Santiagbd_B

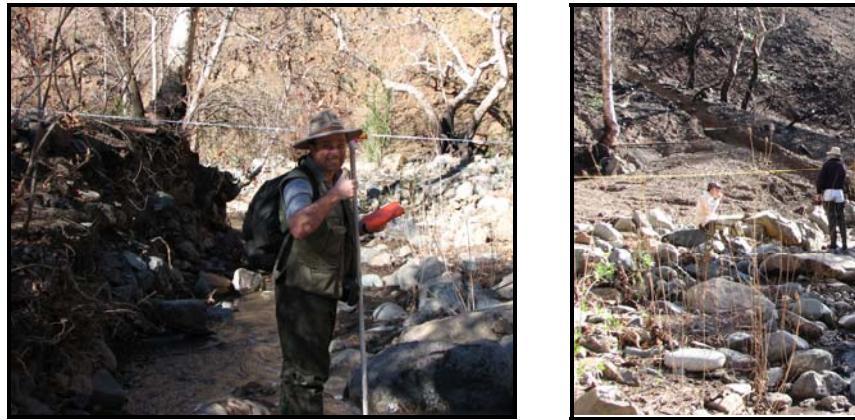
LB U-MW-UC

Looking downstream at Santiagnl_B with view of Looking upstream at Santiagnl_B left bank

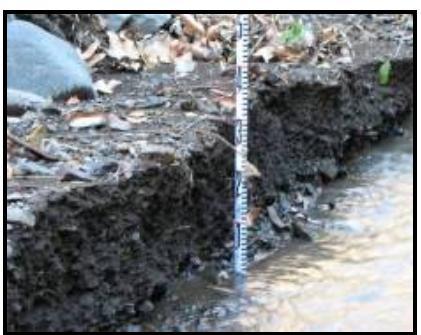
Although not at one of the cross-sections, the purpose of the close-up bank photo (left) is to show how unstable the unconsolidated alluvia are

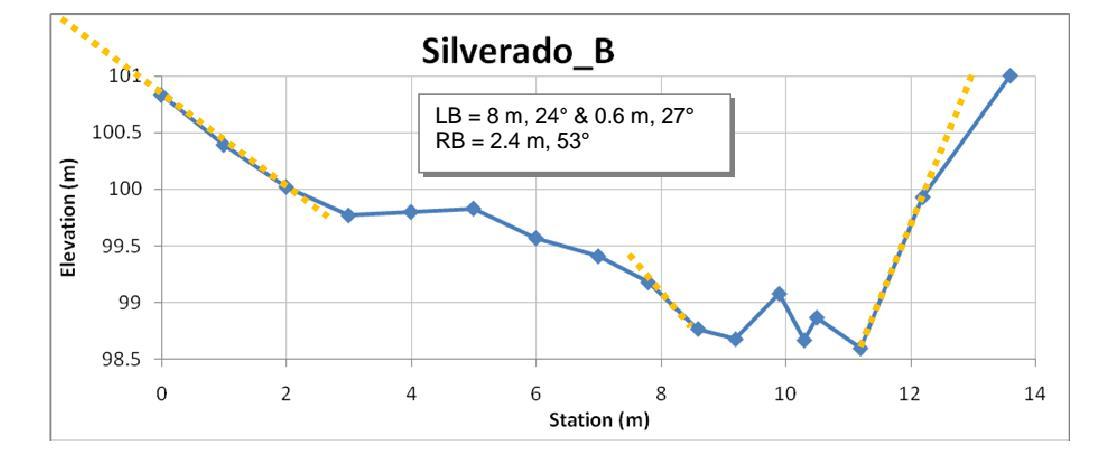
Figure A.71 – Silverado_B

Looking downstream at Silverado_B

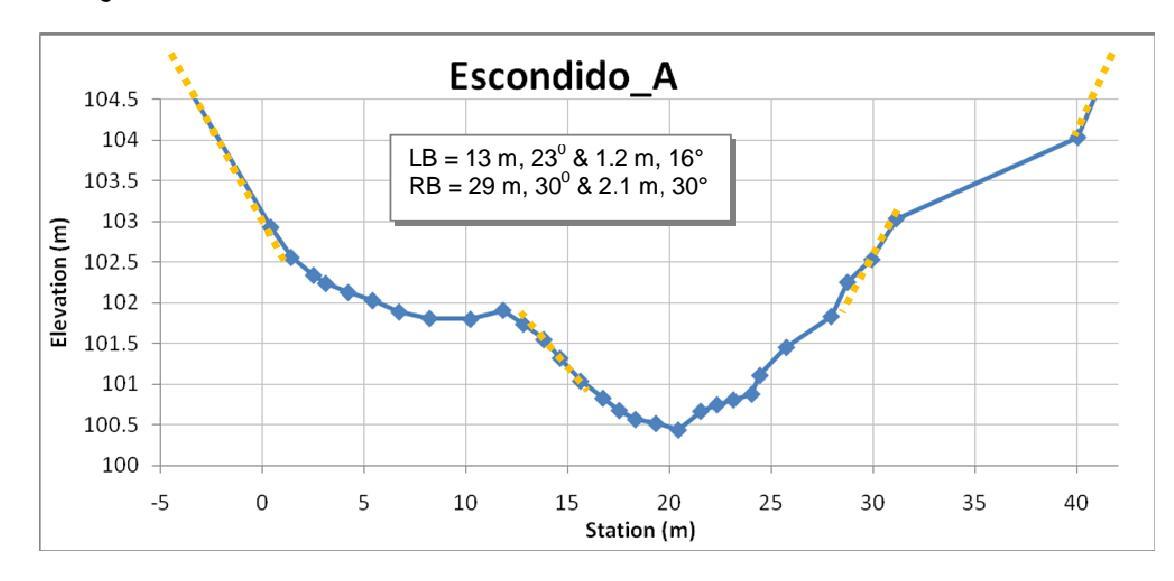
Figure A.72 – Escondido_A

- <image>
- LB S-CONFND (upper) and STABLE-UC RB (lower)
- S-CONFND (upper) and S-CONFND (lower)

Looking downstream at Escondido_A

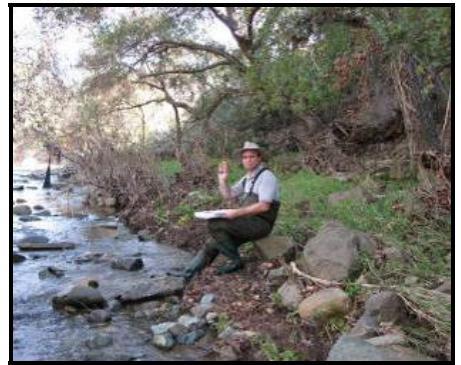
LB S-CONFND (upper) and U-MW-UC (lower)

Looking upstream at left bank of Escondido_B
