APPENDIX A – HYDROMODIFICATION SITE CROSS-SECTIONS, BANKS, AND PHOTOGRAPHS

PURPOSE AND MEASUREMENT PROTOCOL

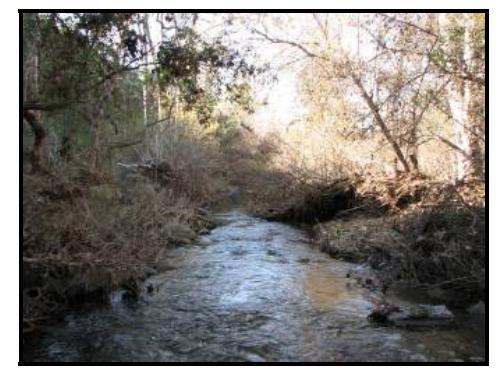
RB S-CONFND (upper) and STABLE-UC (lower)

Looking downstream right channel of Escondido_B

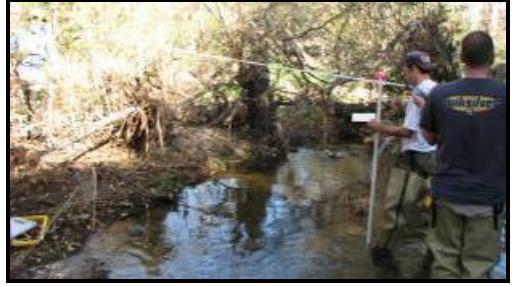
Looking from left bank upstream toward middle island of Escondido_B

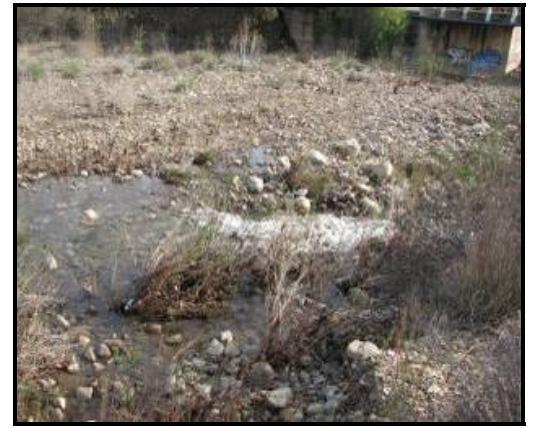
LB U-MW-UC

Looking from right bank of SanAntoni_A at knickpoint just upstream from SanAntoni_B

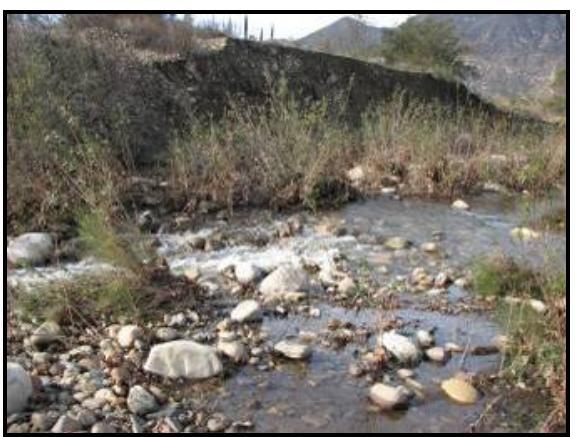
RB STABLE-UC

Looking upstream from near SanAntoni_A, toward left bank of SanAntoni_B

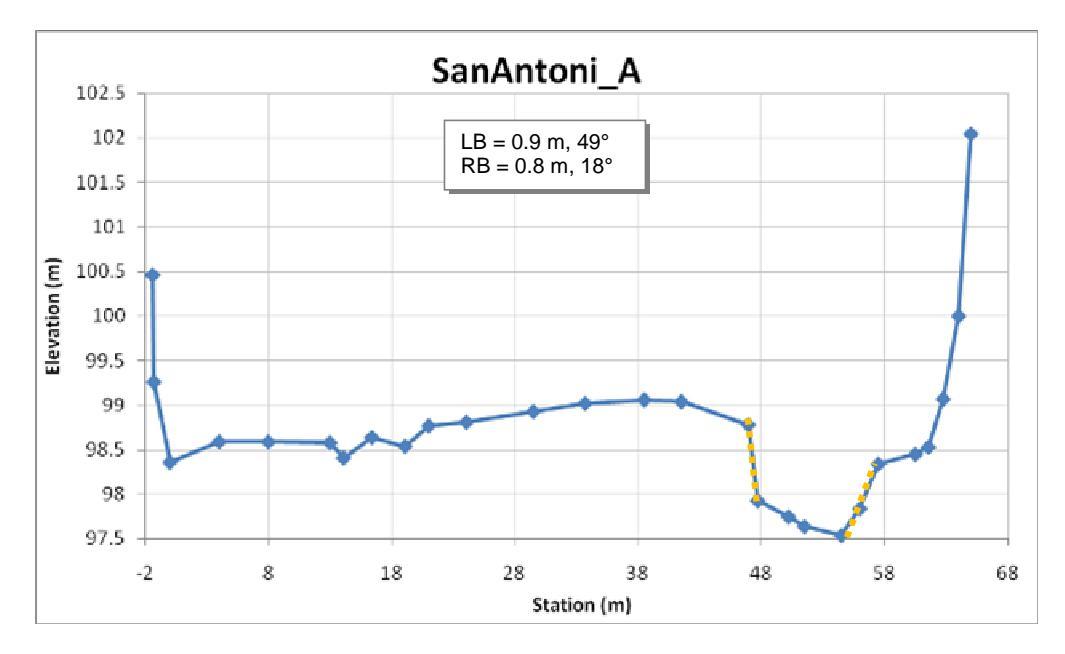
Figure A.74 – SanAntoni_A (San Antonio)

These sites are literally less than 30-m apart. Therefore, the outer banks are only counted once (see SanAntoni_B next page). Only the within the additional incision within the main channel are counted for SanAntoni_A.

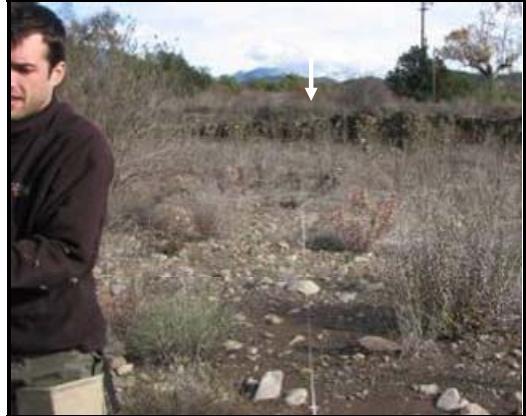
LB U-MW-PC (upper) and STABLE-UC (lower)

Looking at left bank of SanAntoni_B

Although banks are composed of mixed alluvia, they seem to have at least a small degree of consolidation (i.e., poorly consolidated). They stand at angles well over the angle of repose. Furthermore, their height and location indicate that they were formed from deposition quite some time ago (i.e., 50+yrs). I've been using the UC (unconsolidated) label on material that literally just a few years ago was deposited/ a part of the channel bed.

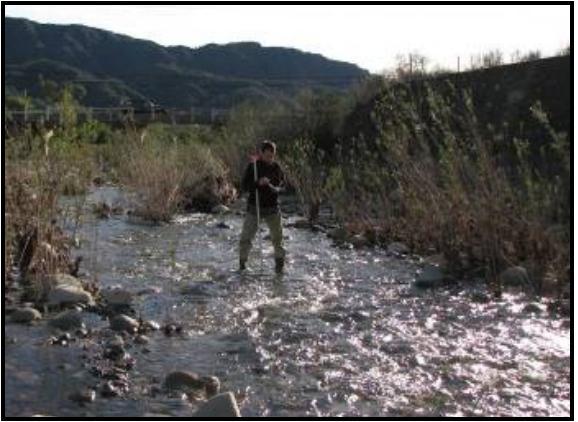
RB U-MW-PC (upper) and STABLE-UC (lower)

Looking downstream of SanAntoni_B

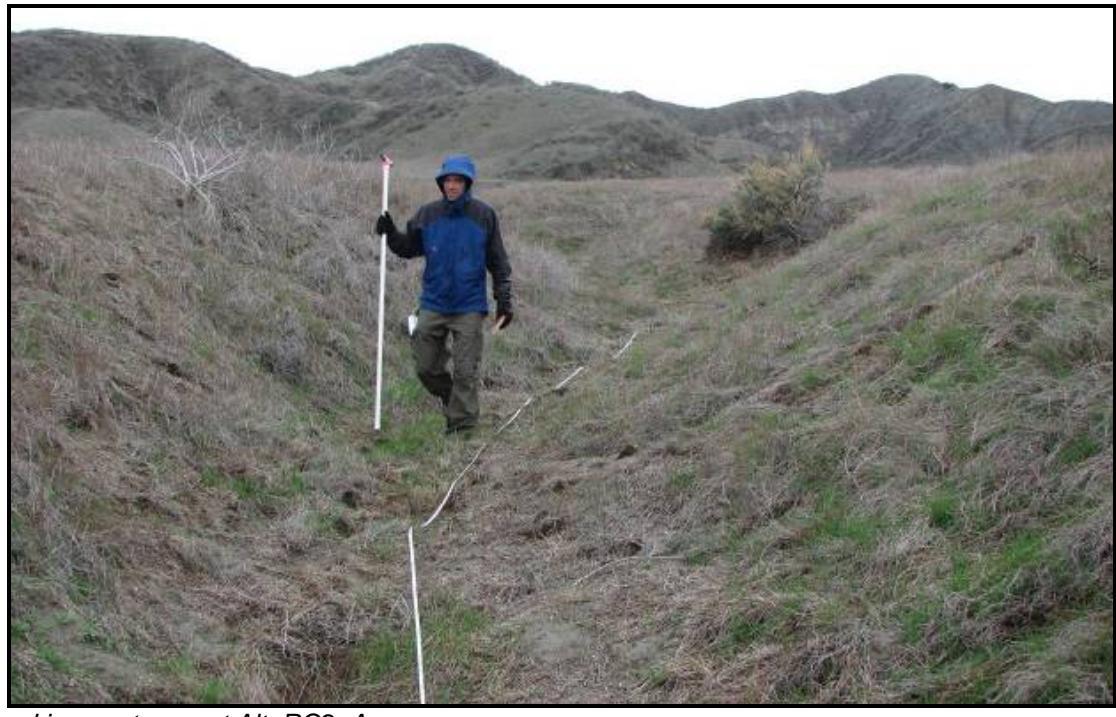
LB STABLE

RB STABLE

Looking upstream at Alt_RC2_A

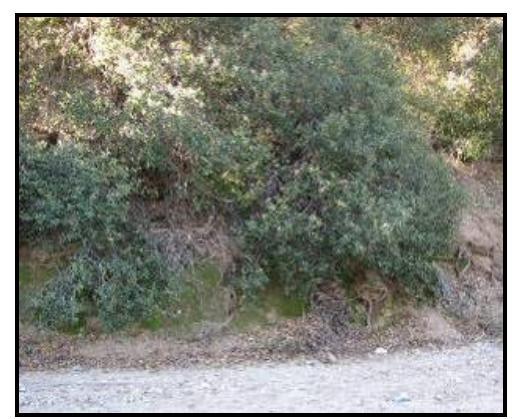
LB U-MW-C

Looking at left bank of Yucaipa_A

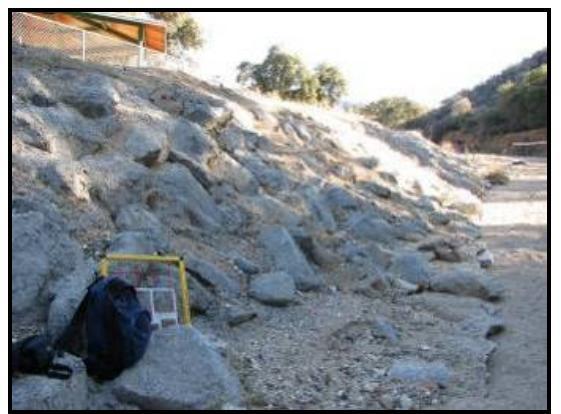
RB S-CONSTR

Looking upstream at right bank of Yucaipa_A

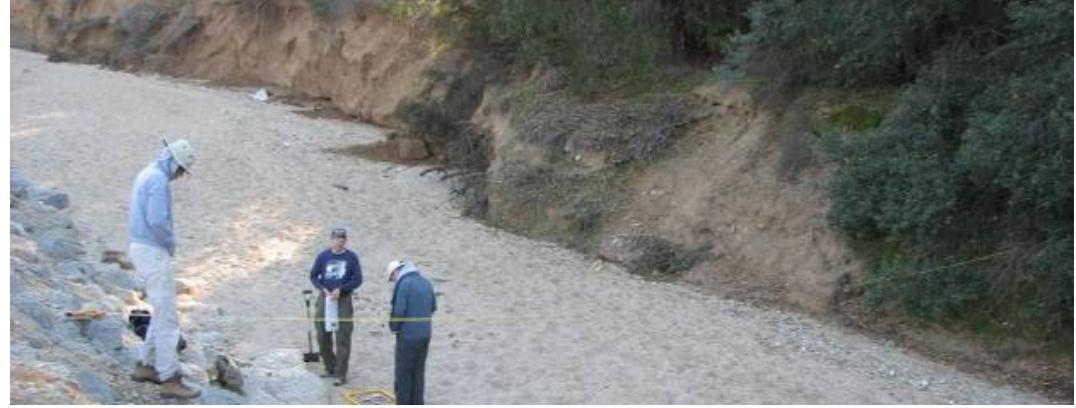
Looking upstream at Yucaipa_A

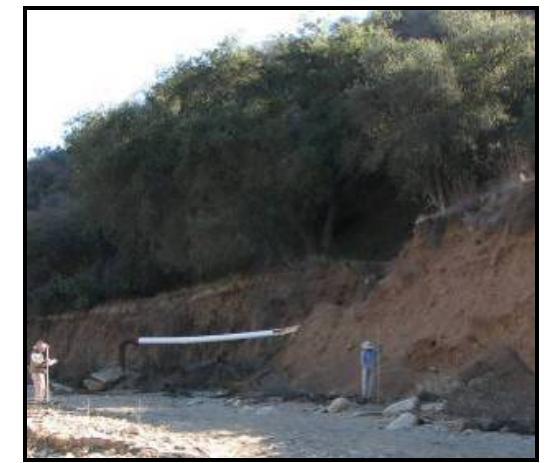
LB U-MW-C

Looking upstream at left bank of Yucaipa_B

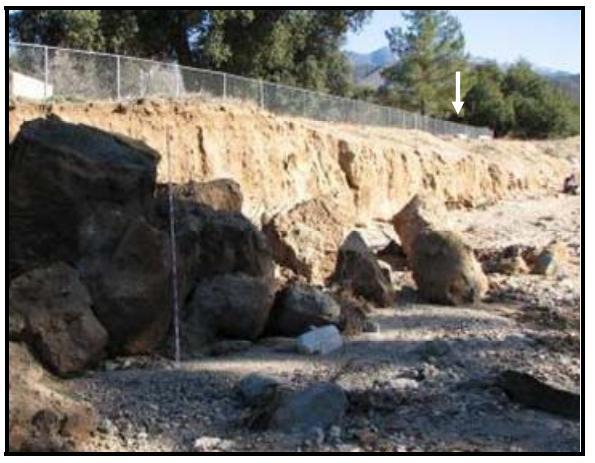
Looking at upstream toward right bank of Yucaipa_B

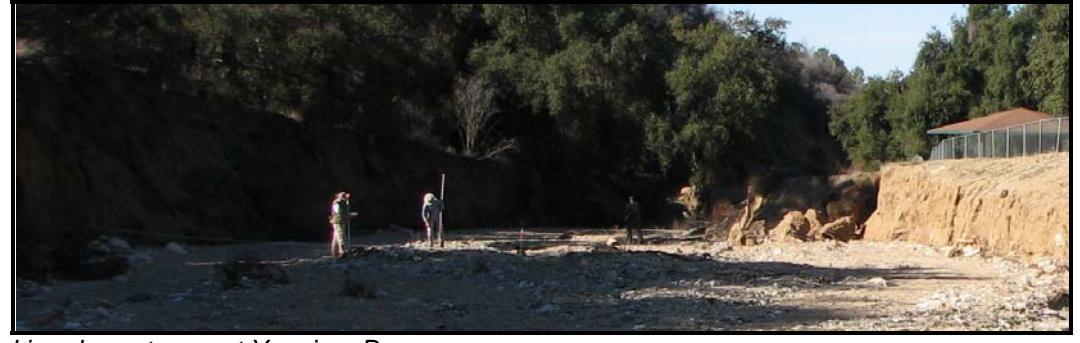
Looking downstream at Yucaipa_B

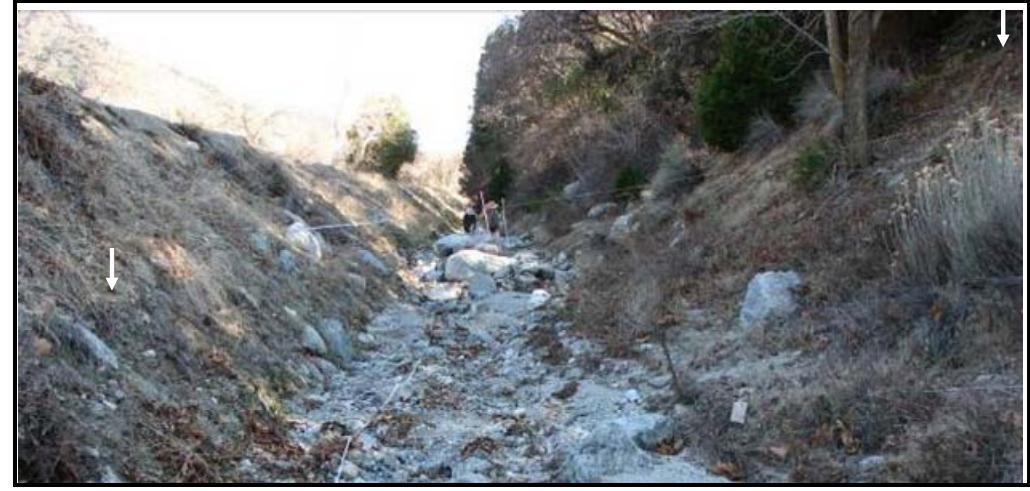
LB U-MW-C RB U-MW-C

Looking upstream at OakGlenn_A

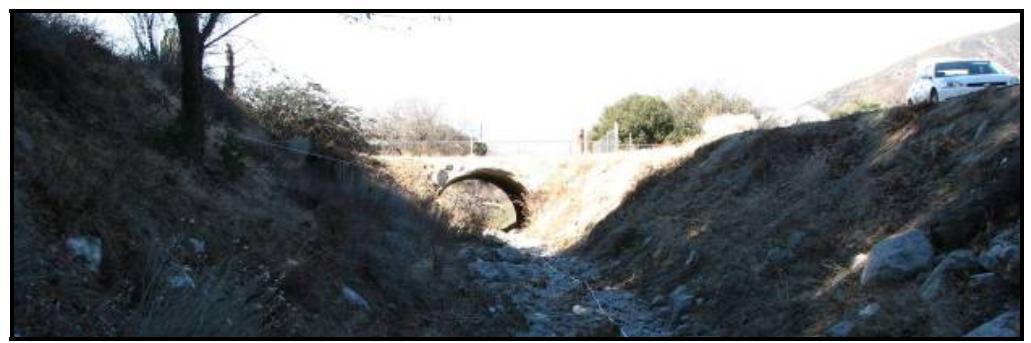
Looking downstream at OakGlenn_A
